# Luckin Food Technology (Shanghai) Co LTD

Ref: FCC Class II Permissive change for FCC ID: 2BO5E-VENUS

This is to request a Class II Permissive change for FCC ID: 2BO5E-VENUS originally granted on 06/09/2025 (date).

Only add new appearance, have the same PCB board and block diagram and operating principle as the certified prototype, except for only change the Main control board (functional) and Hall board (functional), it does not affect Output Power.

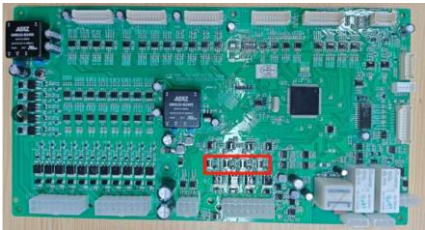
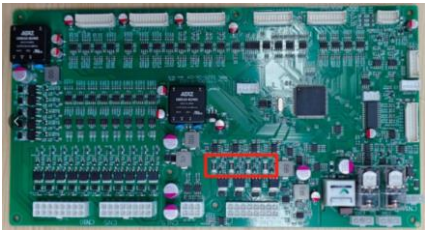
| Original | New | Differences |
|---|---|---|
| | | R451,R427,R435,R465 chip resistance change.<br><br>Improve the accuracy of AD detection. |

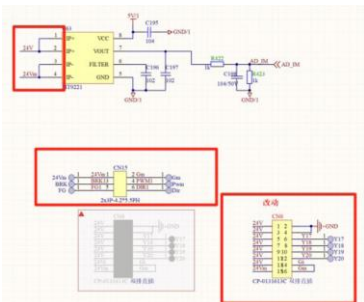
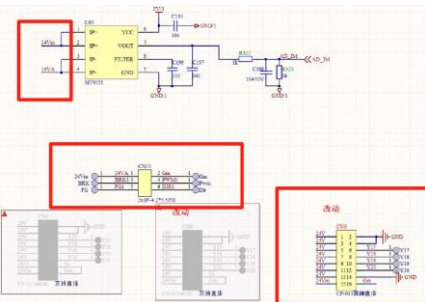
| Original | New | Differences |
|---|---|---|
| | | Modify 24V power supply and ground loop.<br><br>Mainly used to detect whether the brushless motor is blocked; and form a hardware linkage with the Hall board. |

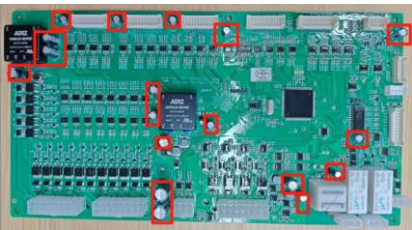
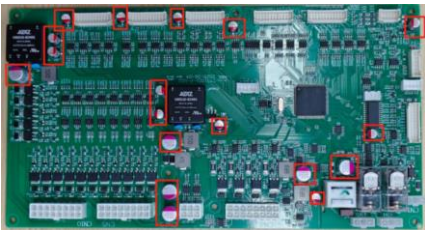
| Original | New | Differences |
|---|---|---|
| | | All electrolytic capacitors are replaced by solid electrolytic capacitors.<br><br>Reduce the equivalent series resistance and improve the service life. |

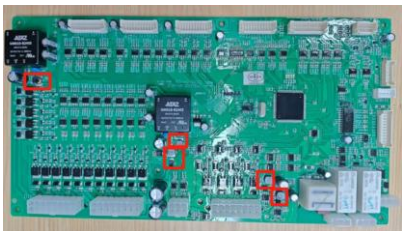
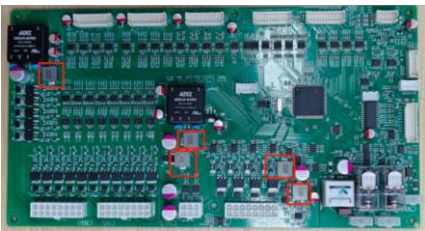
| Original | New | Differences |
|---|---|---|
| | | L2,L3,L4,L8,L9 to shield inductance<br><br>Improve EMC, increase the heat dissipation effect, increase the current flow capacity. |

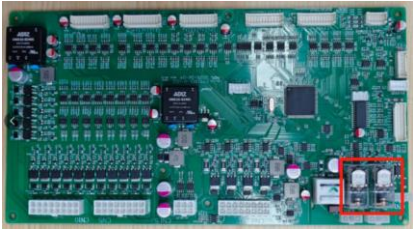
| Original | New | Differences |
|---|---|---|
| | | RLL1,RLL2 Relay Change<br>Manufacturer Changed from Sanyo to Omron<br><br>Improve the working performance of the relay. |

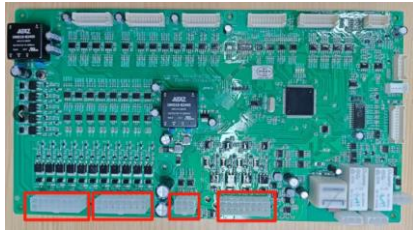
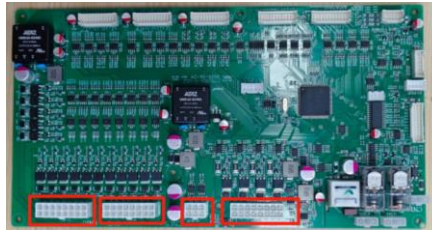
CN6,CN15,CN5,CN10 sockets are replaced by 5566 specifications for 5569 specifications.

The 5569 socket is more solid, and the cable is not easy to loosen.

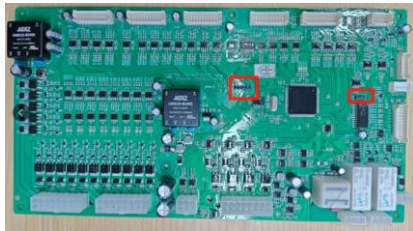
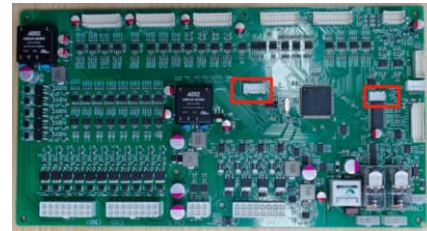
J2,DGB1 Burn Pin Changed from Pin to Socket.

It is convenient for software engineers to debug programs.

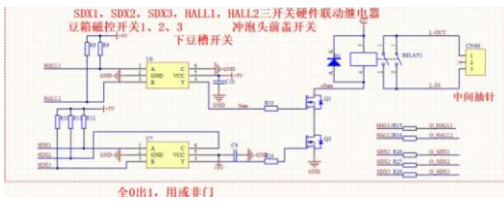
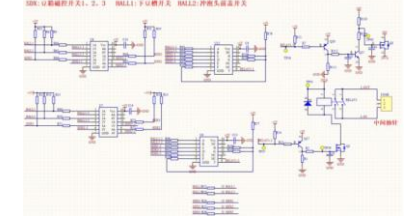
| Original | New | Differences |
|---|---|---|
| | | <p>Added U9 and U13 protection circuits to meet the requirements of safety regulations</p> |

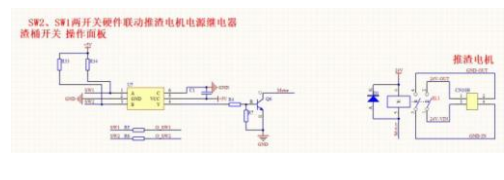
| Original | New | Differences |
|---|---|---|
| | | <p>Add U8 protection circuit to meet the requirements of safety regulations</p> |

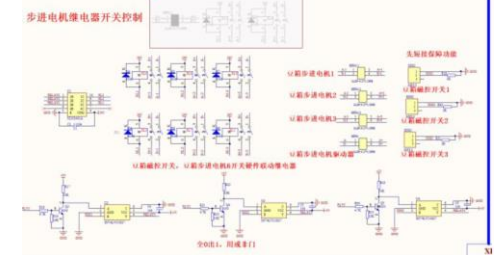
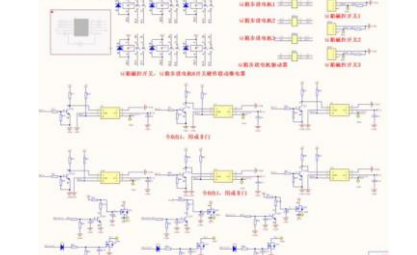
| Original | New | Differences |
|---|---|---|
| | | <p>Added protection circuits U10, U11 and U12 to meet safety requirements</p> |

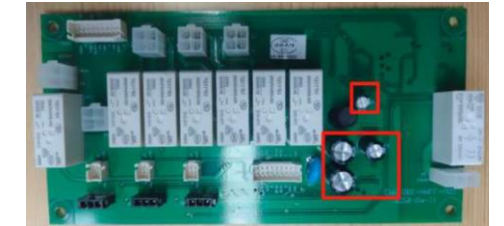
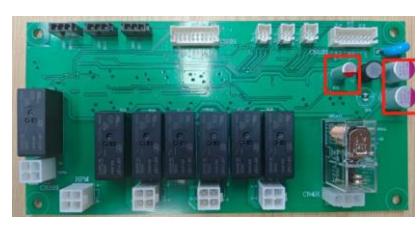
| Original | New | Differences |
|---|---|---|
| | | <p>All electrolytic capacitors are replaced by solid electrolytic capacitors.<br/>Reduce the equivalent series resistance and improve the service life</p> |

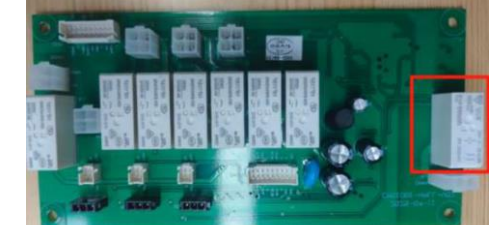
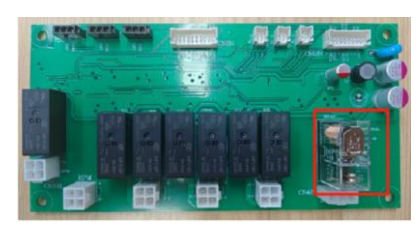
| Original | New | Differences |
|---|---|---|
| | | <p>RELAY1 Relay Change<br/>Manufacturer Changed from Sanyou to Omron<br/>Improve the working performance of the relay</p> |

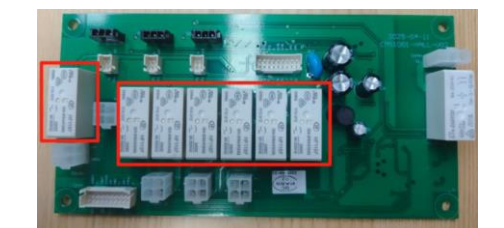
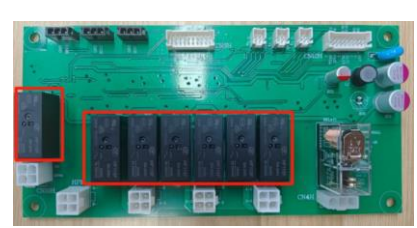
| Original | New | Differences |
|---|---|---|
| | | <p>RL1,3,4,5,6,7,8 relay change<br/>model from HF115-024-2HS4A to HF115-024-2HS4</p> |

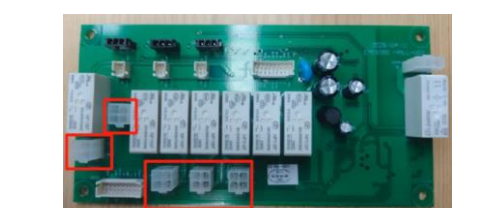
| Original | New | Differences |
|---|---|---|
| | | <p>CN10H;HPM;HPM1;HPM2;HPM3 socket is changed from 5566 specification to 5569 specification.<br/>The 5569 socket is more solid, and the cable is not easy to loosen.</p> |
