## Appendix E: Reference level measurement

## Appendix F: Band edge measurements

## Appendix G: Conducted Spurious Emission

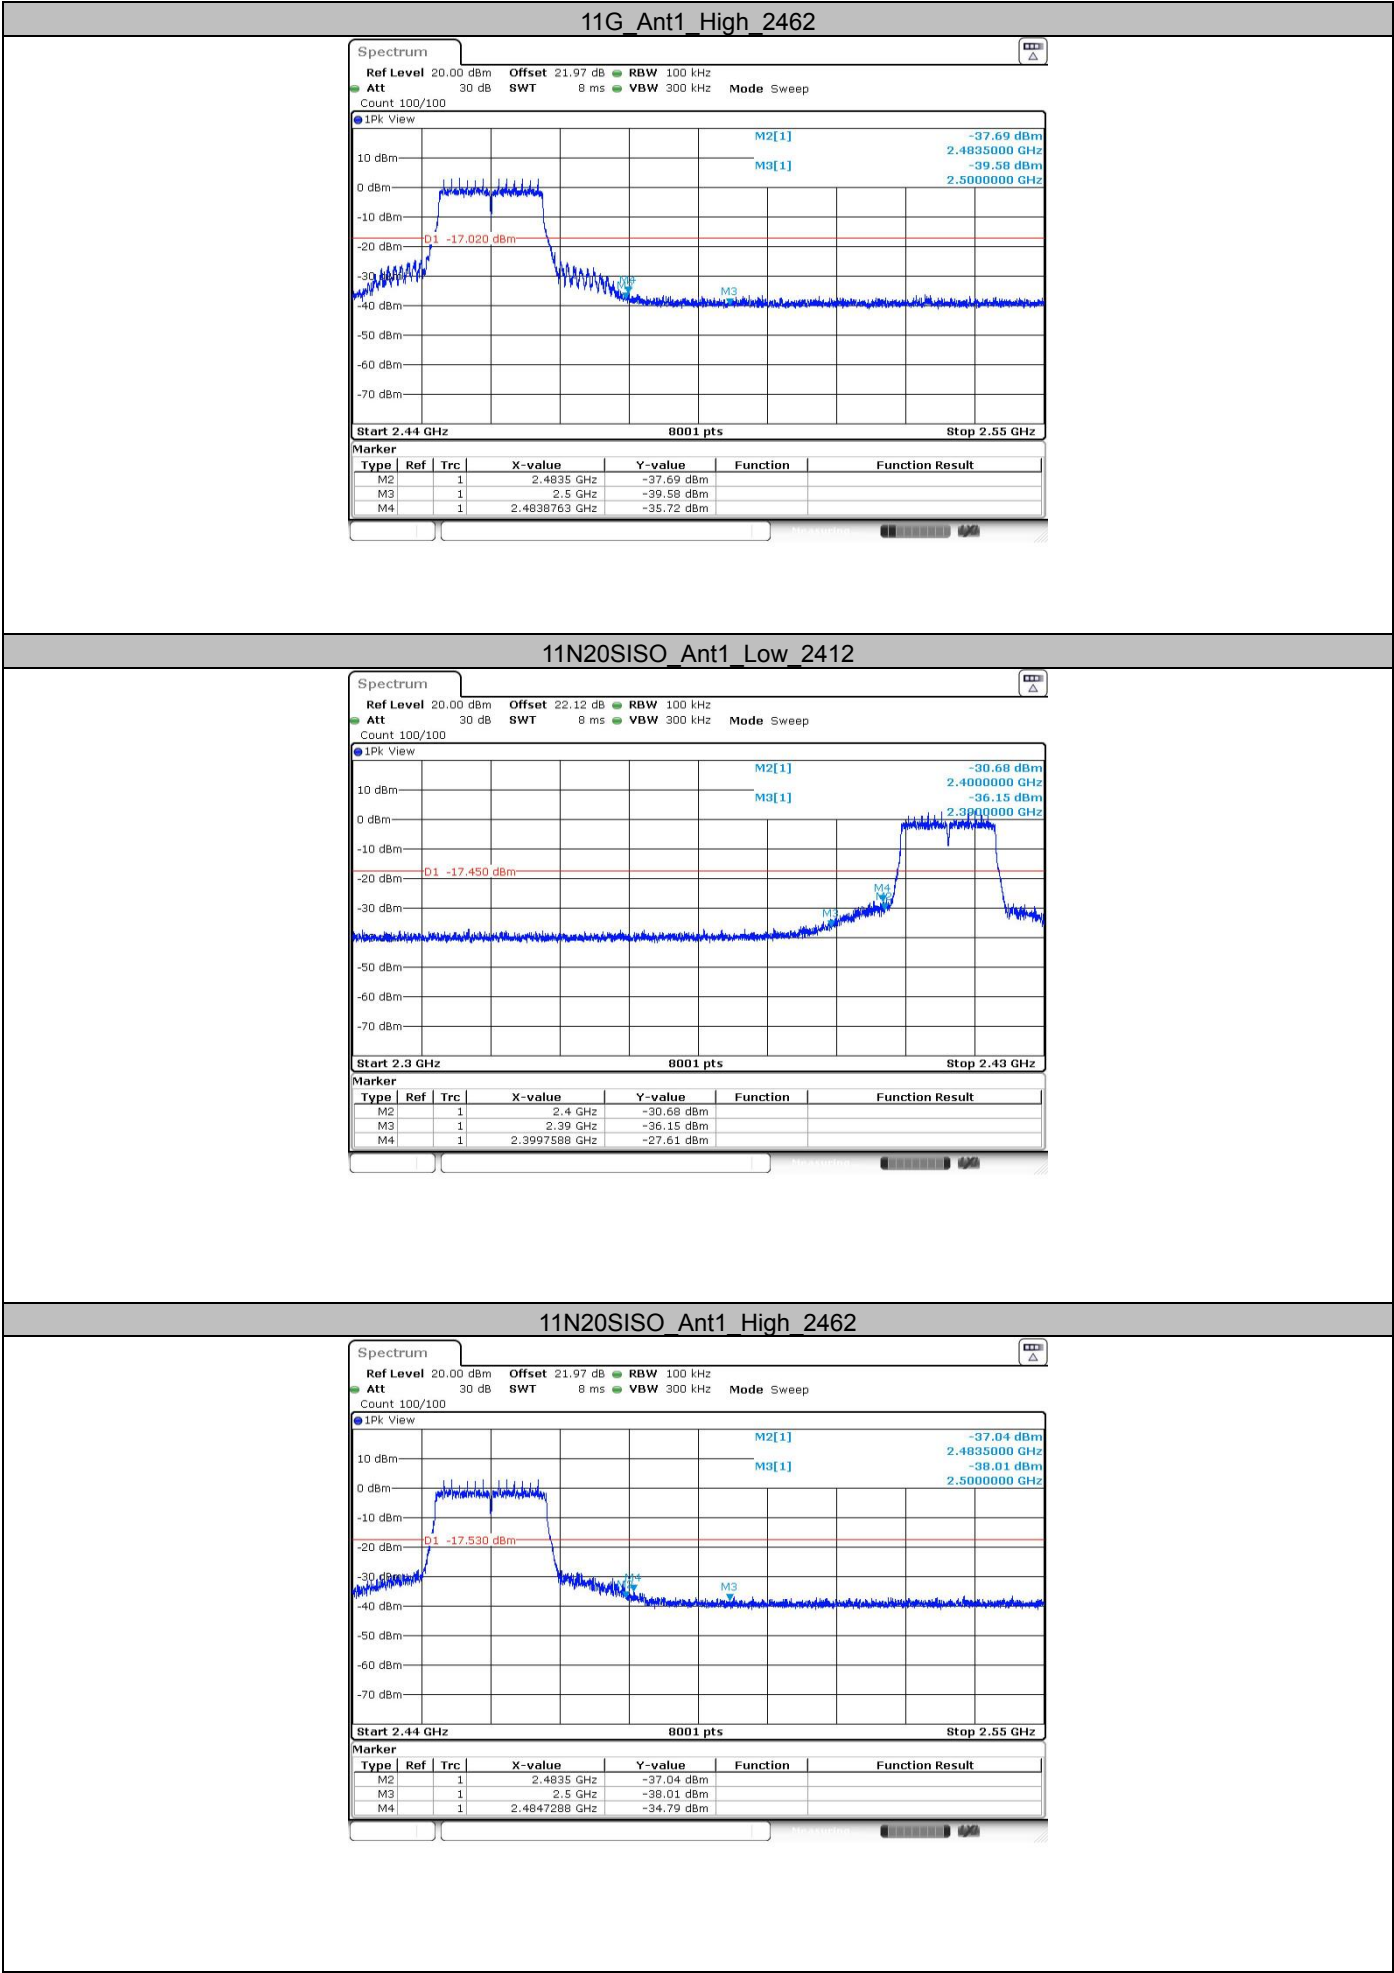
Test Graphs

| TestMode | Antenna | ChName | Frequency[MHz] | RefLevel[dBm] | Result[dBm] | Limit[dBm] | Verdict |
| 11B | Ant1 | Low | 2412 | 5.28 | -26.47 | $\leq -14.72$ | PASS |
| | | High | 2462 | 5.19 | -35.69 | $\leq -14.81$ | PASS |
| 11G | Ant1 | Low | 2412 | 3.24 | -24.53 | $\leq -16.76$ | PASS |
| | | High | 2462 | 2.98 | -35.72 | $\leq -17.02$ | PASS |
| 11N20SISO | Ant1 | Low | 2412 | 2.55 | -27.61 | $\leq -17.45$ | PASS |
| | | High | 2462 | 2.47 | -34.79 | $\leq -17.53$ | PASS |
| 11N40SISO | Ant1 | Low | 2422 | 0.73 | -26.35 | $\leq -19.27$ | PASS |
| | | High | 2452 | 1.06 | -29.51 | $\leq -18.94$ | PASS |

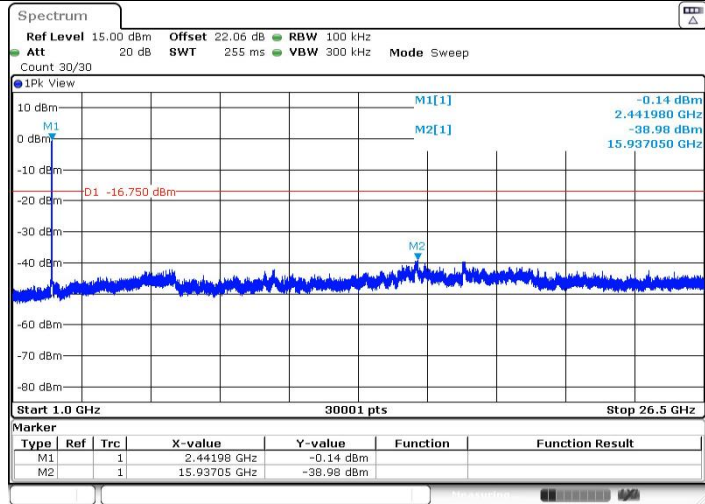
## 11N20SISO\_Ant1\_2437\_1000~26500

| TestMode | Antenna | Frequency[MHz] | FreqRange [Mhz] | RefLevel [dBm] | Result [dBm] | Limit [dBm] | Verdict |
|---|---|---|---|---|---|---|---|
| | | | 1000~26500 | 3.25 | -38.98 | ≤-16.75 | PASS |

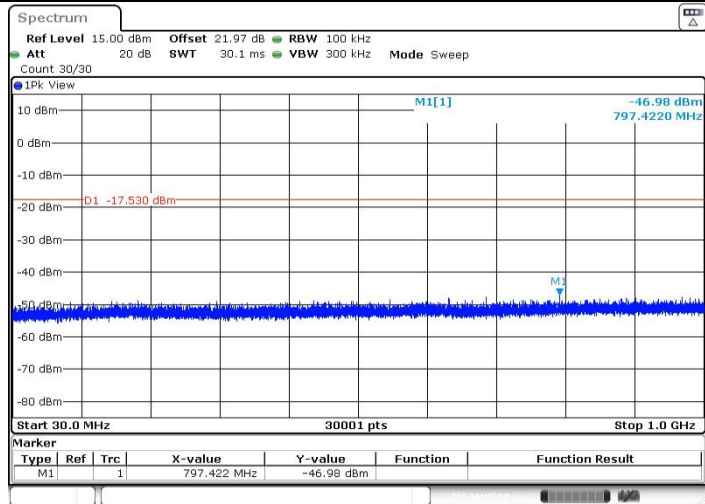
## 11N20SISO\_Ant1\_2462\_30~1000

| TestMode | Antenna | Frequency[MHz] | FreqRange [Mhz] | RefLevel [dBm] | Result [dBm] | Limit [dBm] | Verdict |
|---|---|---|---|---|---|---|---|
| | | 2462 | 30~1000 | 2.47 | -46.98 | ≤-17.53 | PASS |

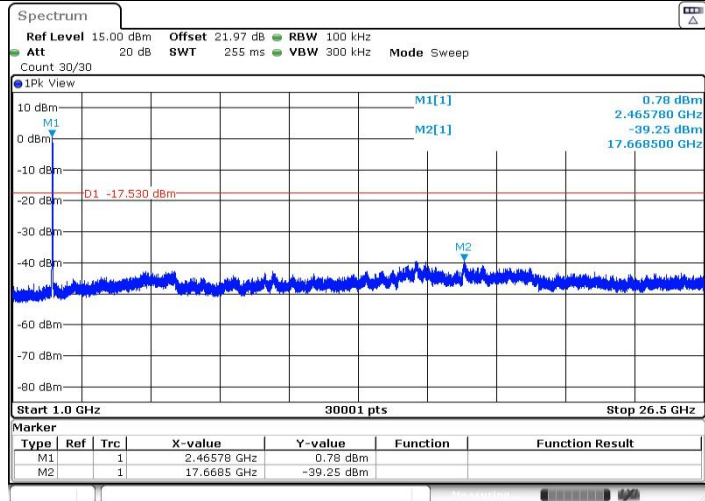
## 11N20SISO\_Ant1\_2462\_1000~26500

| TestMode | Antenna | Frequency[MHz] | FreqRange [Mhz] | RefLevel [dBm] | Result [dBm] | Limit [dBm] | Verdict |
|---|---|---|---|---|---|---|---|
| | | | 1000~26500 | 2.47 | -39.25 | ≤-17.53 | PASS |
