## APPENDIX A: PHOTOGRAPHS OF TEST SETUP

## APPENDIX B: PHOTOGRAPHS OF EUT

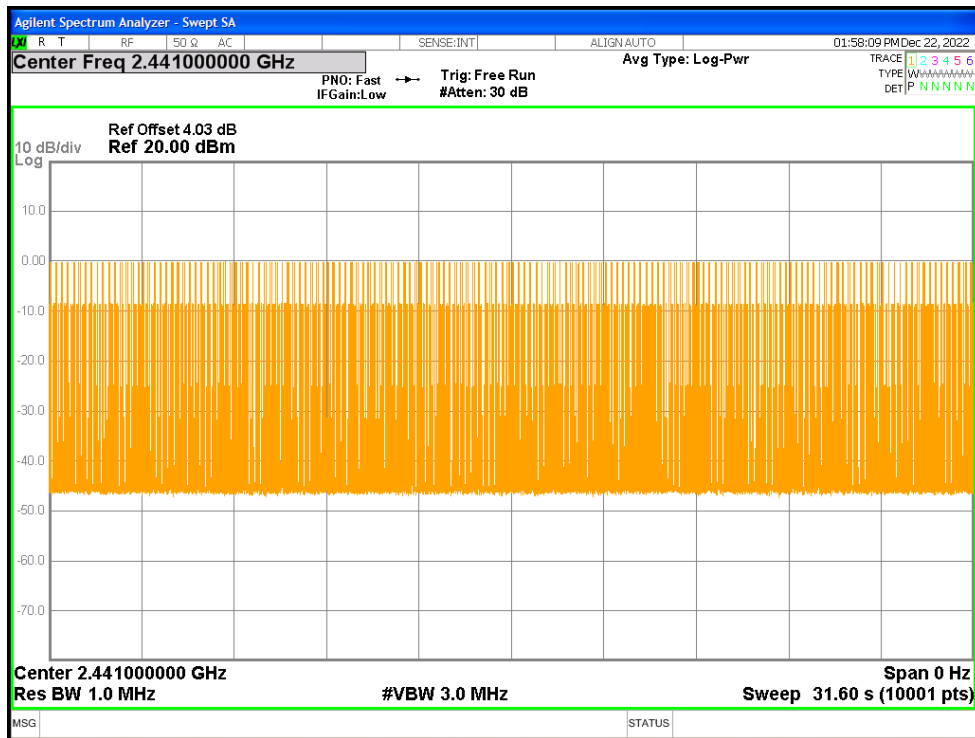
Dwell NVNT 1-DH3 2441MHz Ant1 One Burst

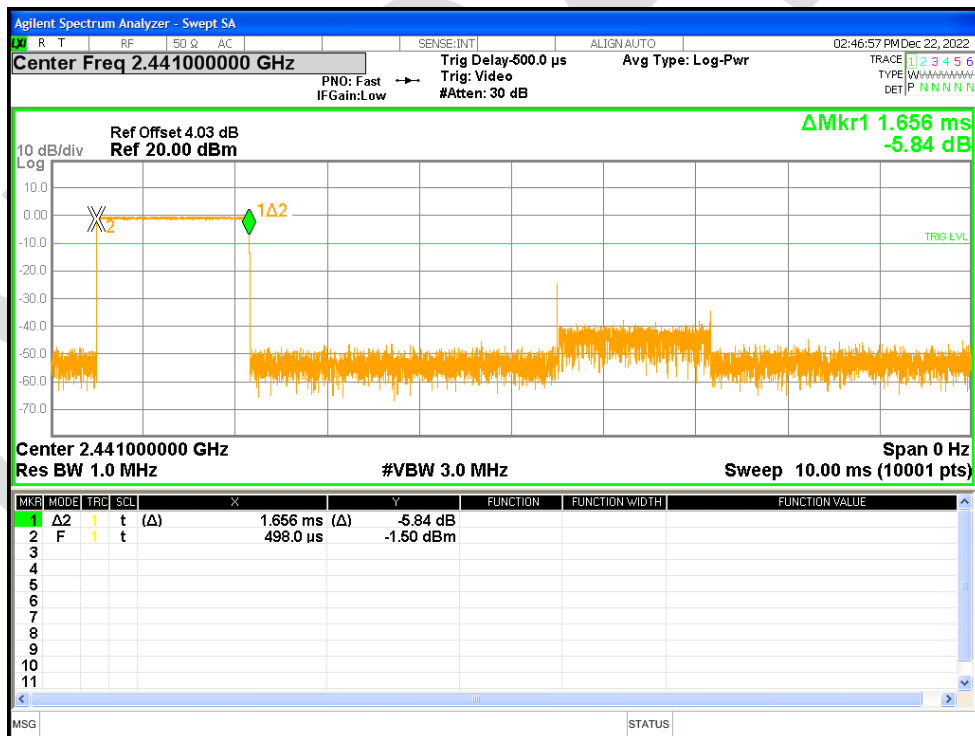
Dwell NVNT 1-DH3 2441MHz Ant1 Accumulated

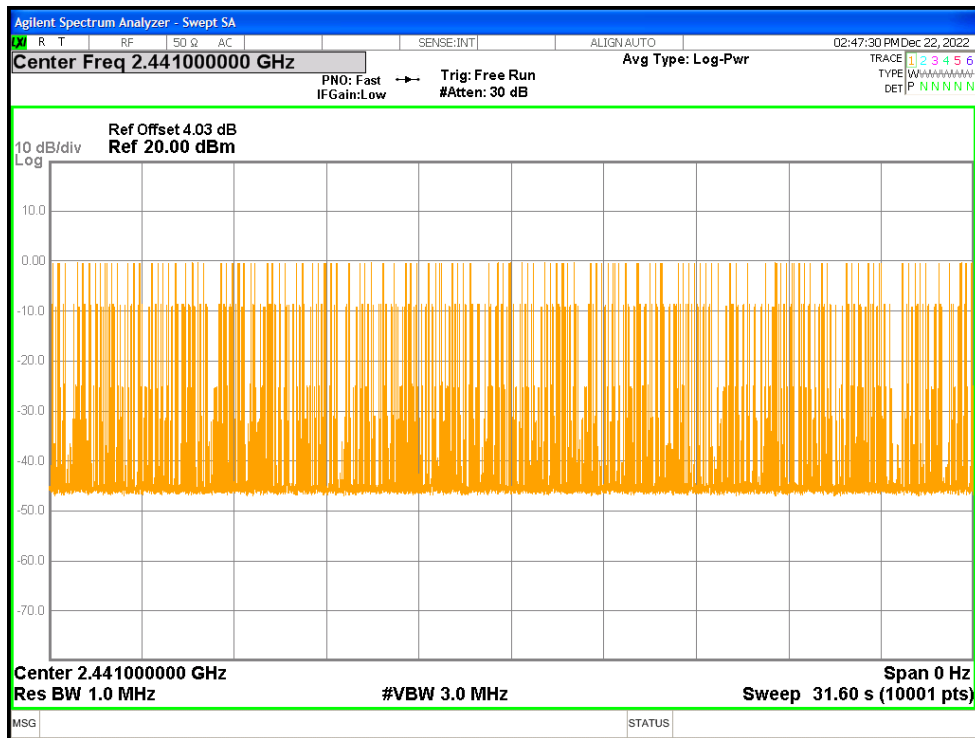
Dwell NVNT 1-DH5 2441MHz Ant1 One Burst

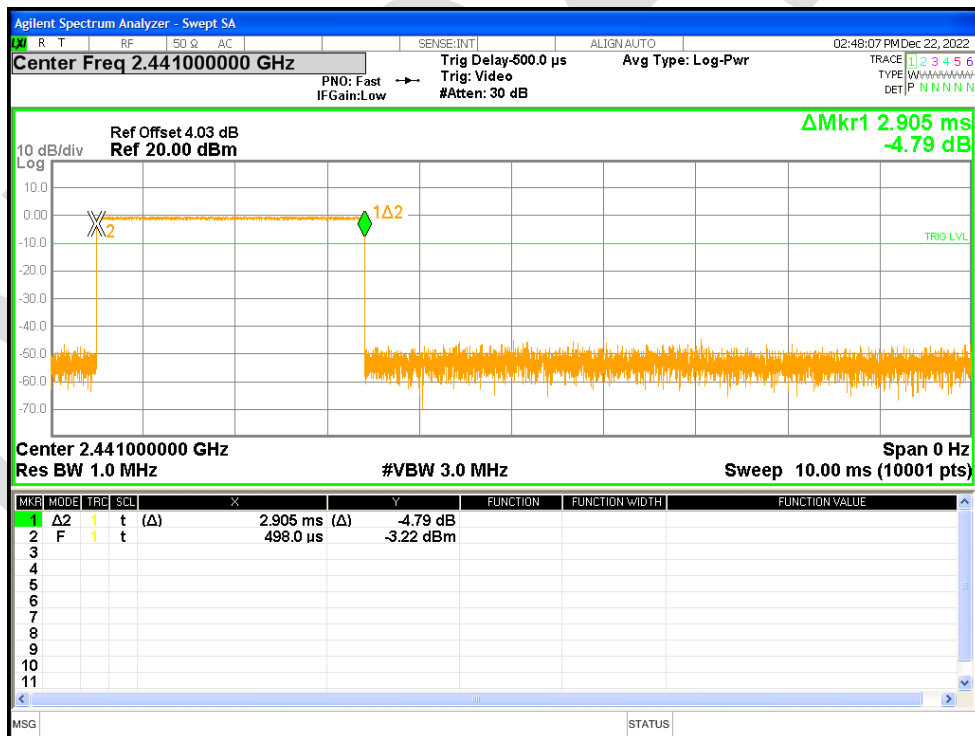
Dwell NVNT 1-DH5 2441MHz Ant1 Accumulated

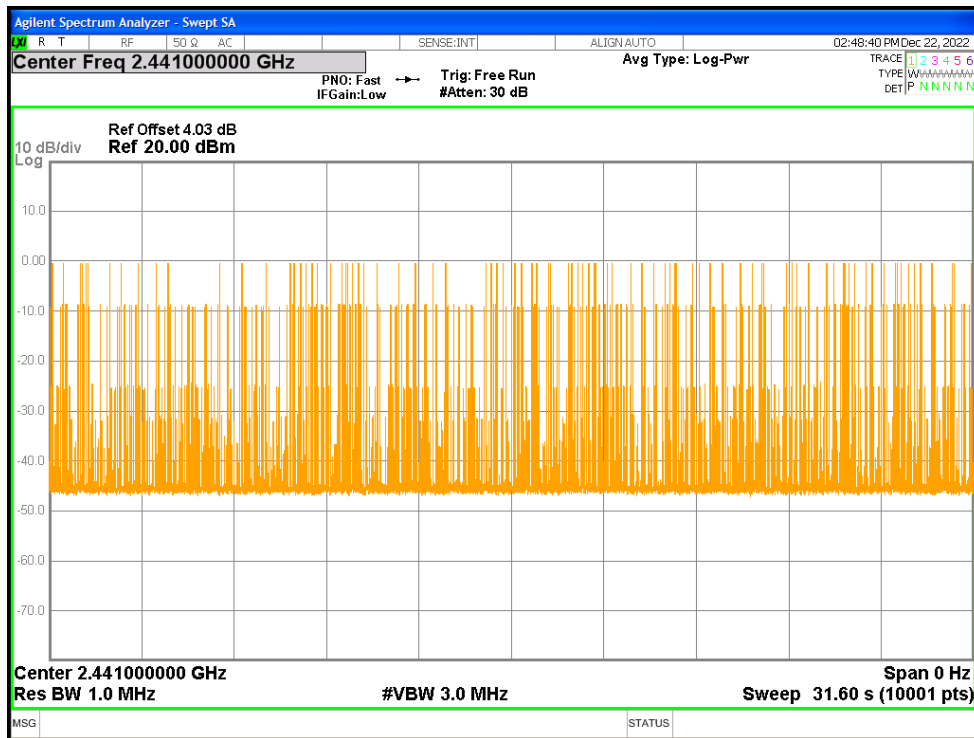
Dwell NVNT 2-DH1 2441MHz Ant1 One Burst

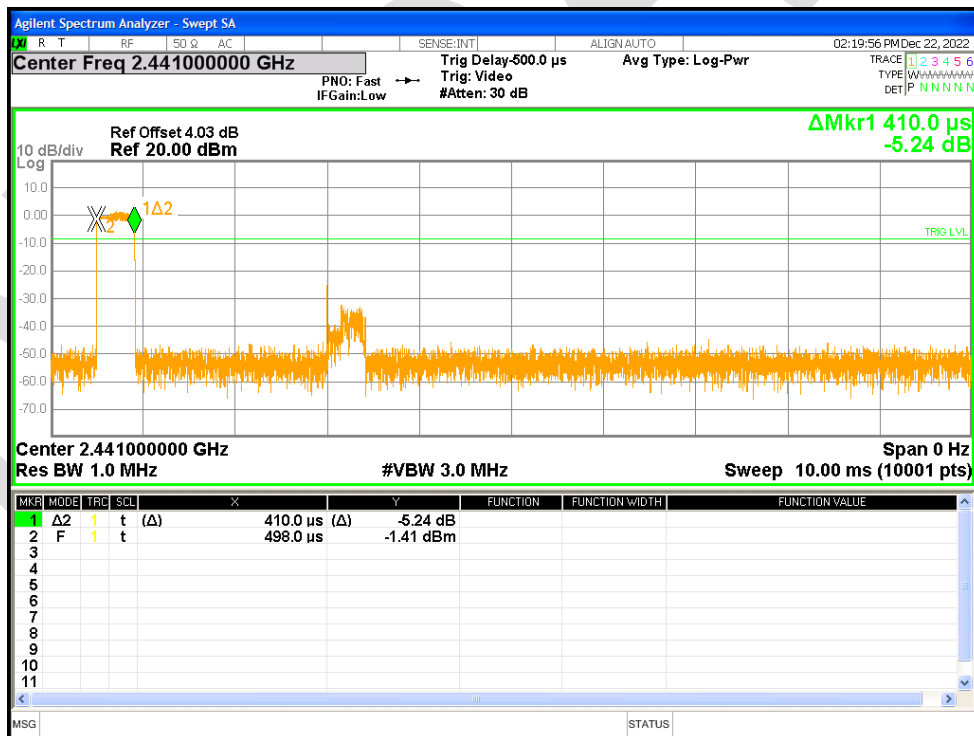
Dwell NVNT 2-DH1 2441MHz Ant1 Accumulated

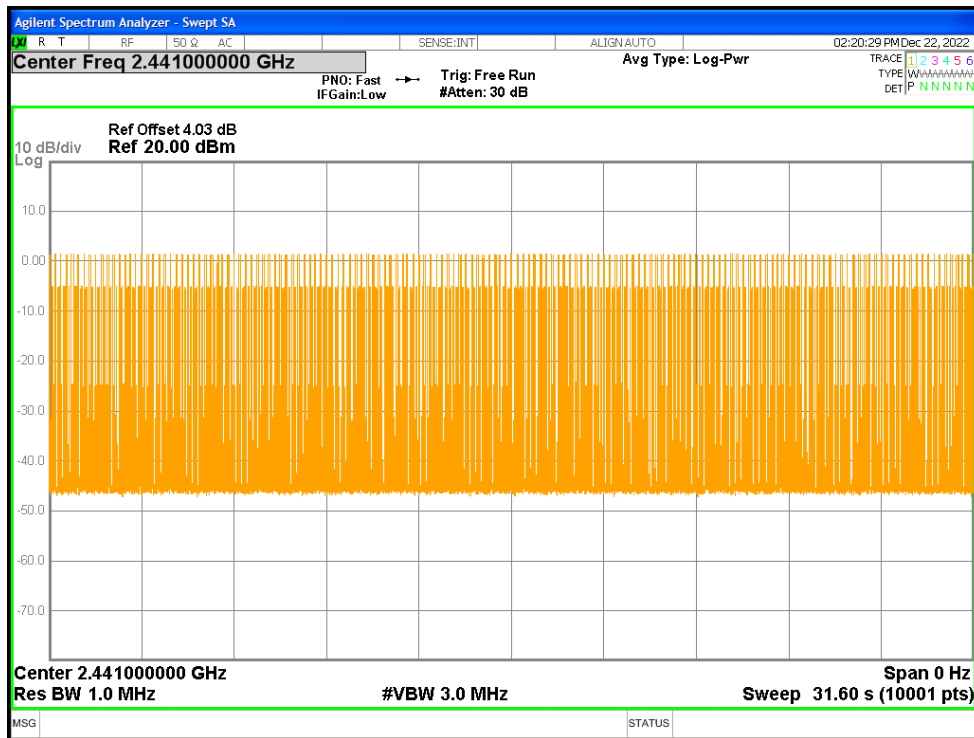
Dwell NVNT 2-DH5 2441MHz Ant1 One Burst

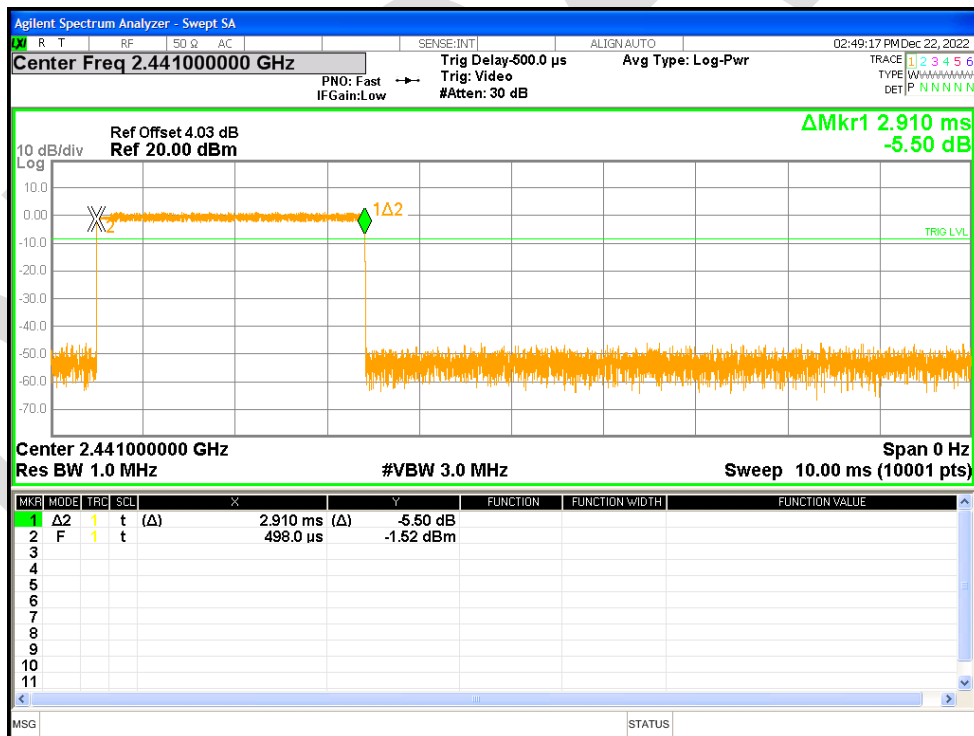
Dwell NVNT 2-DH5 2441MHz Ant1 Accumulated

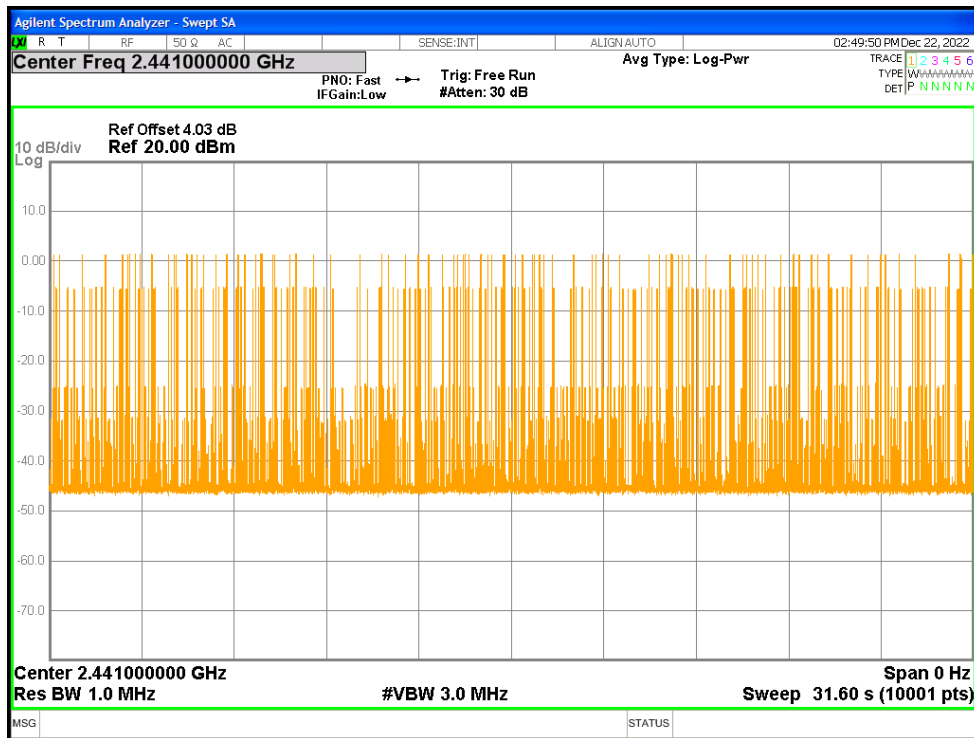
Dwell NVNT 3-DH1 2441MHz Ant1 One Burst

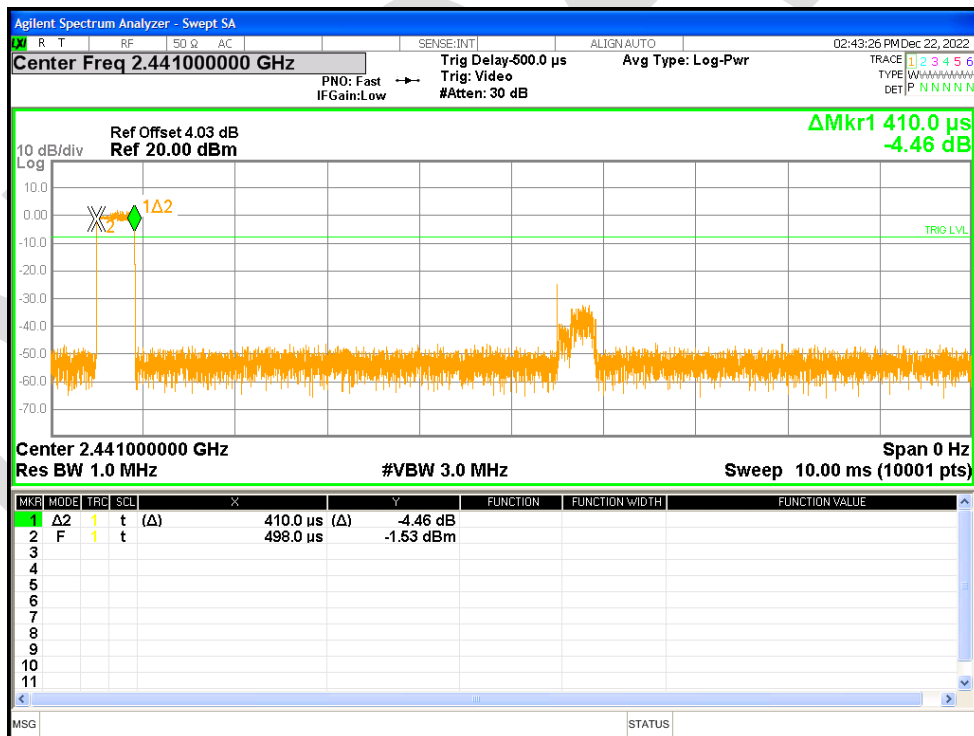
Dwell NVNT 3-DH1 2441MHz Ant1 Accumulated

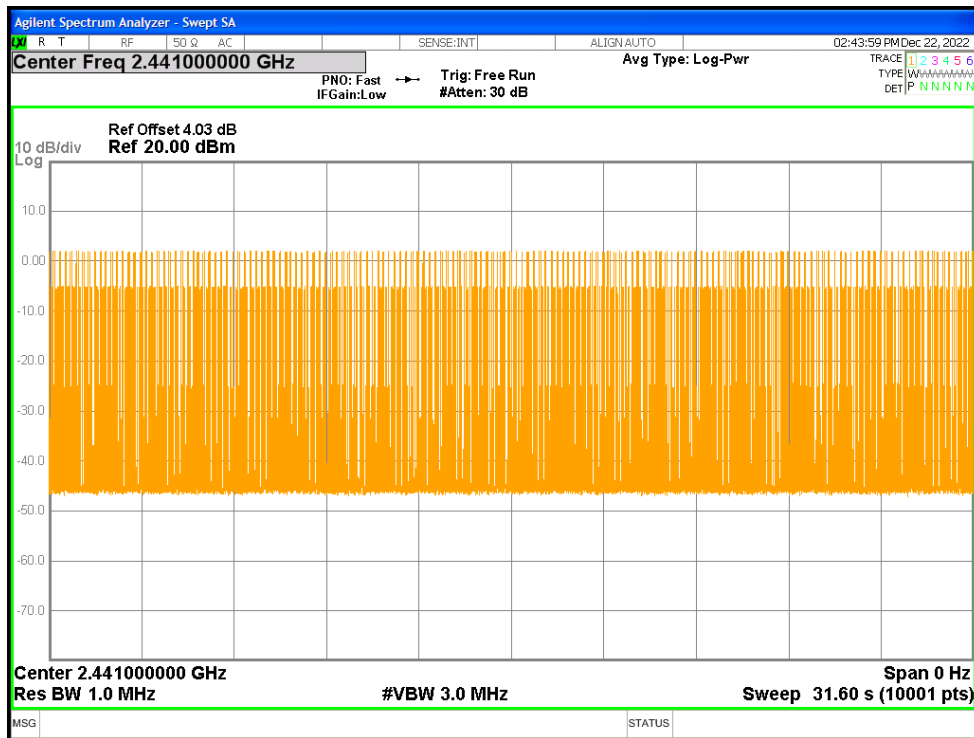
Dwell NVNT 3-DH5 2441MHz Ant1 One Burst

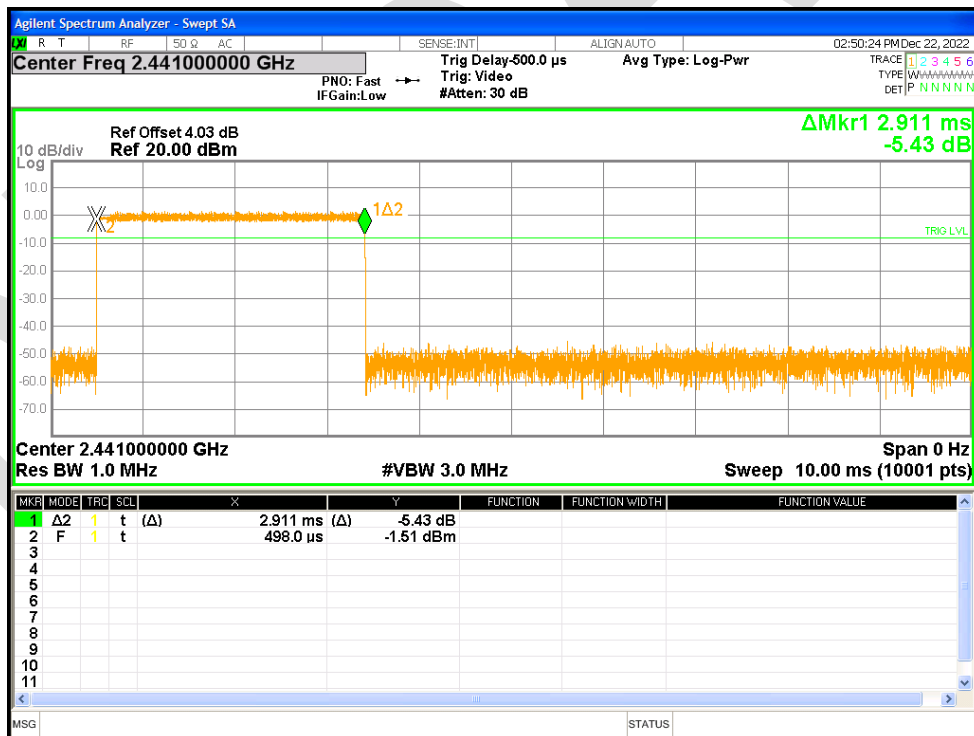
Dwell NVNT 3-DH5 2441MHz Ant1 Accumulated

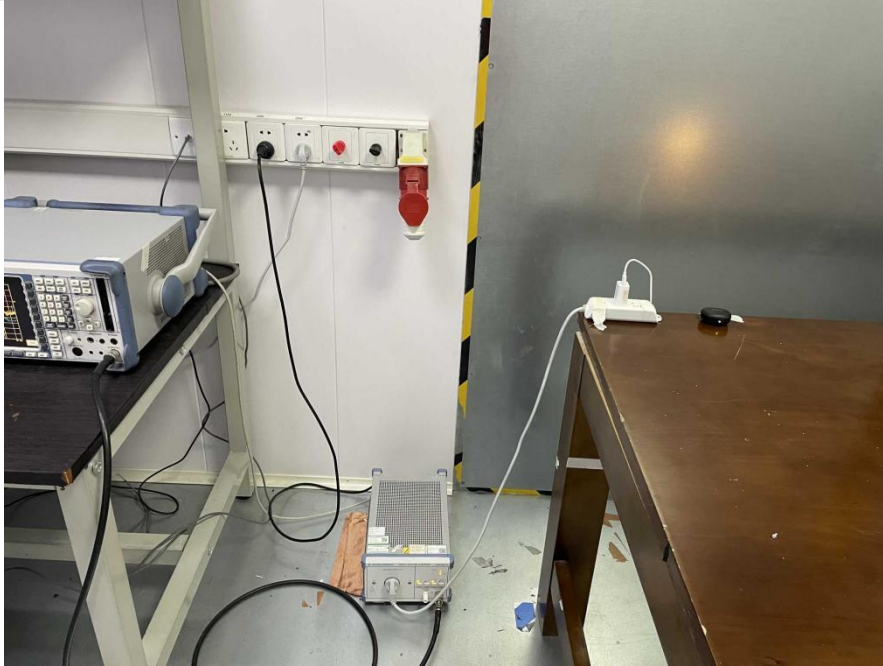
### Conducted Emissions at AC Power Line (150kHz-30MHz)

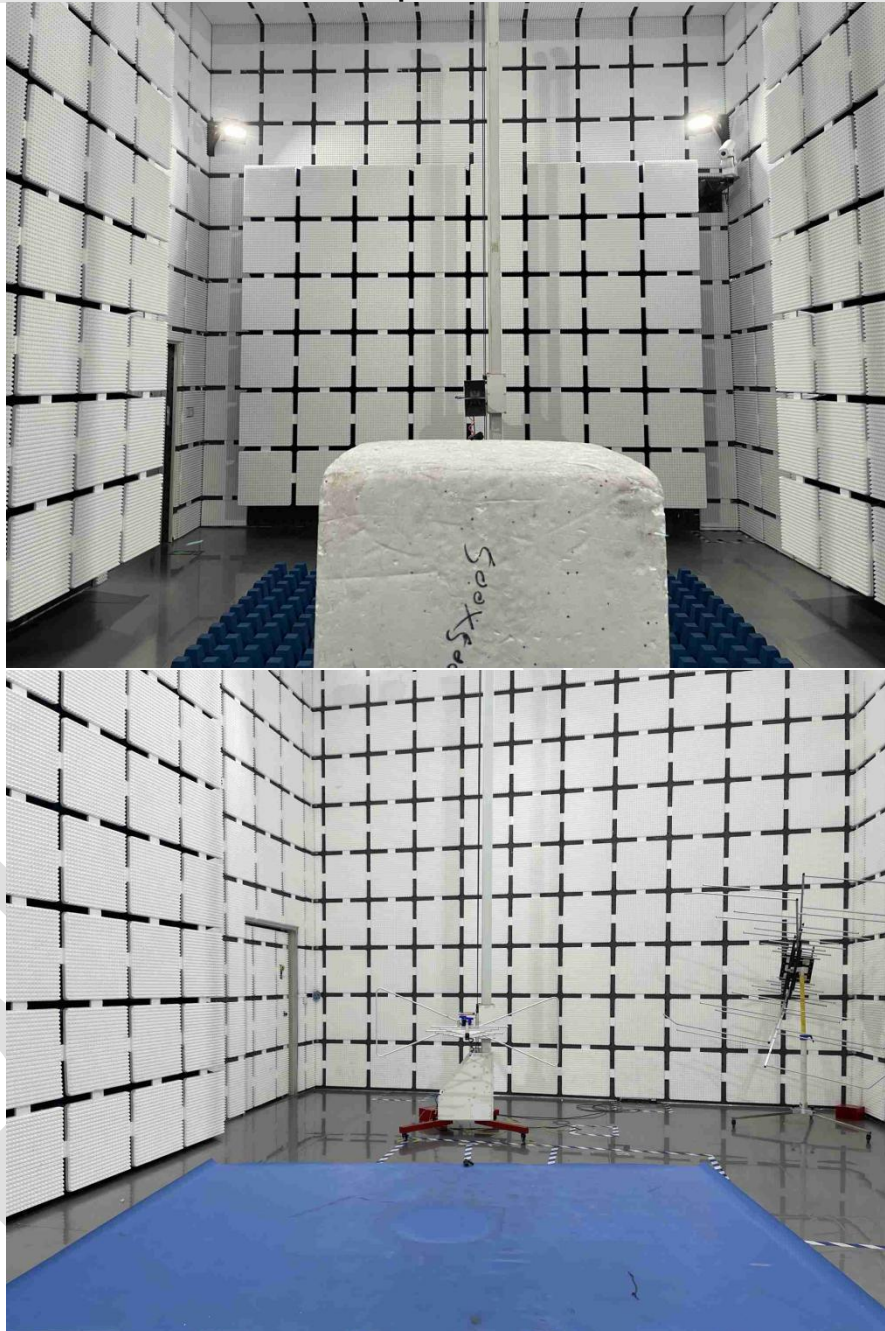
### Radiated Spurious Emissions
