## APPENDIX A: PHOTOGRAPHS OF TEST SETUP

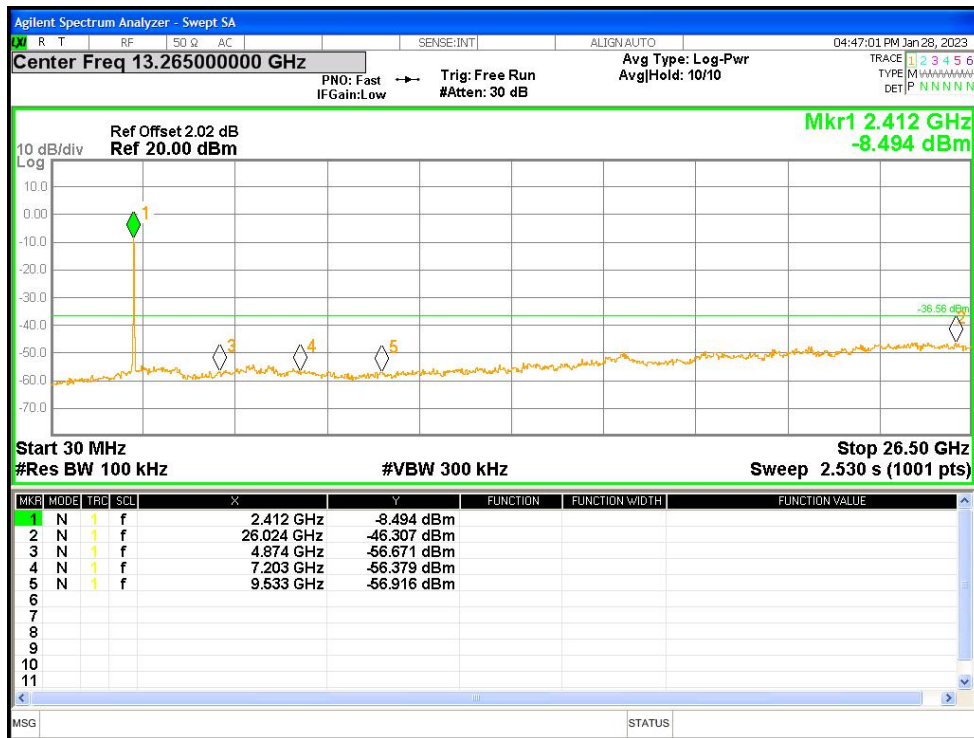
Tx. Spurious NVNT n40 2437MHz Ant1 Ref

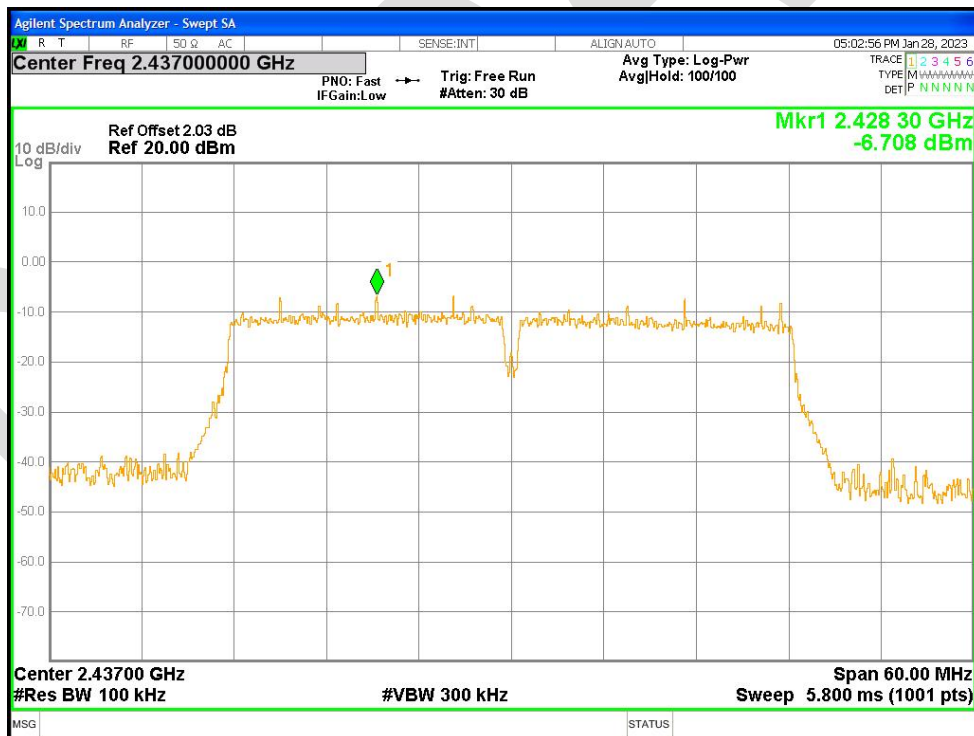
Tx. Spurious NVNT n40 2437MHz Ant1 Emission

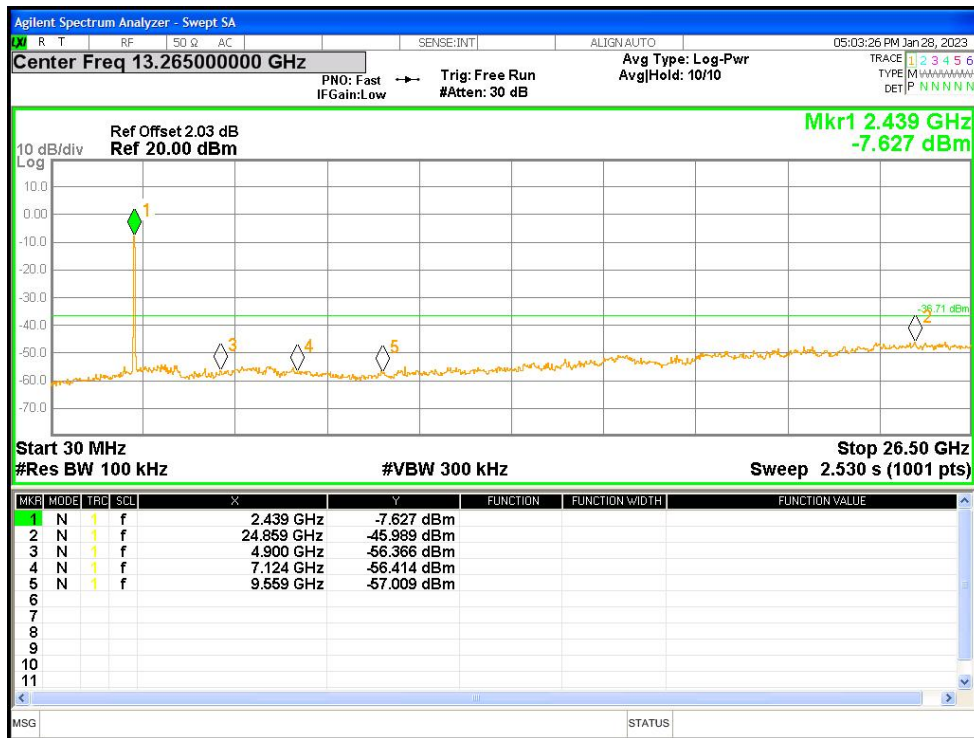
Tx. Spurious NVNT n40 2452MHz Ant1 Ref

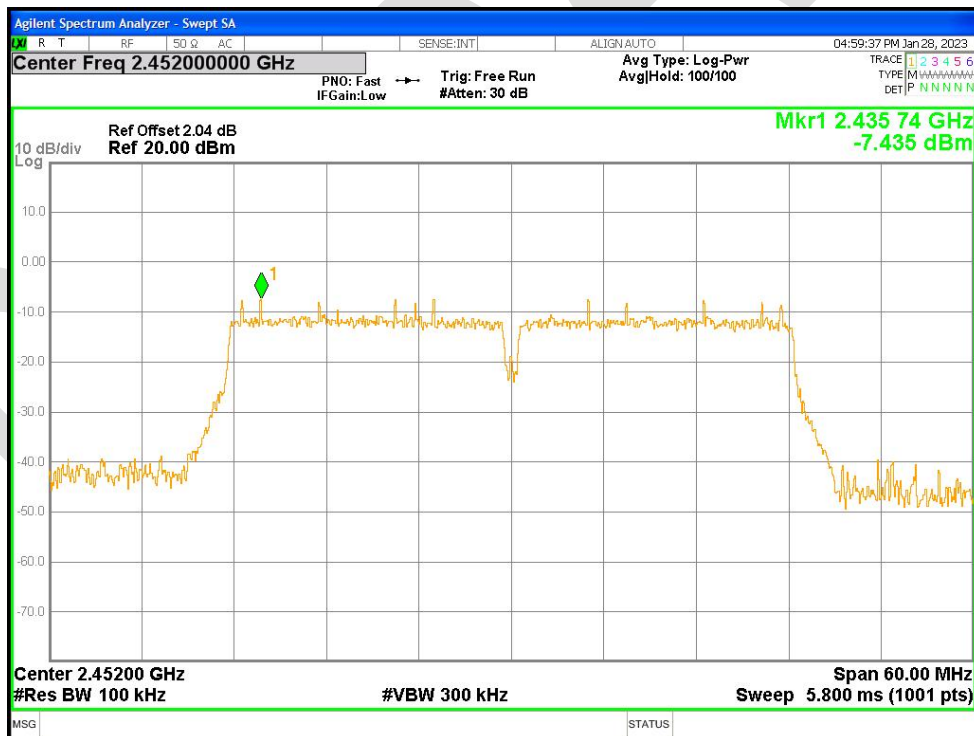
Tx. Spurious NVNT n40 2452MHz Ant1 Emission
