### **APPENDIX 3: Photographs of test setup**

#### **Radiated Spurious Emission**

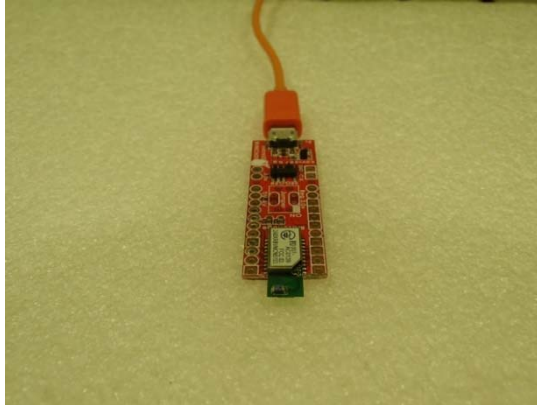
**X-axis**

### Worst Case Position

Below 1 GHz (Horizontal: X-axis / Vertical: X-axis)

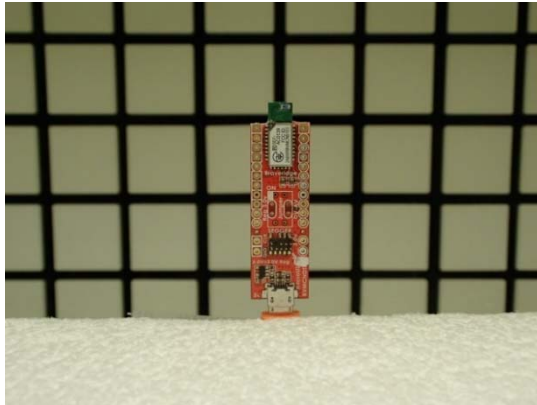
**Y-axis**

Above 1 GHz (Horizontal: Z-axis / Vertical: Y-axis)
