## Appendix E: Band edge measurements

## Appendix F: Conducted Spurious Emission

## Appendix G: Frequency Stability

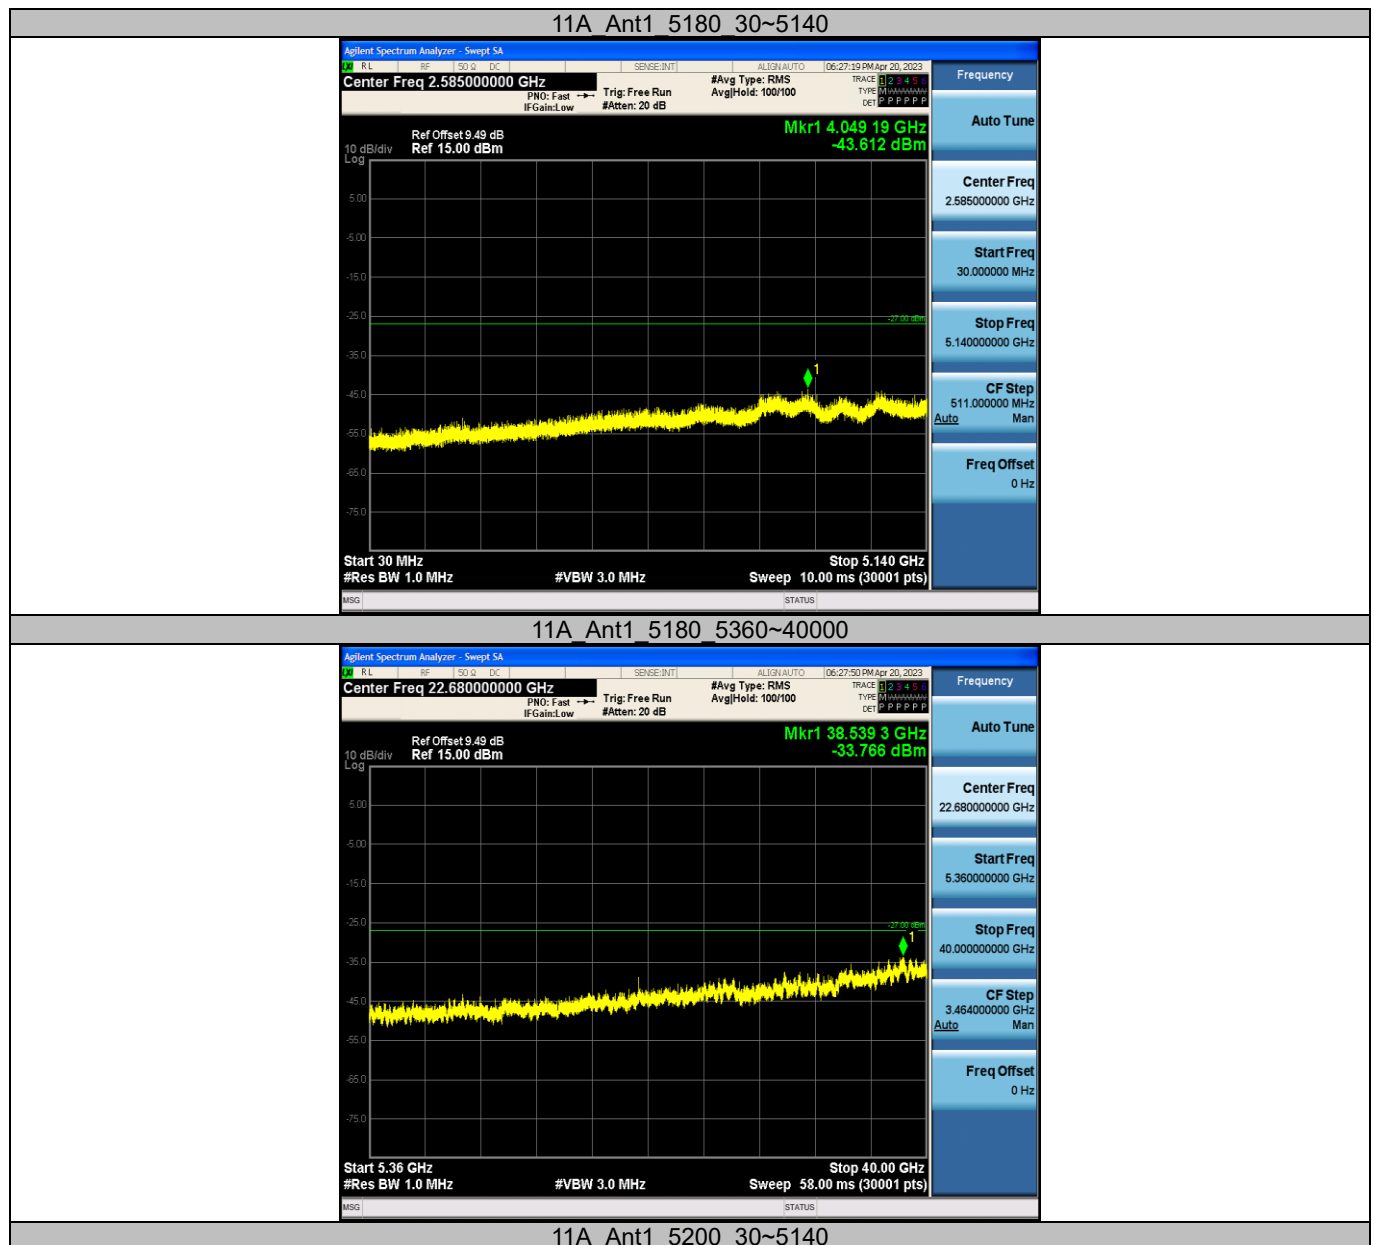
Test Graphs

- 1.All modes were tested,data just shown the worst test mode.
- 2.Offset include antenna gain and cable factor.
