## Appendix G: Band edge measurements

## Appendix H: Conducted Spurious Emission Test Result

## 14. TEST SETUP PHOTO

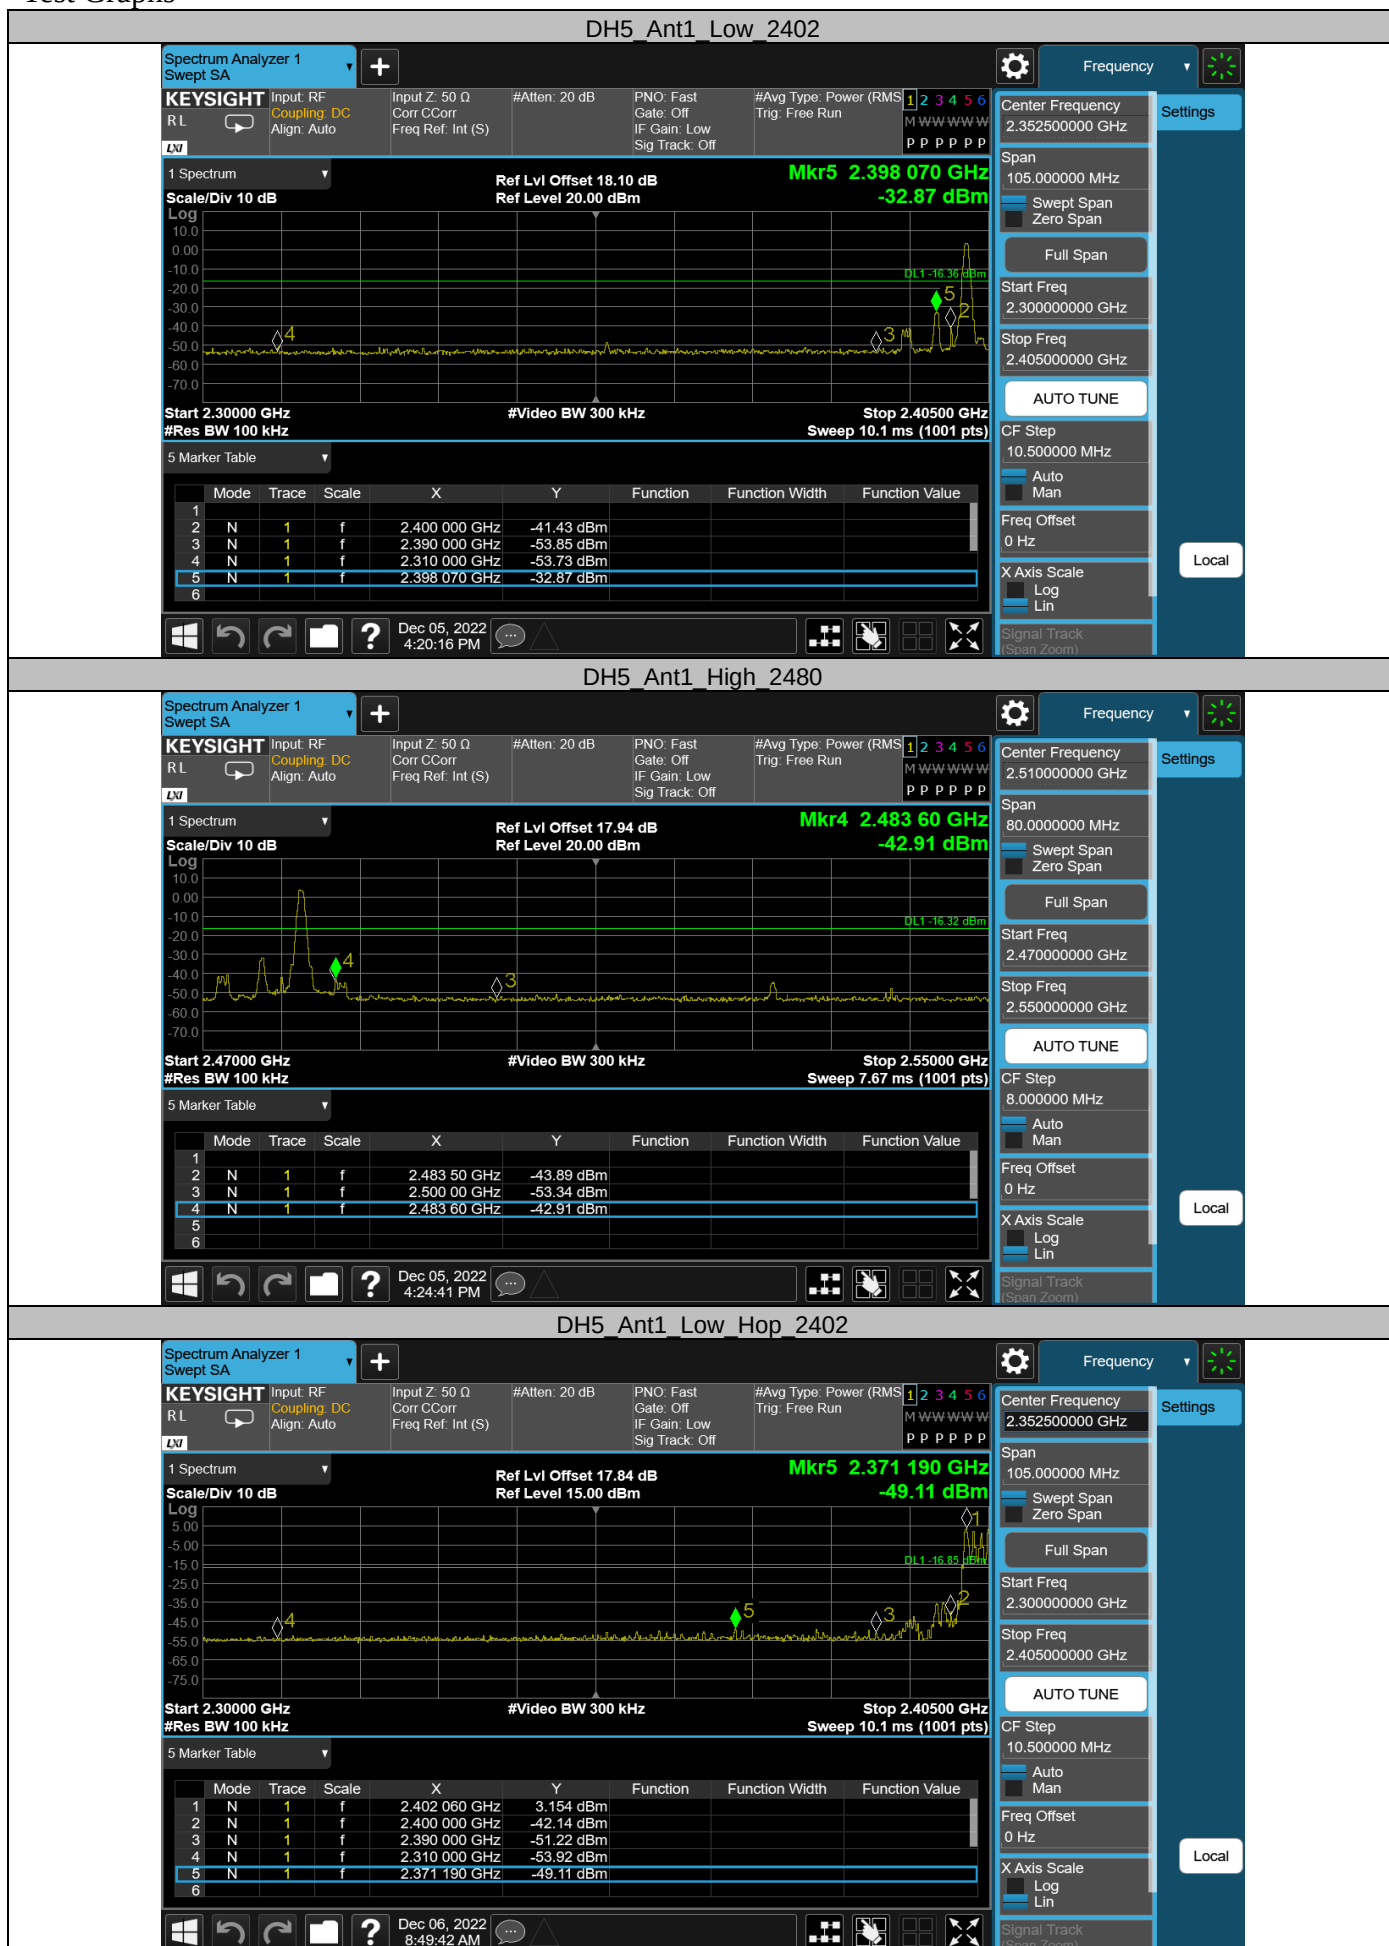
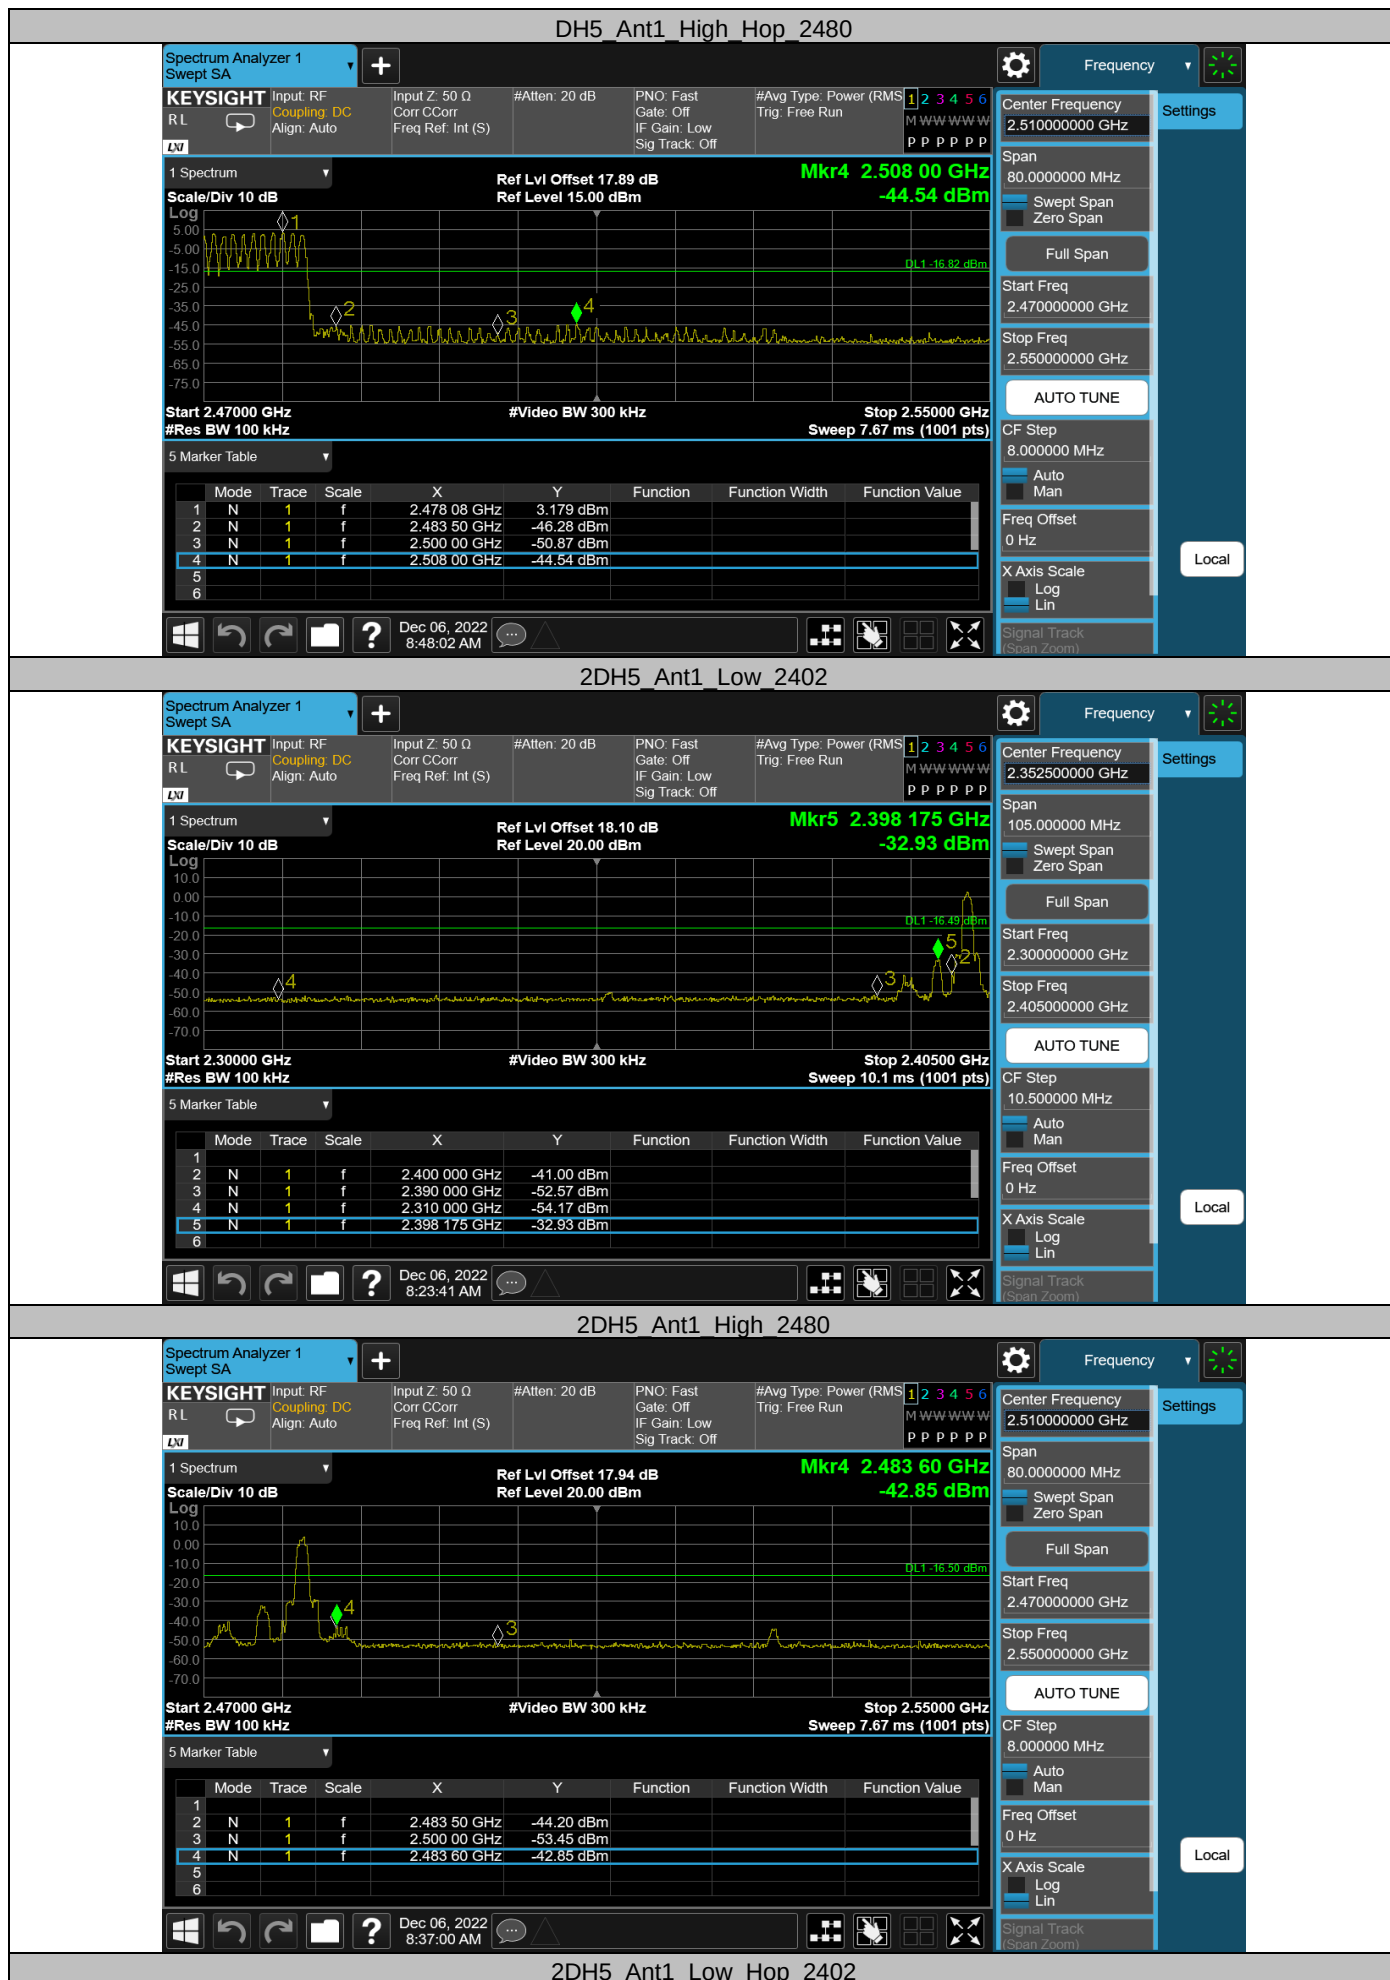
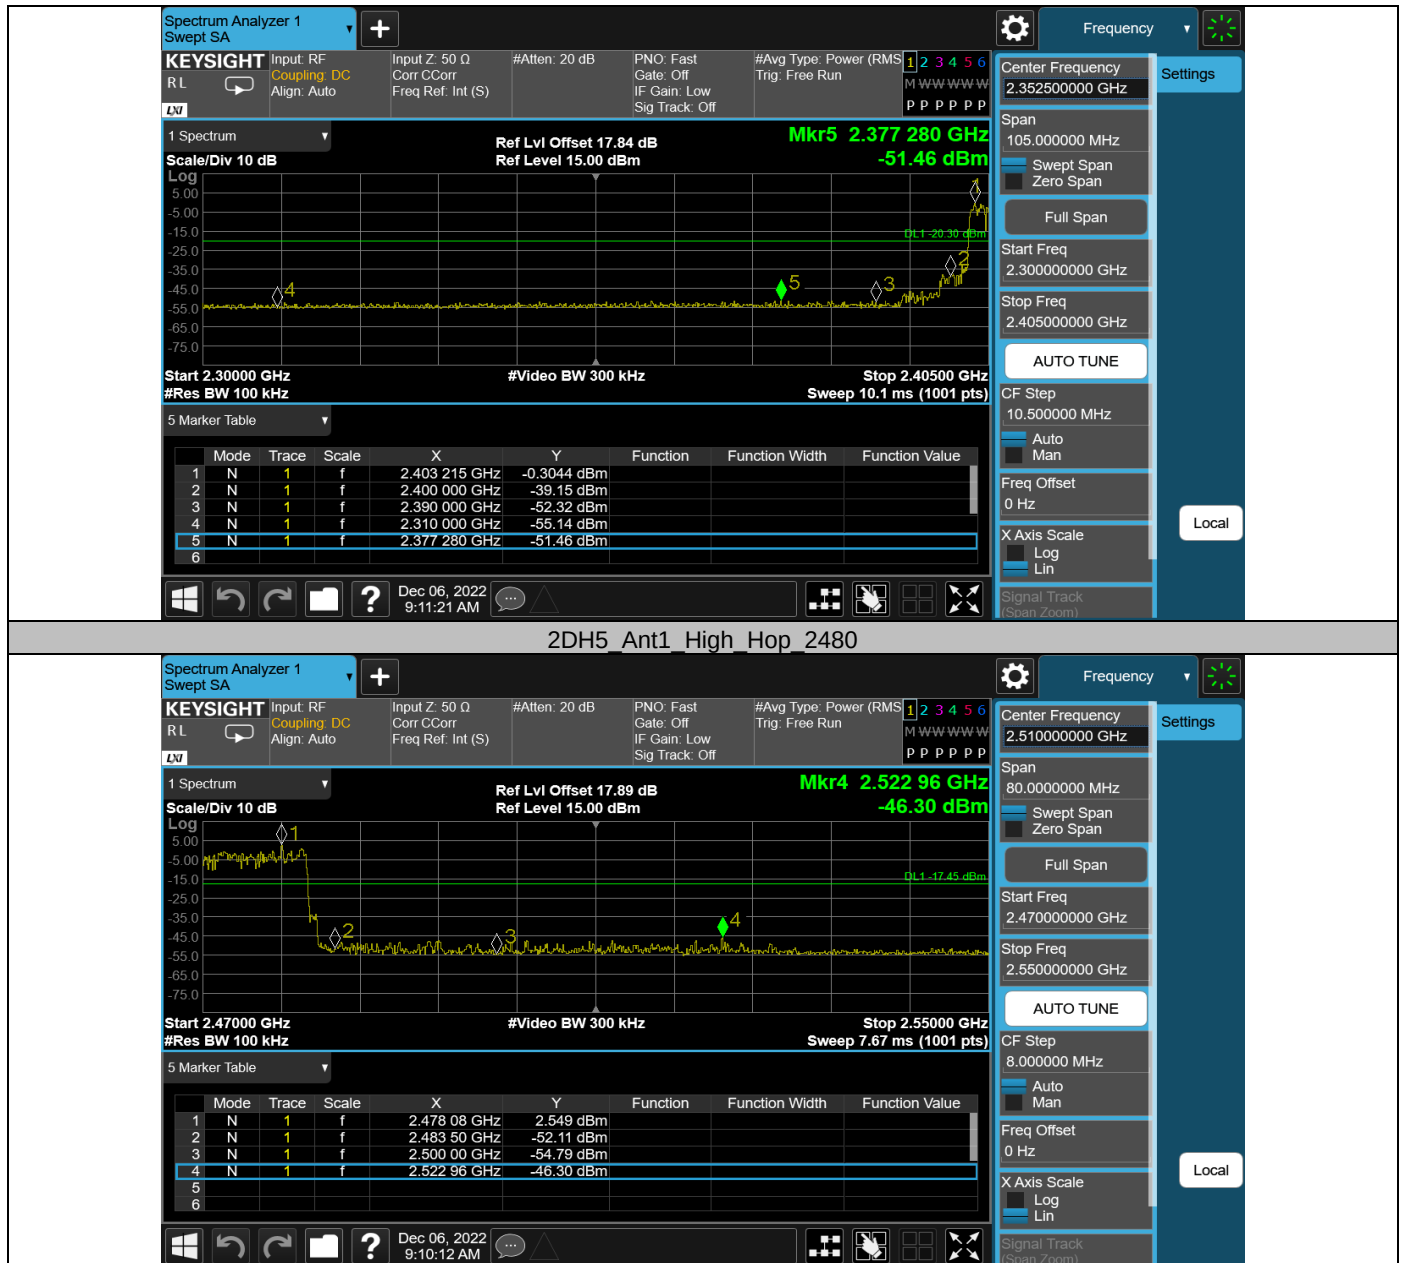
## Test Graphs

| Test Mode | Antenna | Ch Name | Freq(MHz) | Ref Level [dBm] | Result [dBm] | Limit [dBm] | Verdict |
| DH5 | Ant1 | Low | 2402 | 3.64 | -32.87 | $\leq -16.36$ | PASS |
| | | High | 2480 | 3.68 | -42.91 | $\leq -16.32$ | PASS |
| | | Low | Hop_2402 | 3.15 | -49.11 | $\leq -16.85$ | PASS |
| | | High | Hop_2480 | 3.18 | -44.54 | $\leq -16.82$ | PASS |
| 2DH5 | Ant1 | Low | 2402 | 3.51 | -32.93 | $\leq -16.49$ | PASS |
| | | High | 2480 | 3.50 | -42.85 | $\leq -16.5$ | PASS |
| | | Low | Hop_2402 | -0.30 | -51.46 | $\leq -20.3$ | PASS |
| | | High | Hop_2480 | 2.55 | -46.3 | $\leq -17.45$ | PASS |

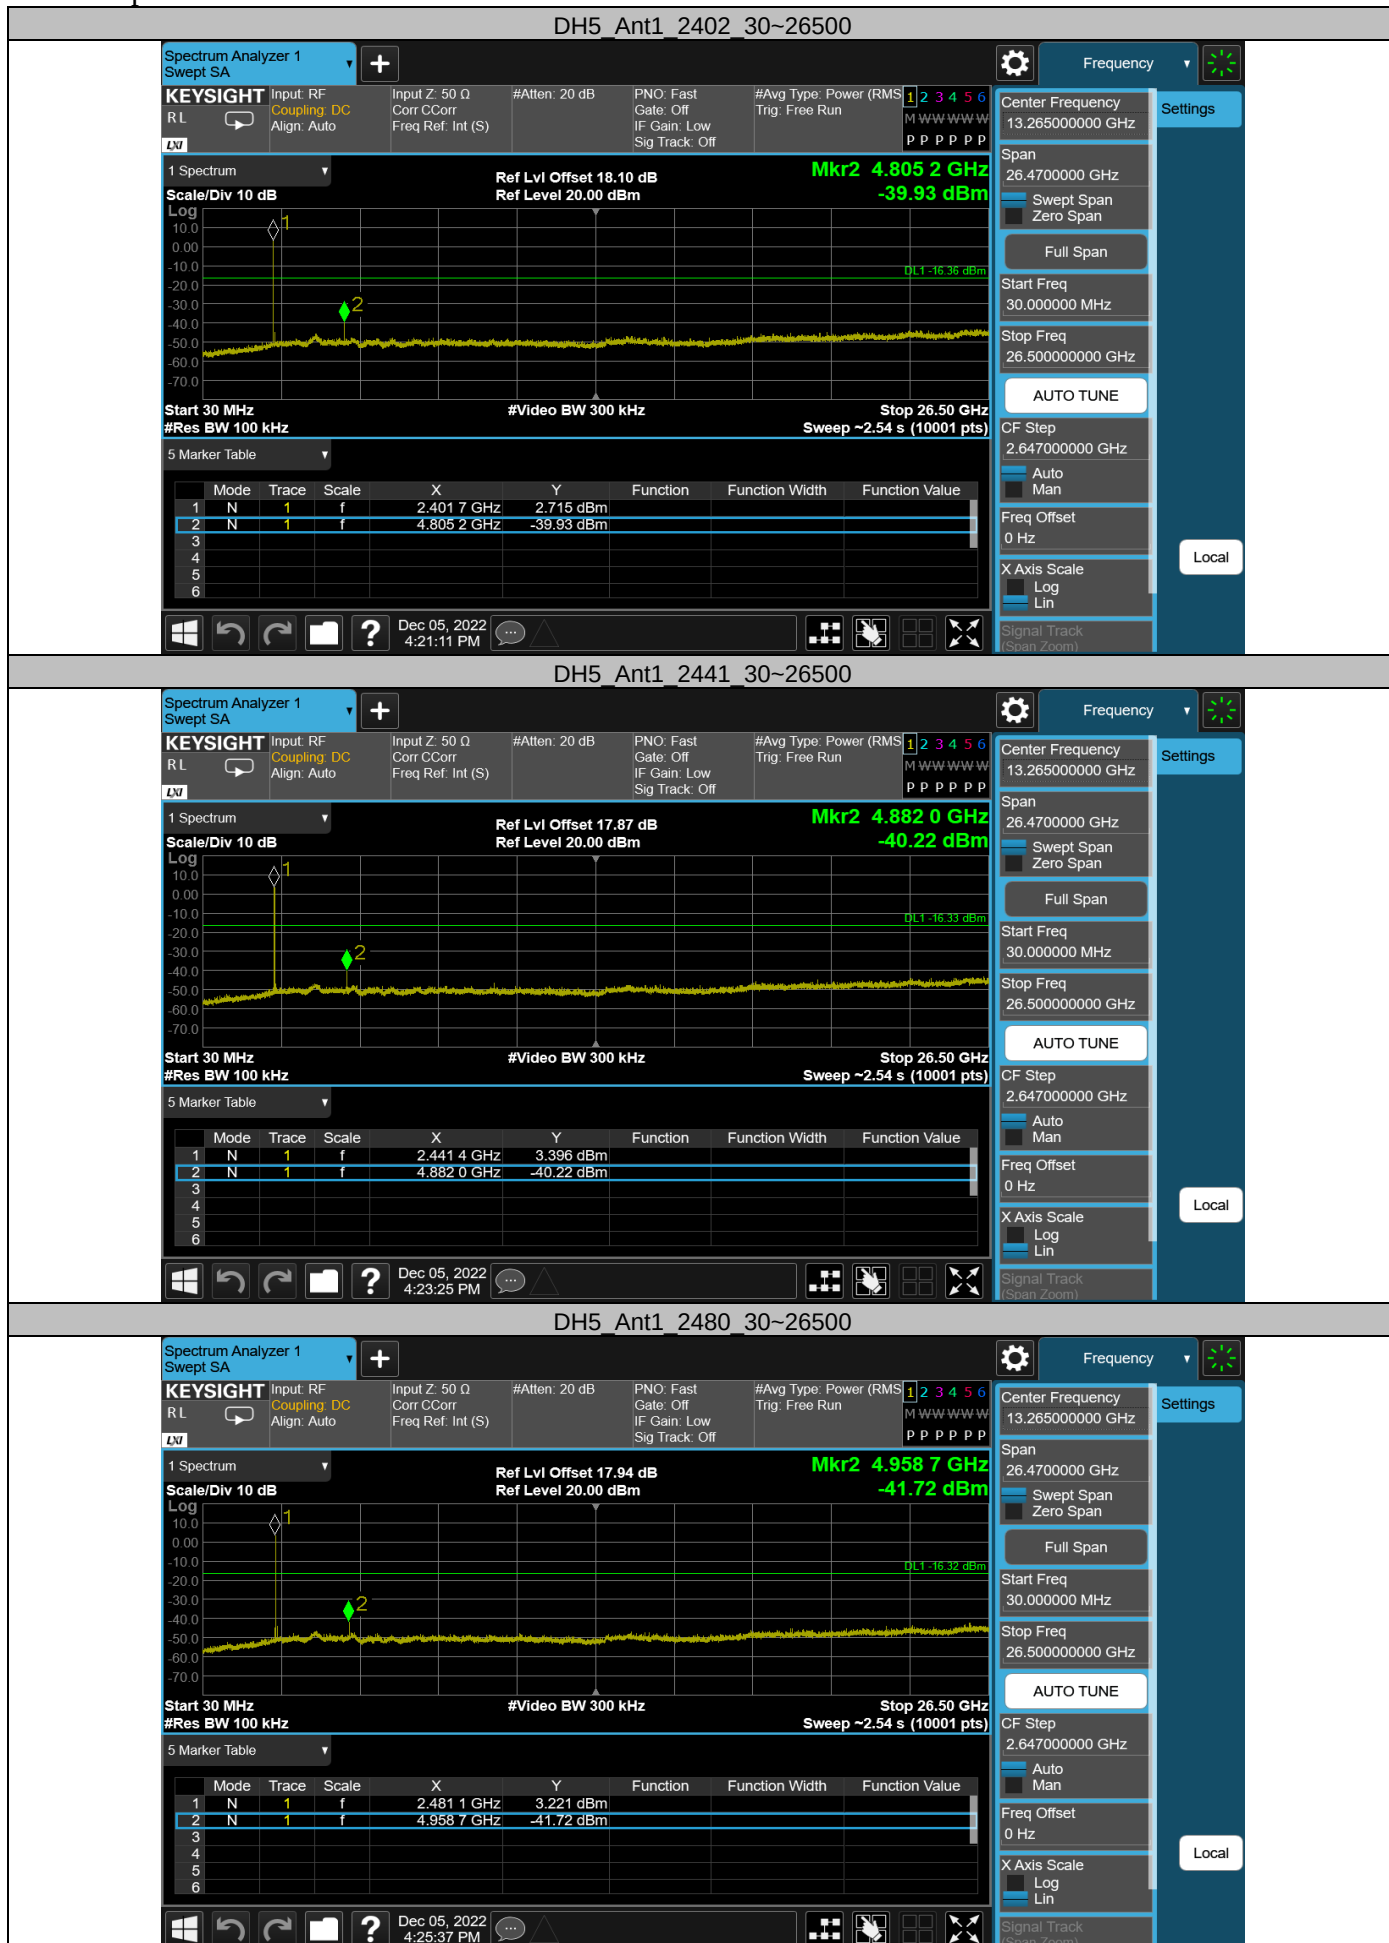
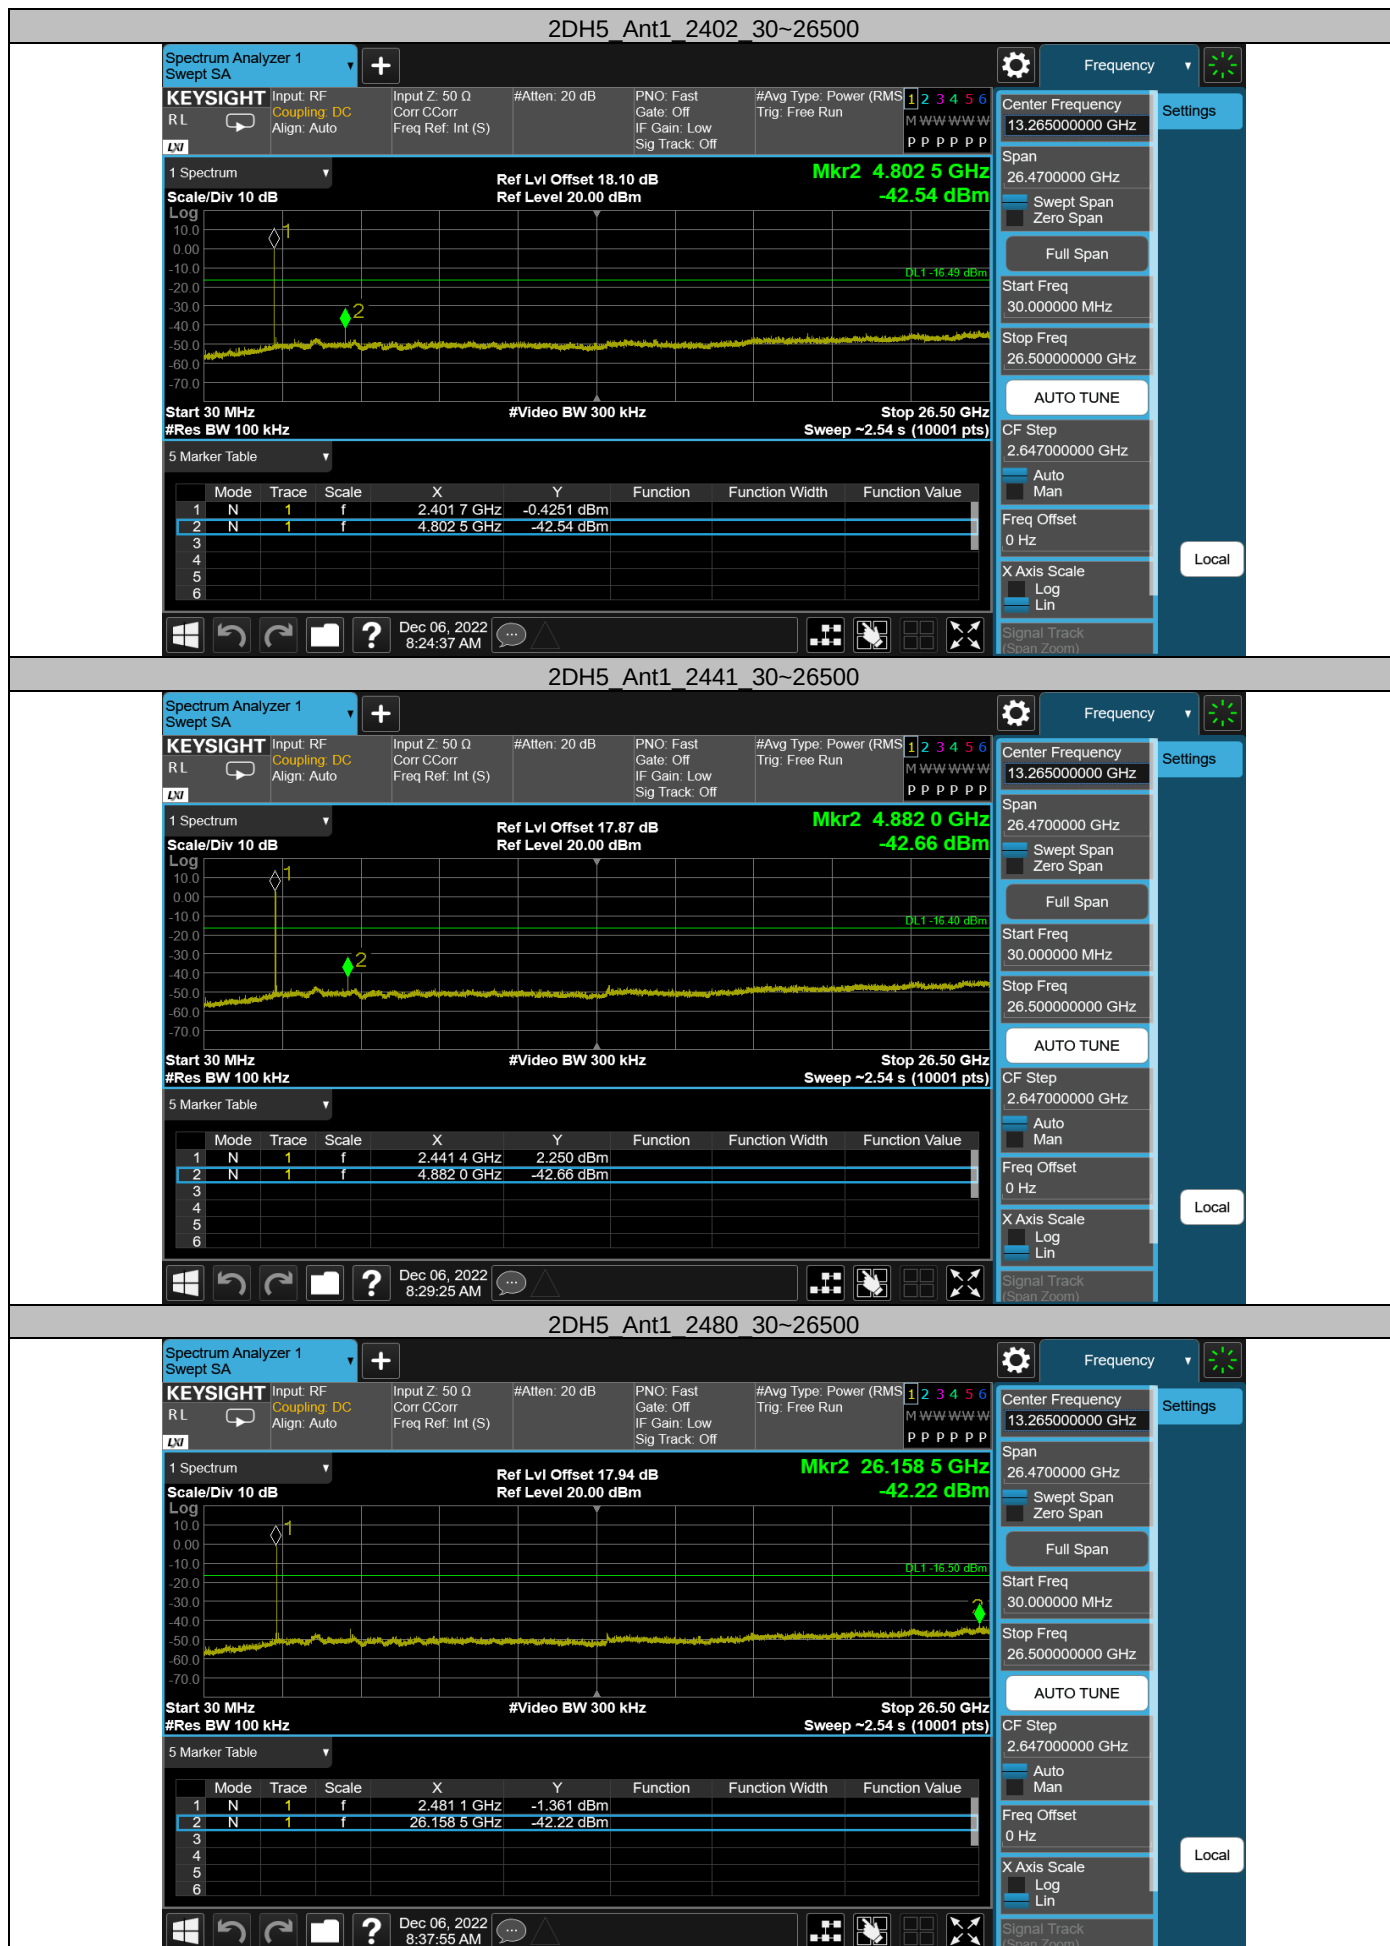
## Test Graphs

| Test Mode | Antenna | Freq(MHz) | Freq Range<br>[MHz] | Ref Level<br>[dBm] | Result<br>[dBm] | Limit<br>[dBm] | Verdict |
| DH5 | Ant1 | 2402 | 30~26500 | 3.64 | -39.93 | $\leq -16.36$ | PASS |
| | | 2441 | 30~26500 | 3.67 | -40.22 | $\leq -16.33$ | PASS |
| | | 2480 | 30~26500 | 3.68 | -41.72 | $\leq -16.32$ | PASS |
| 2DH5 | Ant1 | 2402 | 30~26500 | 3.51 | -42.54 | $\leq -16.49$ | PASS |
| | | 2441 | 30~26500 | 3.60 | -42.66 | $\leq -16.4$ | PASS |
| | | 2480 | 30~26500 | 3.50 | -42.22 | $\leq -16.5$ | PASS |

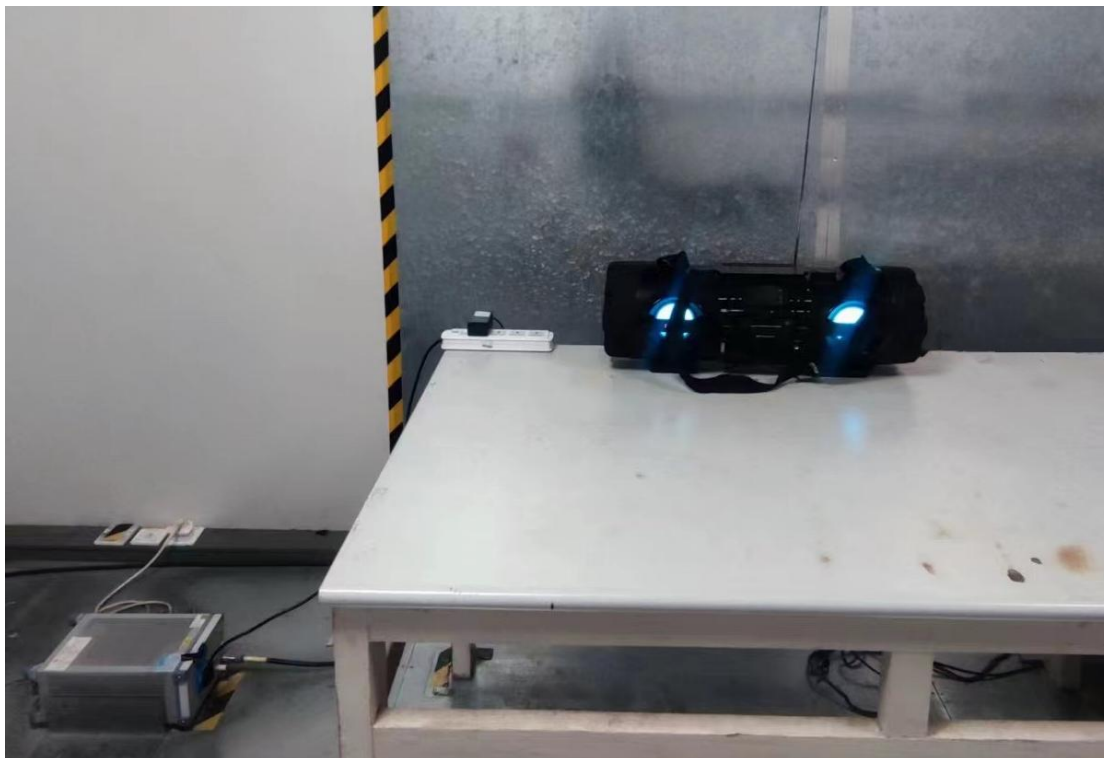
Conducted Test

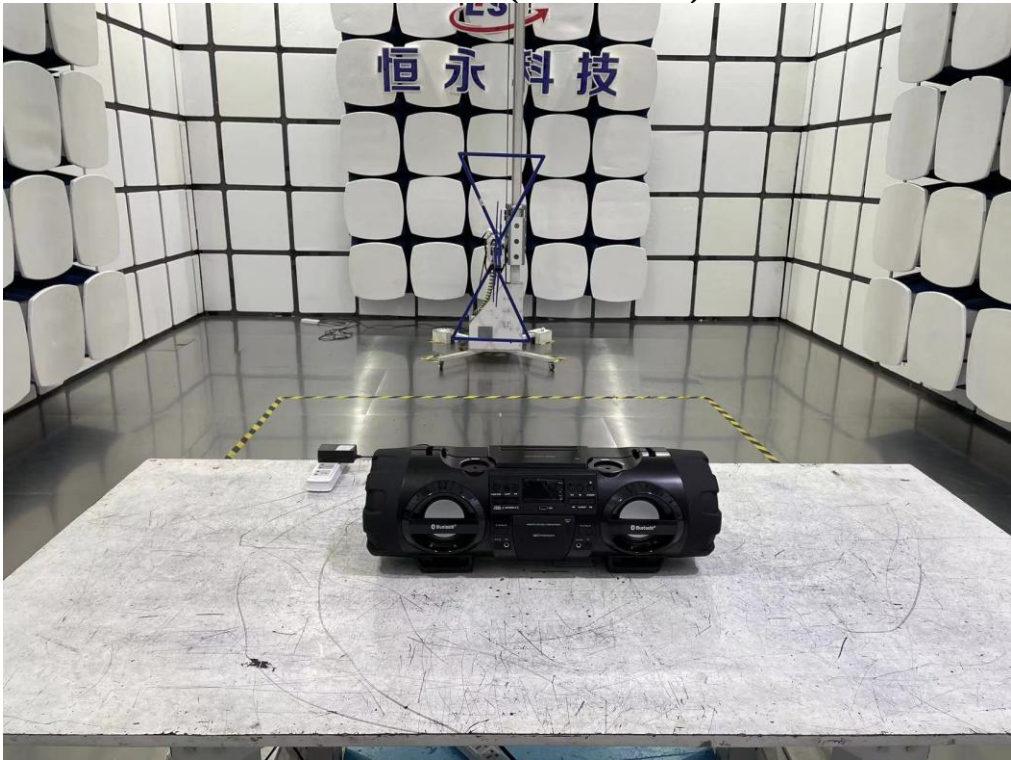
Radiated Test (Below 1GHz)

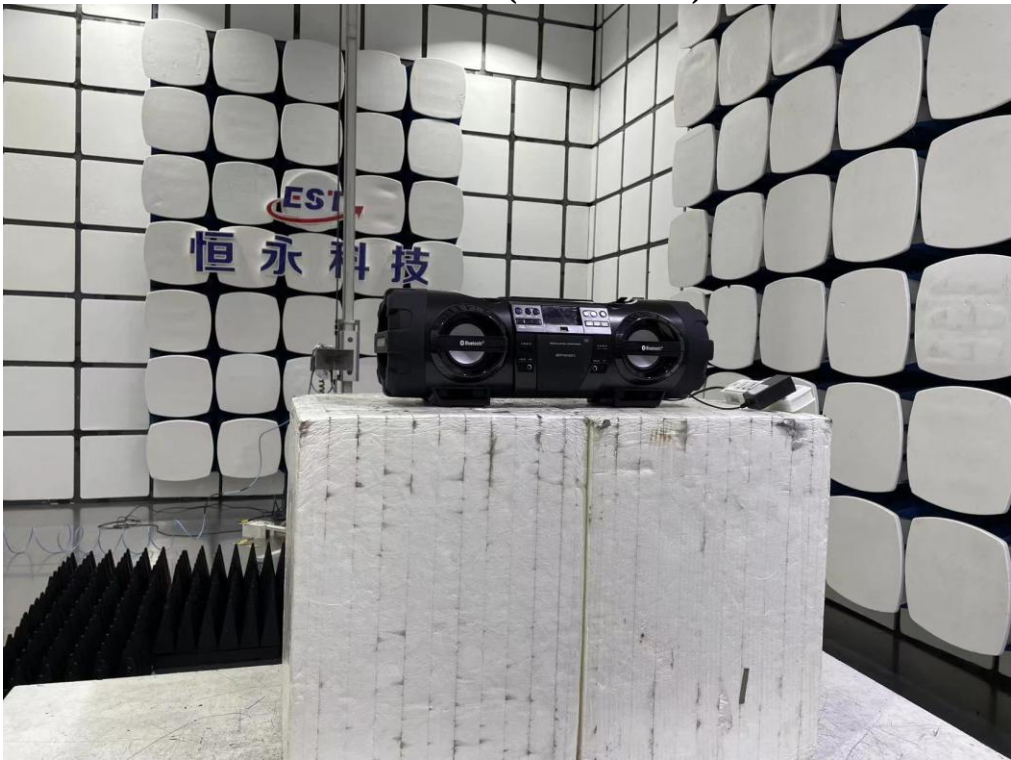
Radiated Test (Above 1GHz)
