## 6 Photographs of the Test Set-Up

**Prüfbericht - Nr.: CN223NTZ 001**  
Test report no.

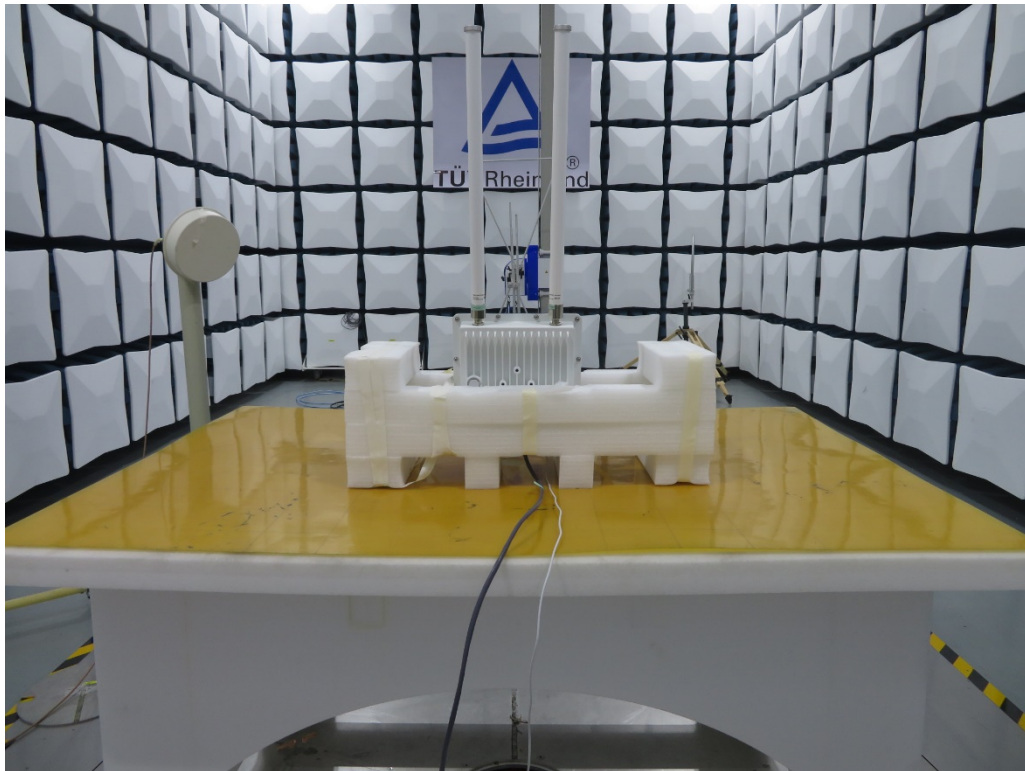
**Photograph 1: Set-up for Co-Located Radiated Spurious Emissions, below 1GHz**

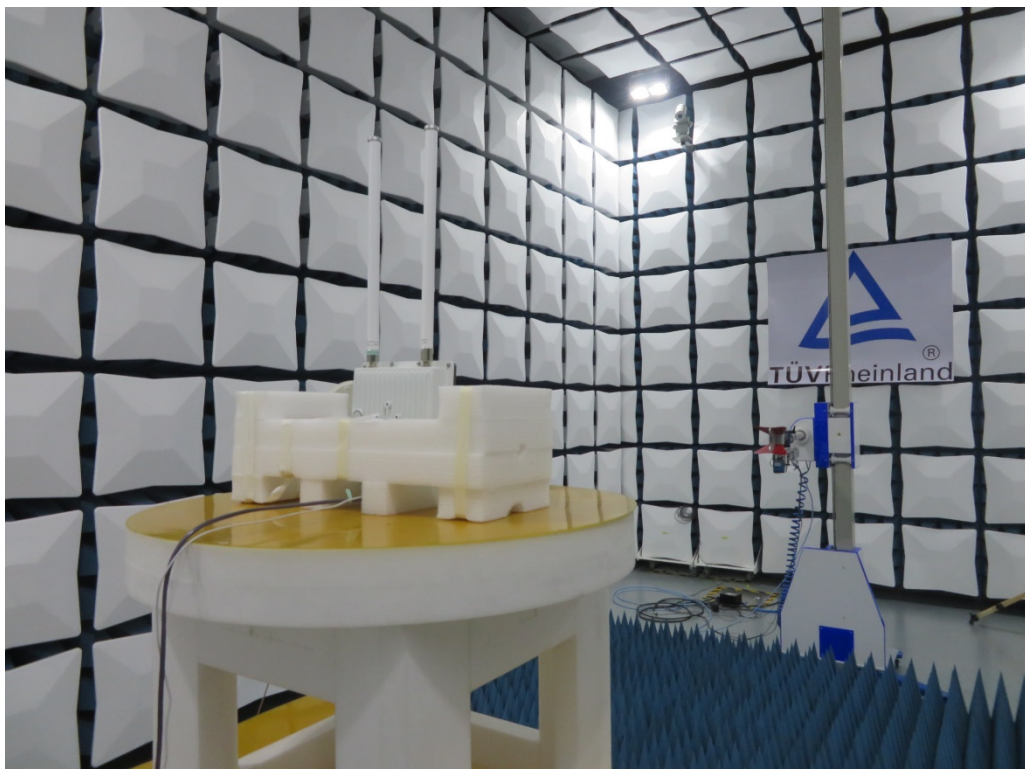
**Photograph 2: Set-up for Co-Located Radiated Spurious Emissions, above 1GHz**
