## Appendix B: photographs of test setup

Reference to the test report no. BLA-EMC-202505-A2301

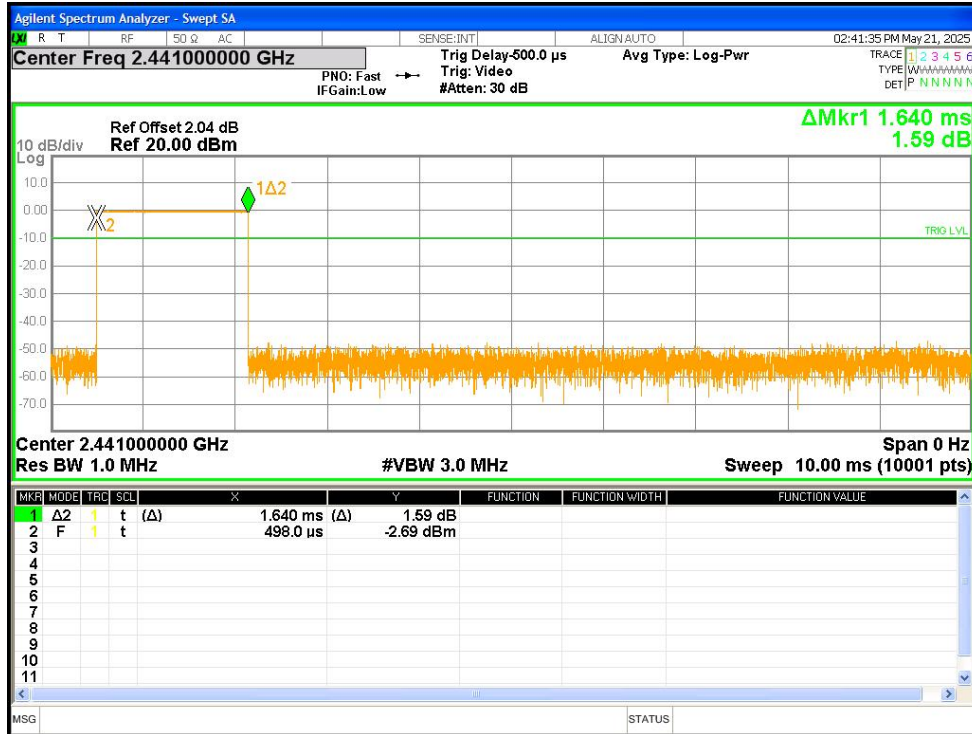
### Dwell NVNT 1-DH3 2441MHz Ant1 One Burst

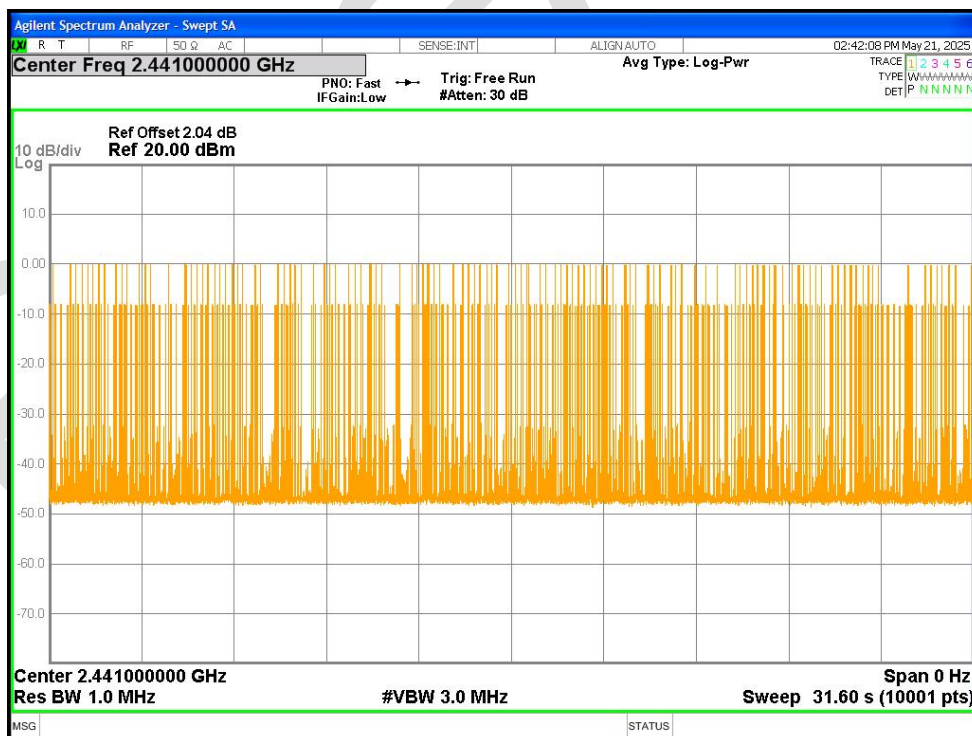
### Dwell NVNT 1-DH3 2441MHz Ant1 Accumulated

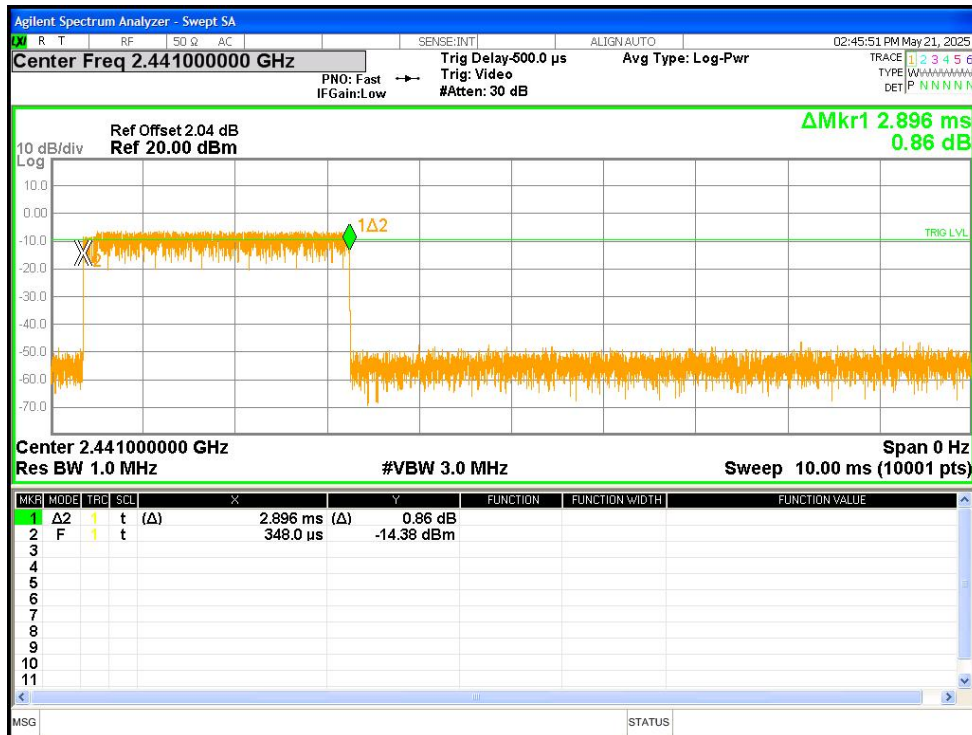
### Dwell NVNT 3-DH5 2441MHz Ant1 One Burst

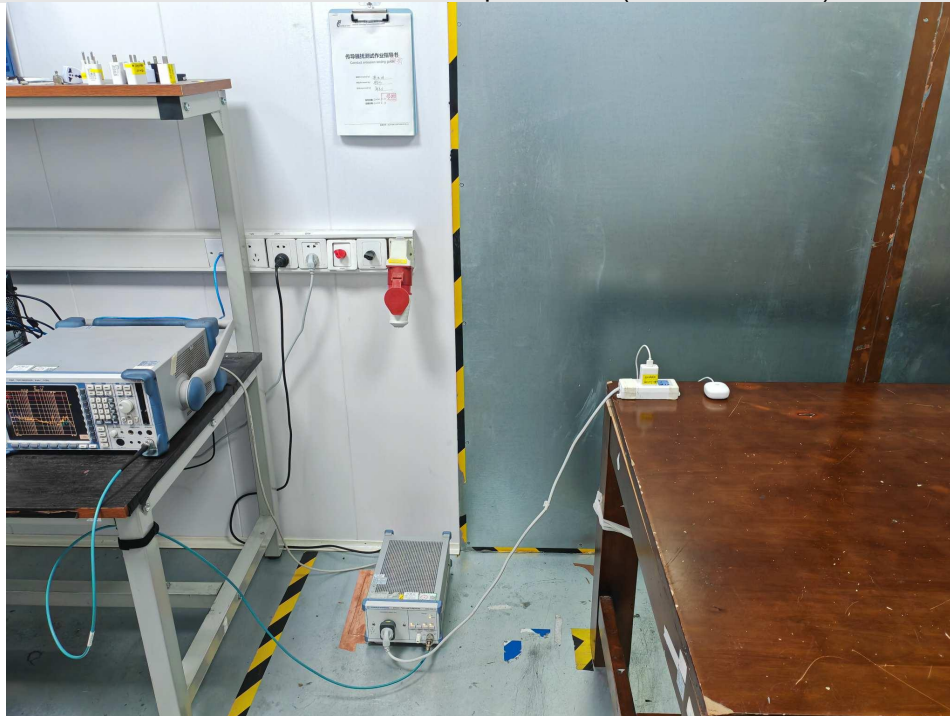
Conducted emissions at AC power line (150kHz-30MHz)

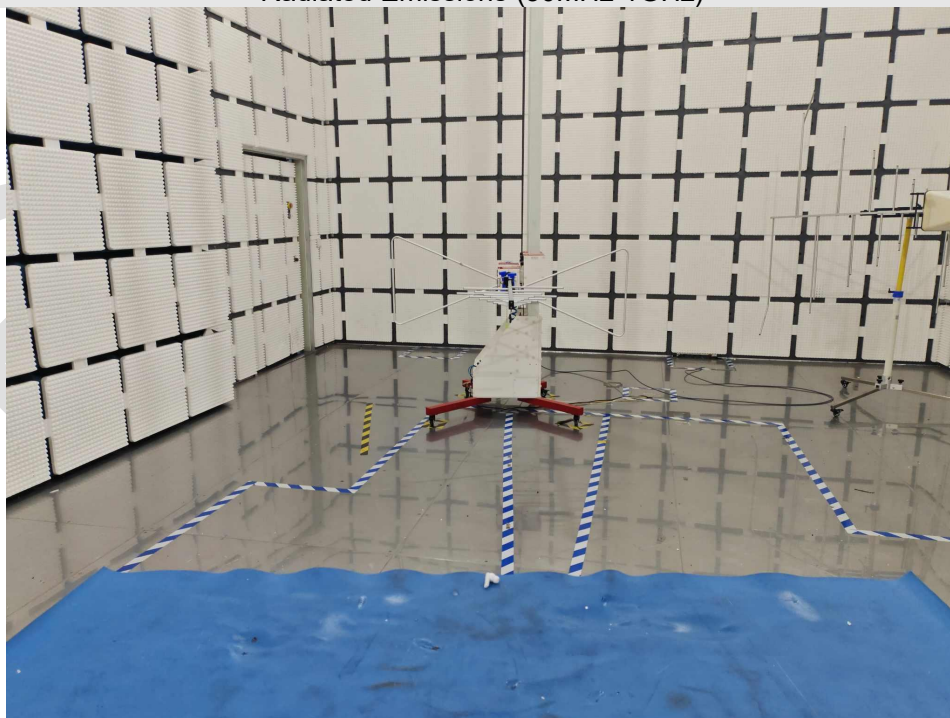
Radiated Emissions (30MHz-1GHz)
