## Appendix B: photographs of test setup

## Appendix C: photographs of EUT

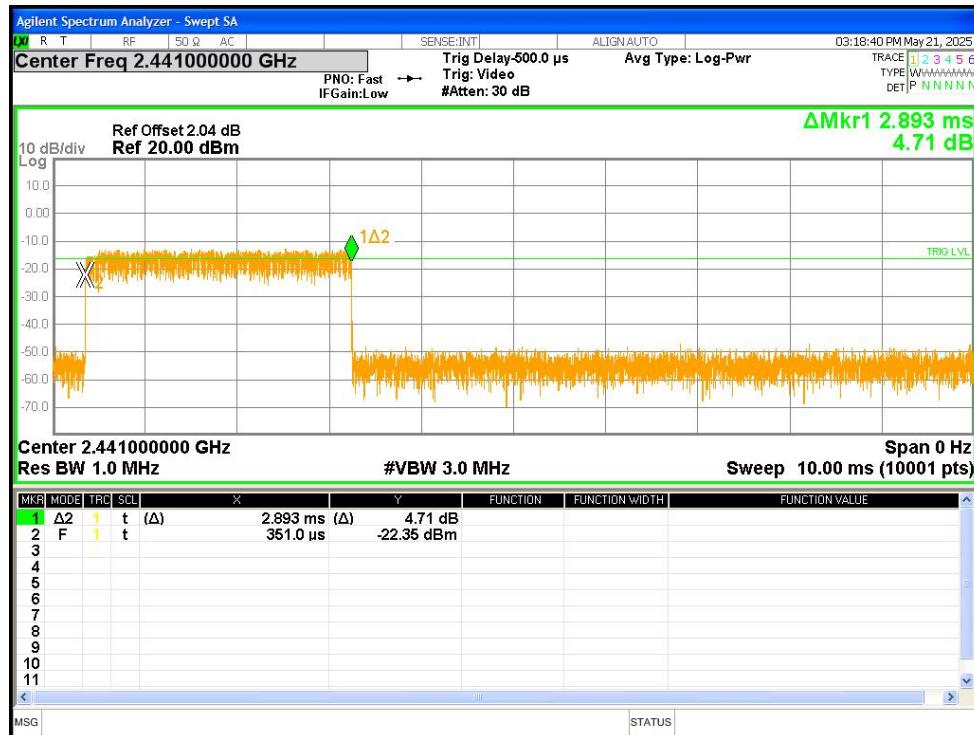
### Dwell NVNT 2-DH5 2441MHz Ant1 One Burst

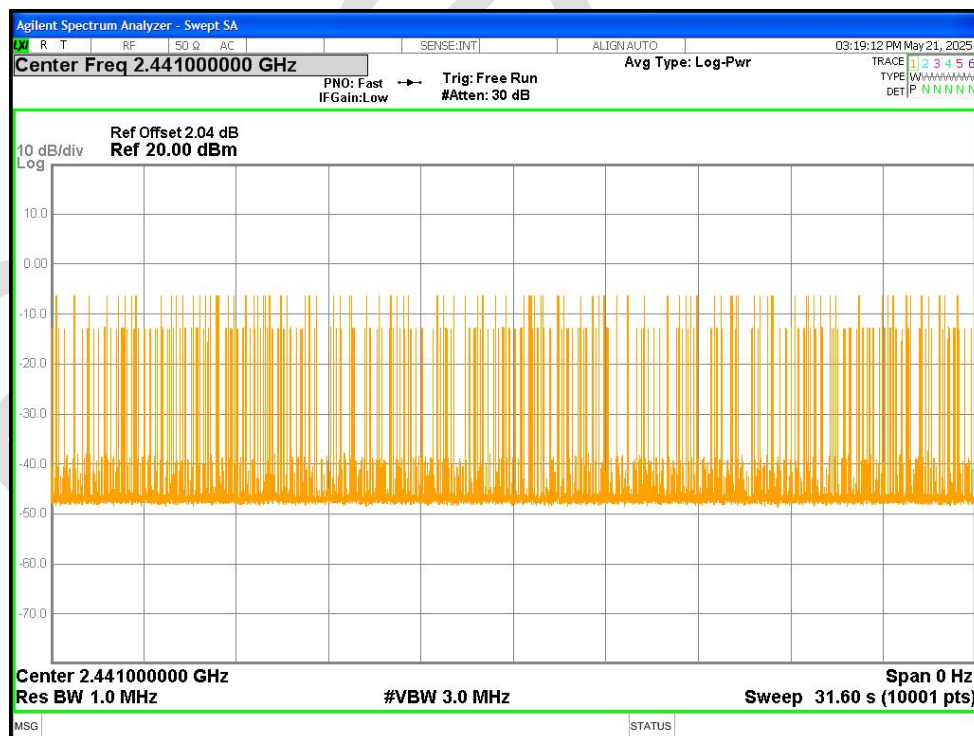
### Dwell NVNT 2-DH5 2441MHz Ant1 Accumulated

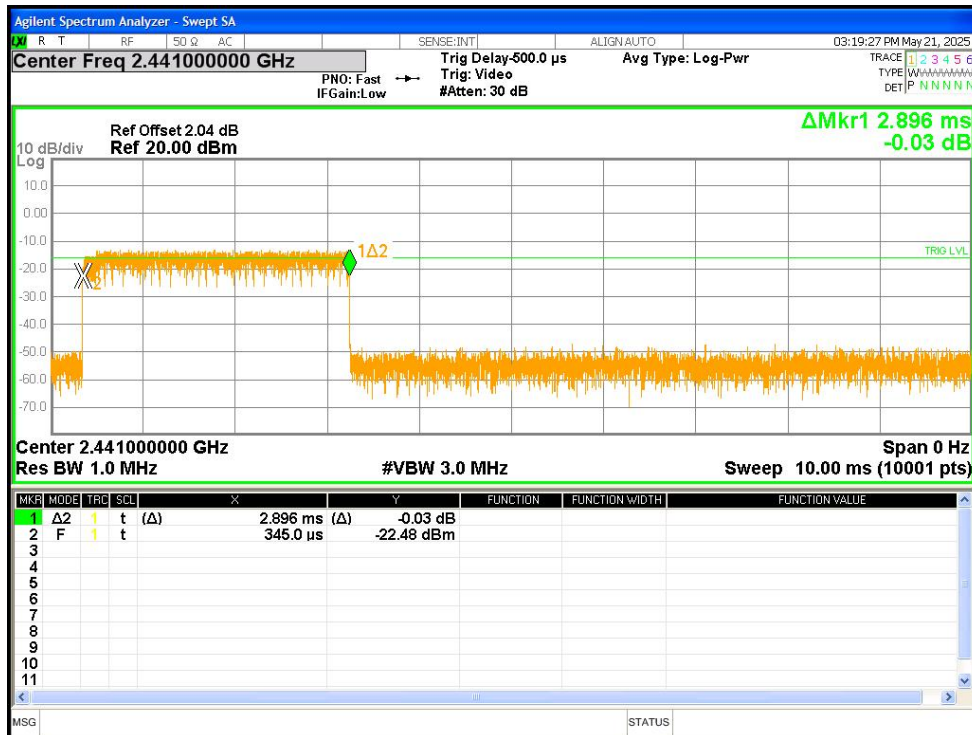
### Dwell NVNT 3-DH5 2441MHz Ant1 One Burst

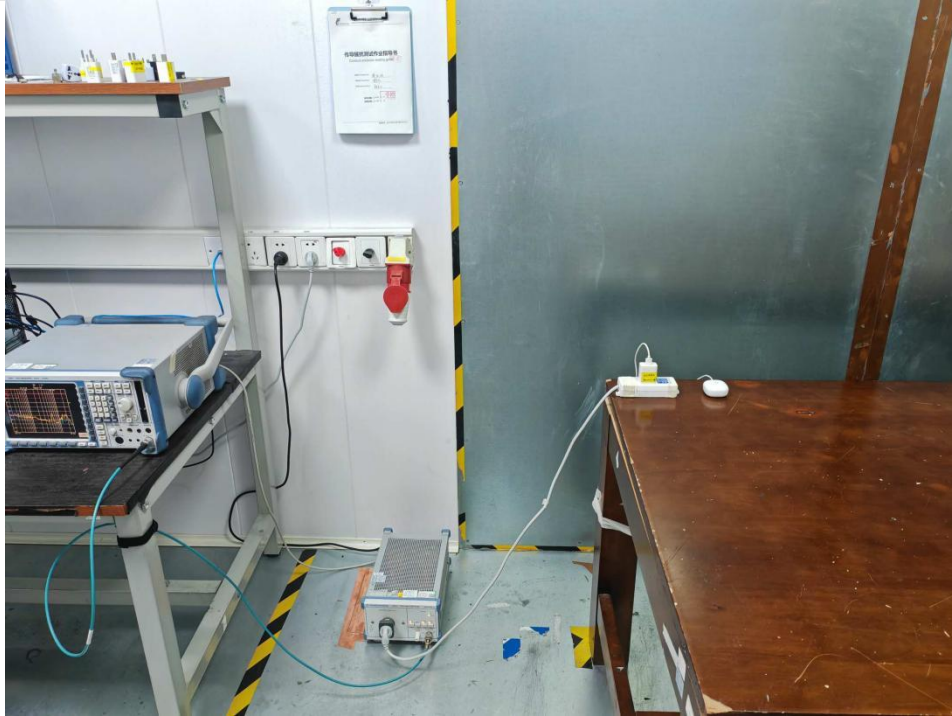
Conducted emissions at AC power line (150kHz-30MHz)

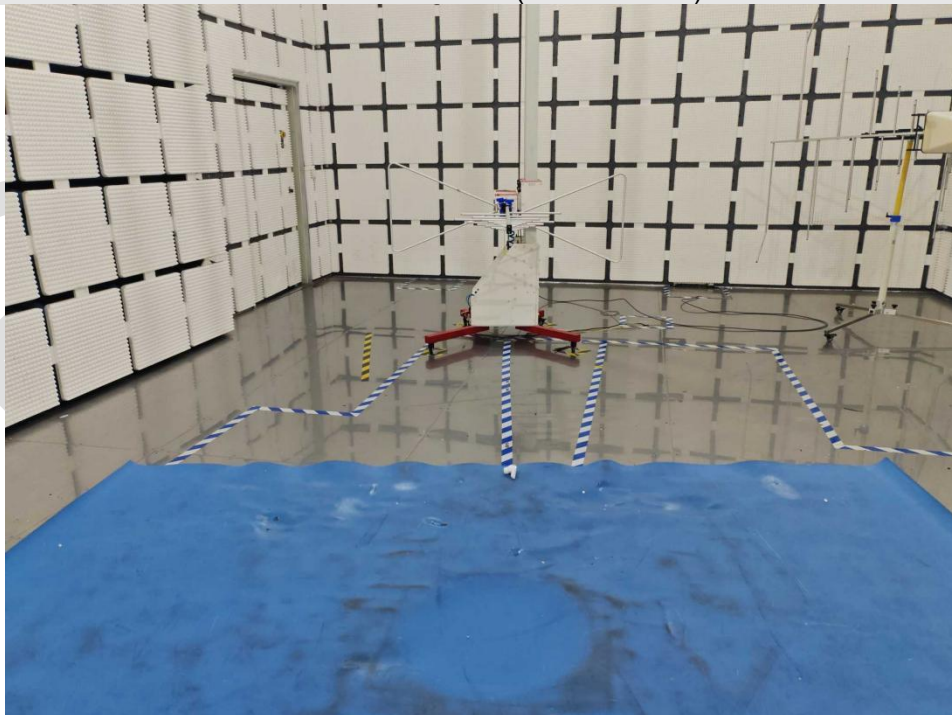
Radiated Emissions (30MHz-1GHz)
