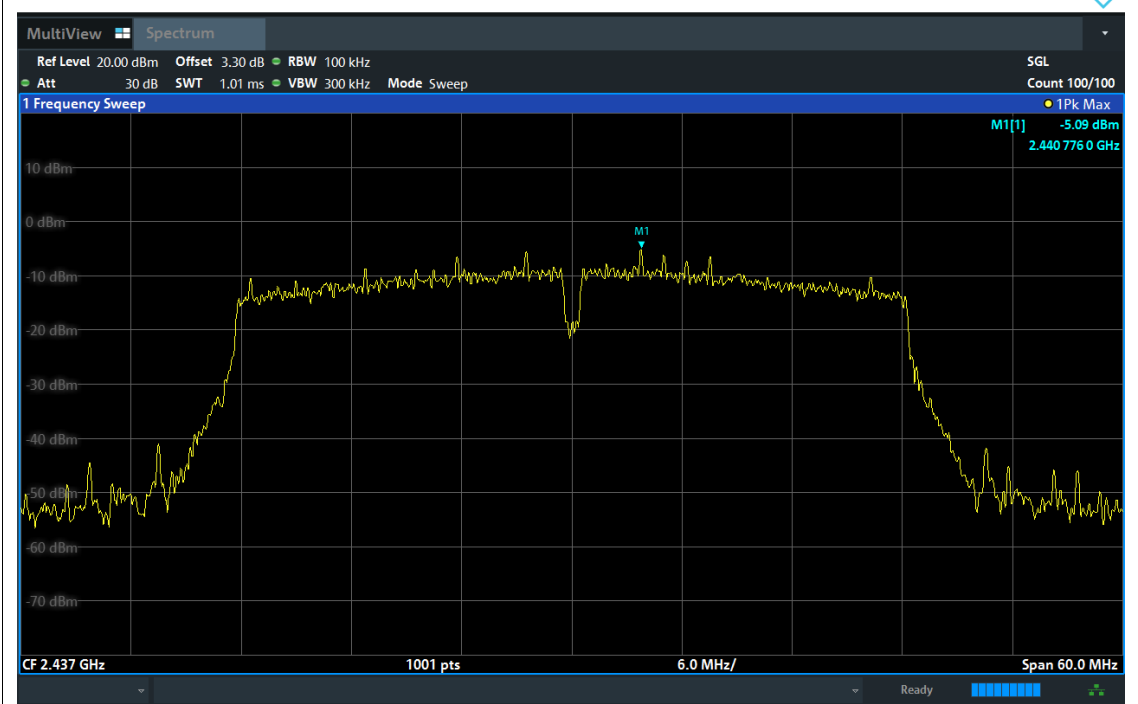
Tx. Spurious NVNT n40 2437MHz Ant1 Ref

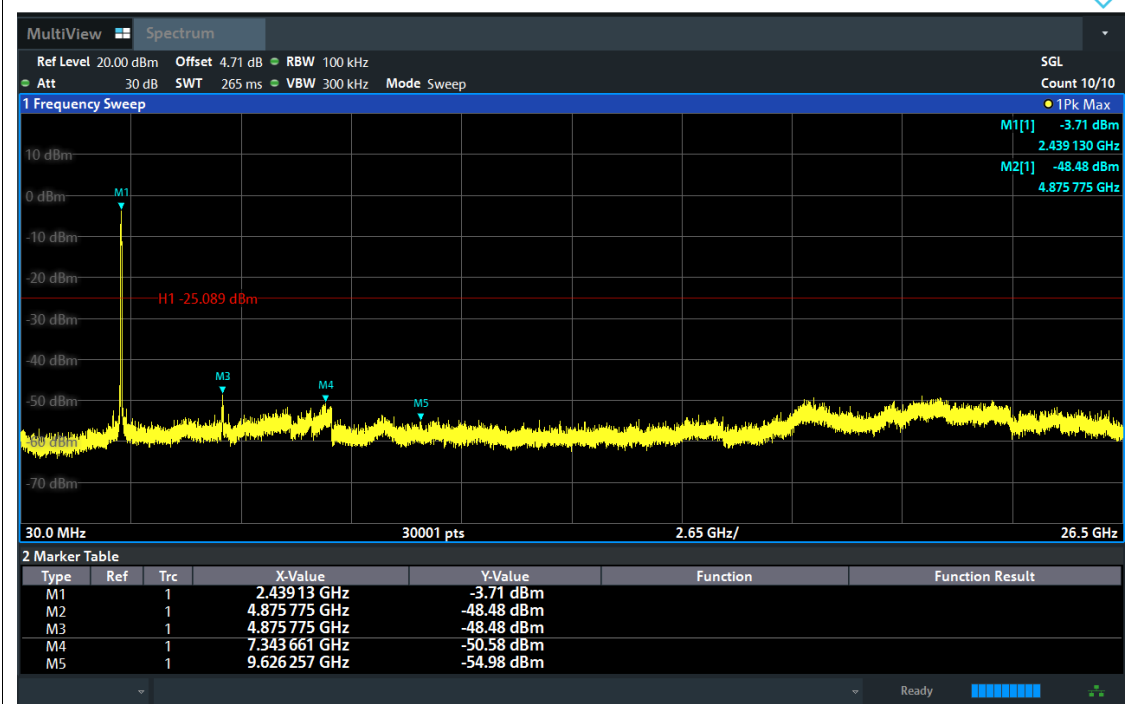
Tx. Spurious NVNT n40 2437MHz Ant1 Emission

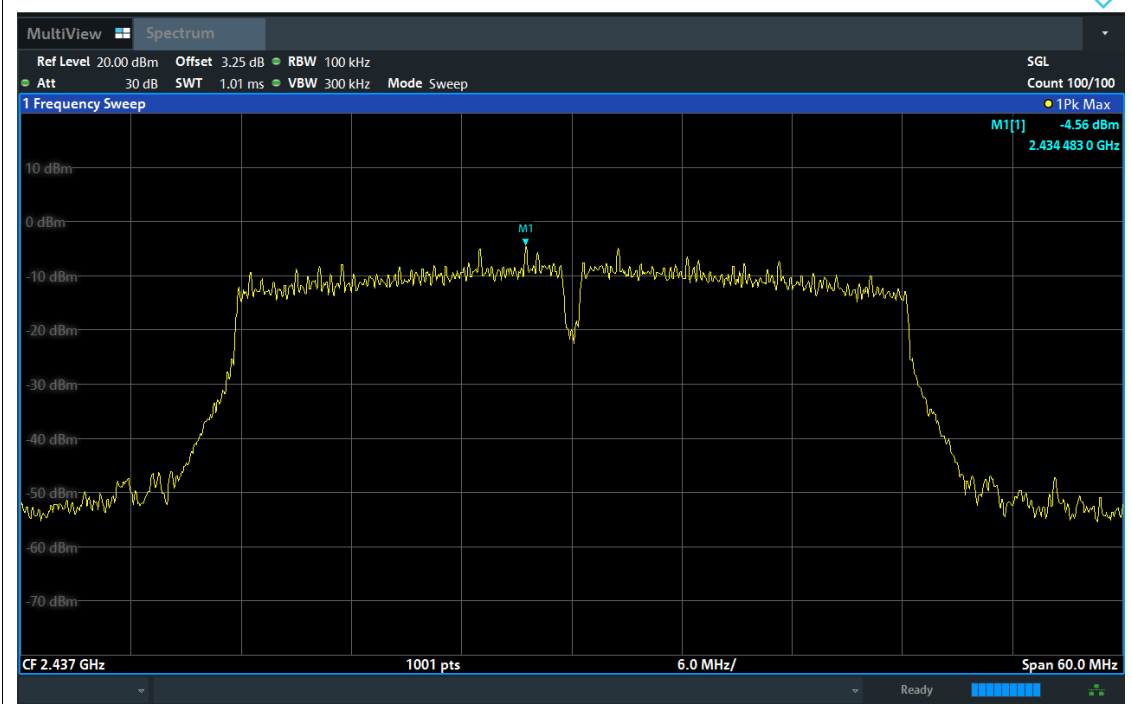
Tx. Spurious NVNT n40 2437MHz Ant2 Ref

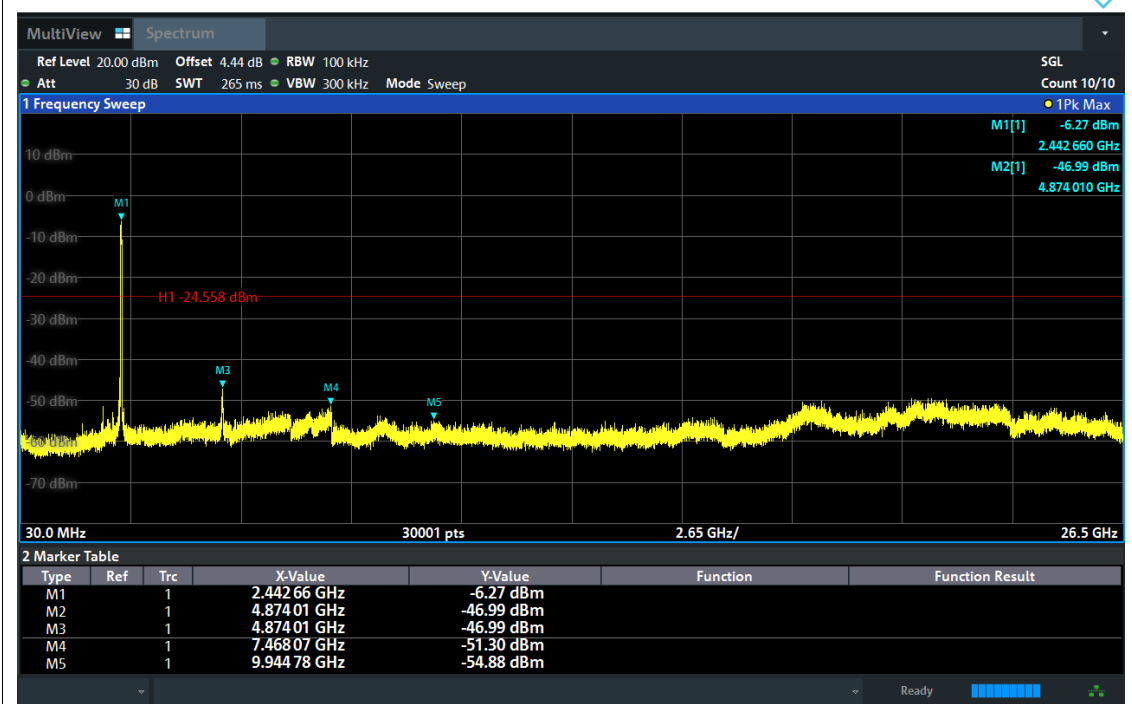
Tx. Spurious NVNT n40 2437MHz Ant2 Emission

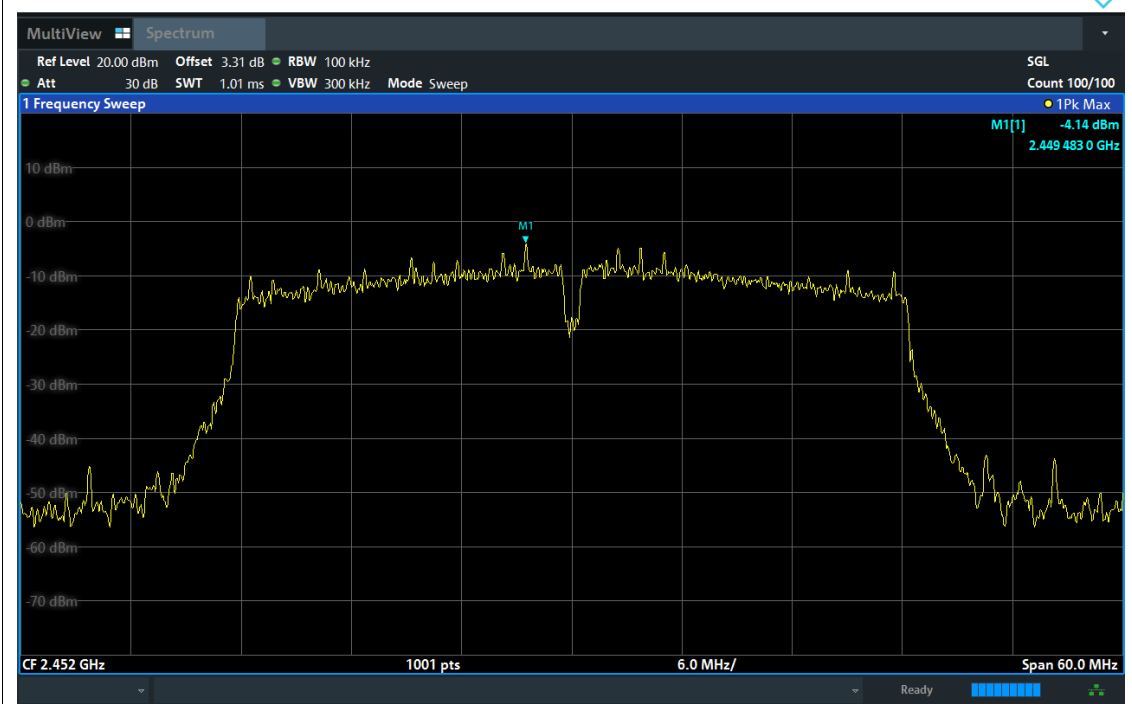
Tx. Spurious NVNT n40 2452MHz Ant1 Ref

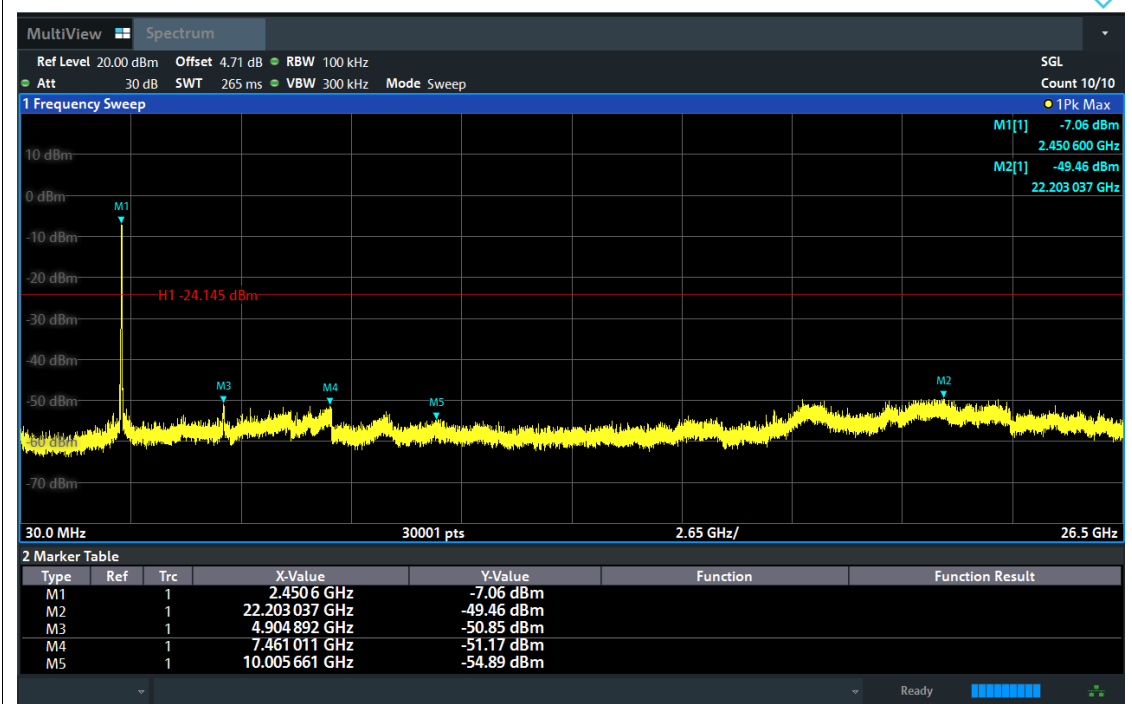
Tx. Spurious NVNT n40 2452MHz Ant1 Emission

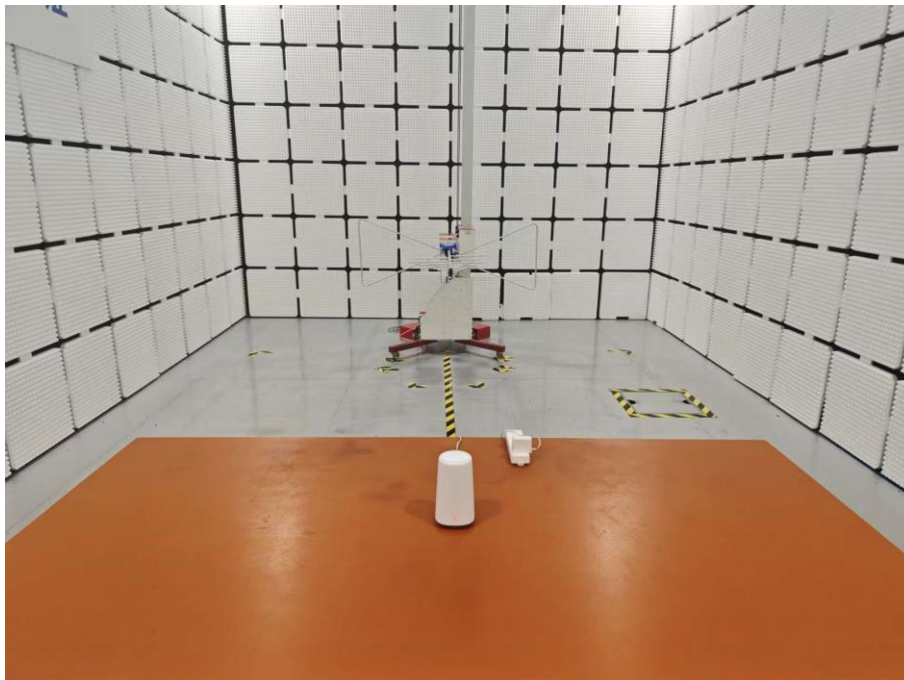
Radiated Emission Below 1GHz

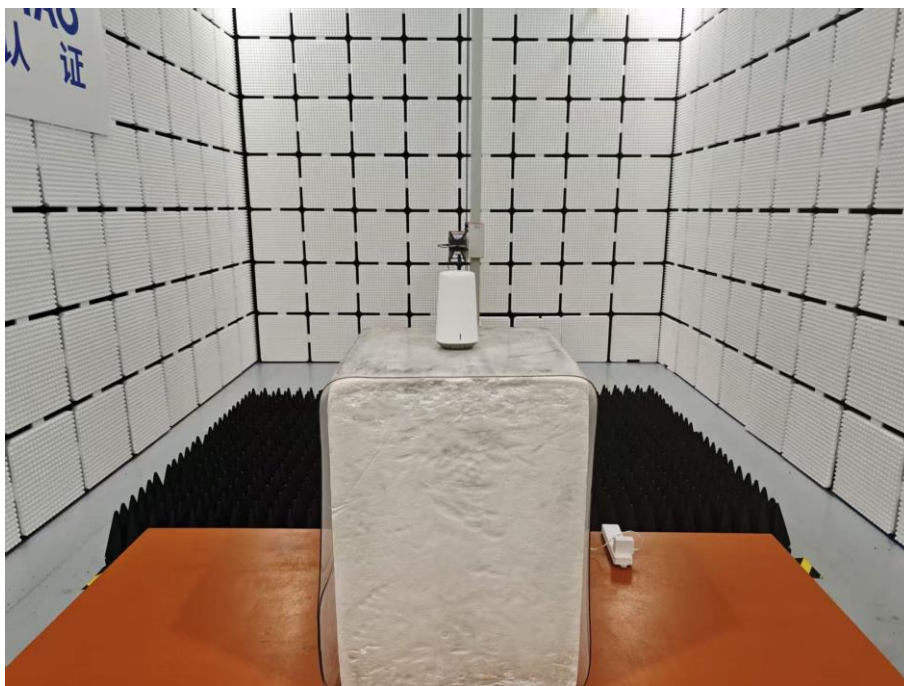
Radiated Emission Above 1GHz

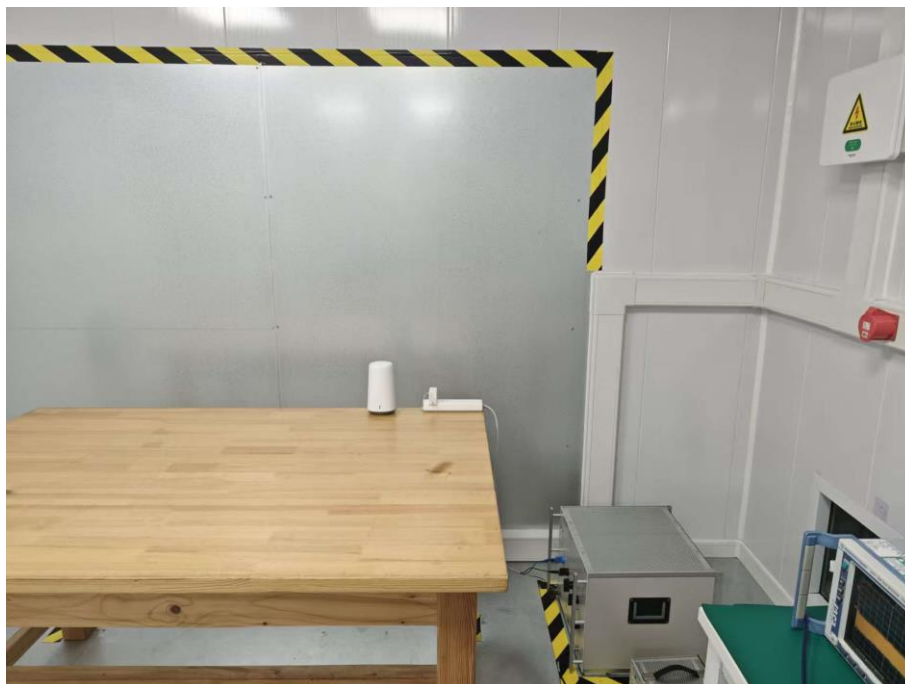
Conducted emission
