## Appendix G: Conducted Spurious Emission

### Test Result

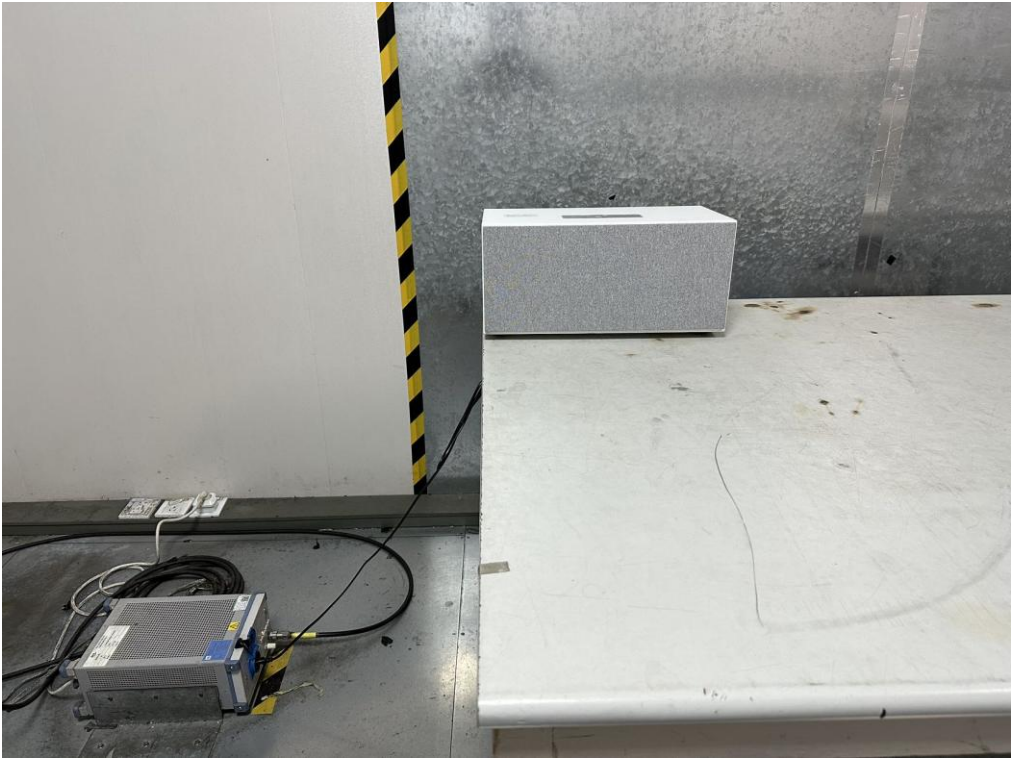
Conducted Test

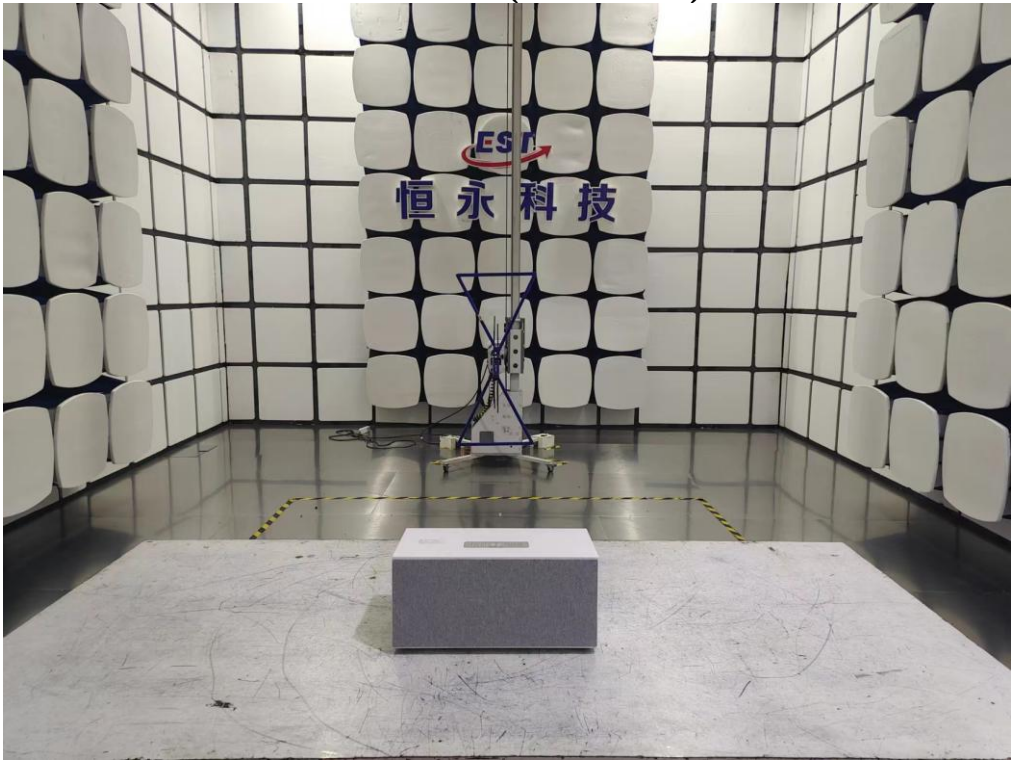
**Radiated Test (Below 1GHz)**

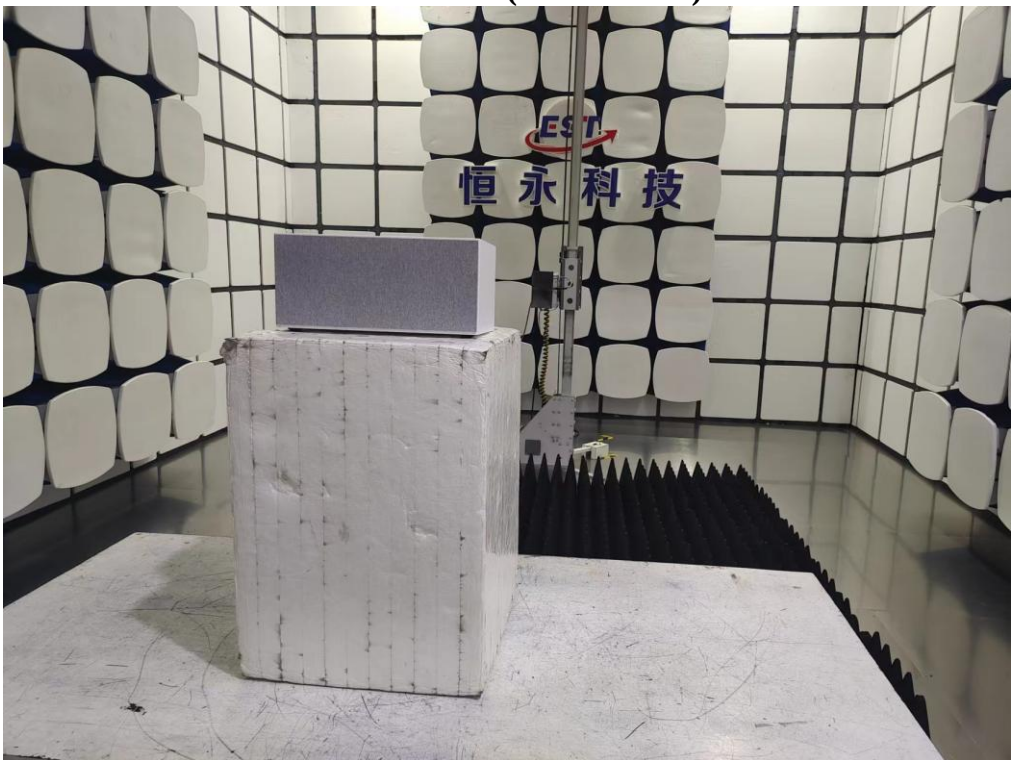
**Radiated Test (Above 1GHz)**
