Reference to the test report no. BLA-EMC-202601-A3401

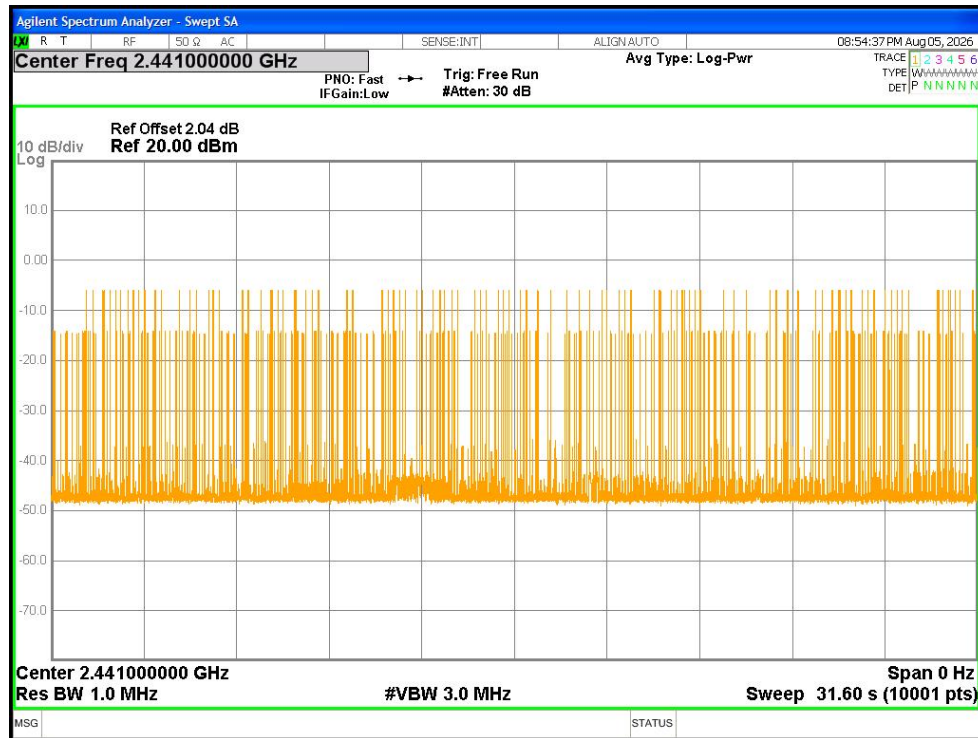
Dwell NVNT 2-DH1 2441MHz Ant1 One Burst

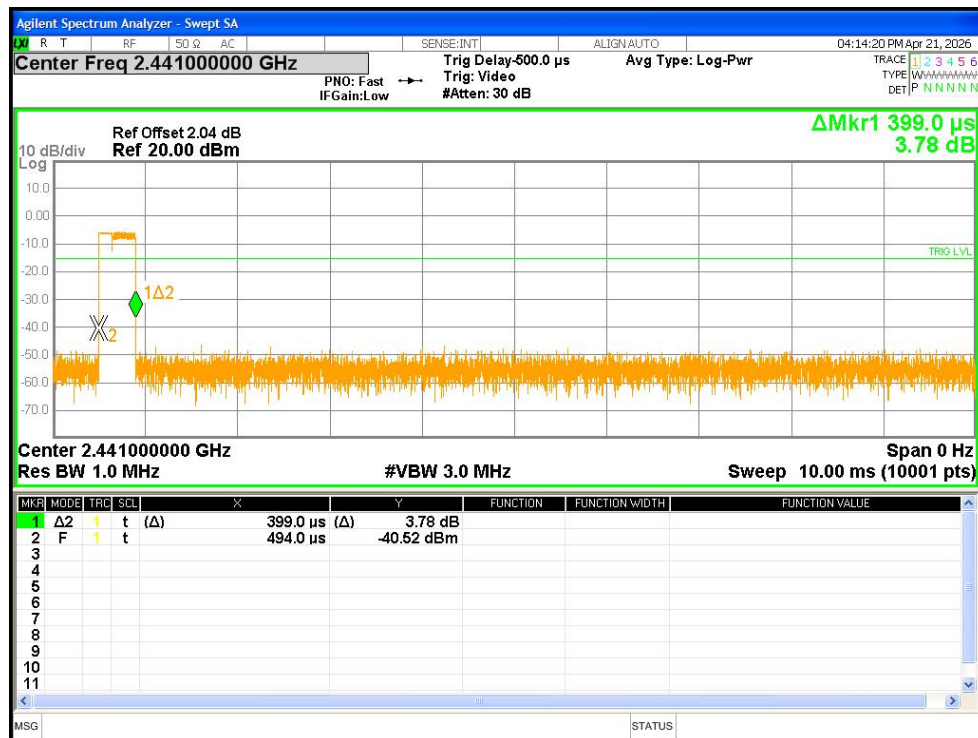
Dwell NVNT 2-DH1 2441MHz Ant1 Accumulated

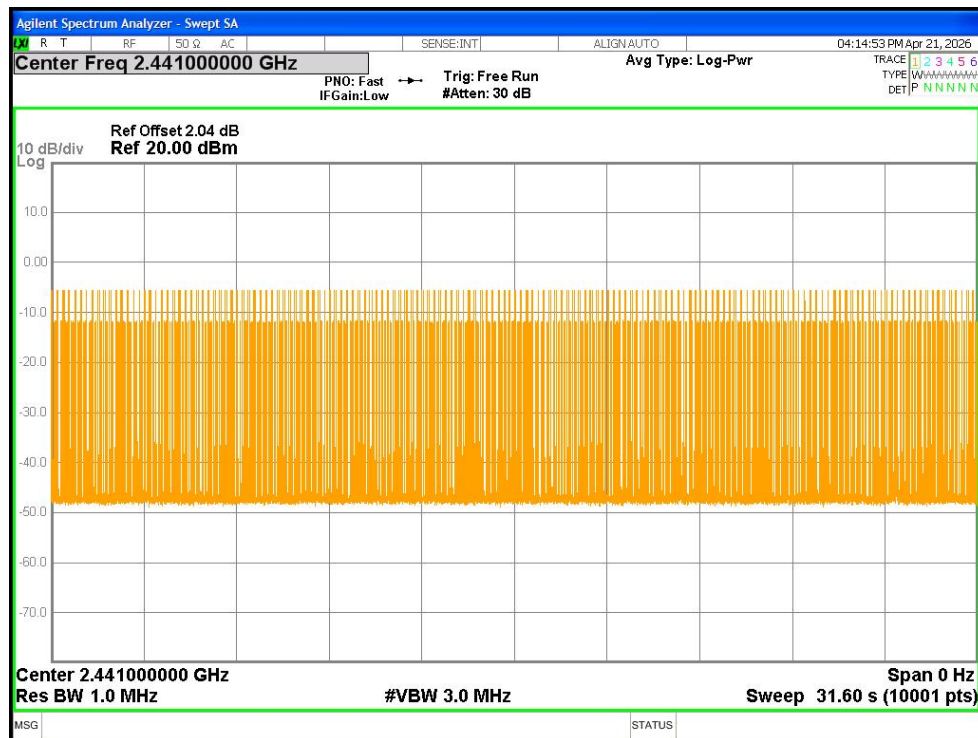
Dwell NVNT 2-DH3 2441MHz Ant1 One Burst

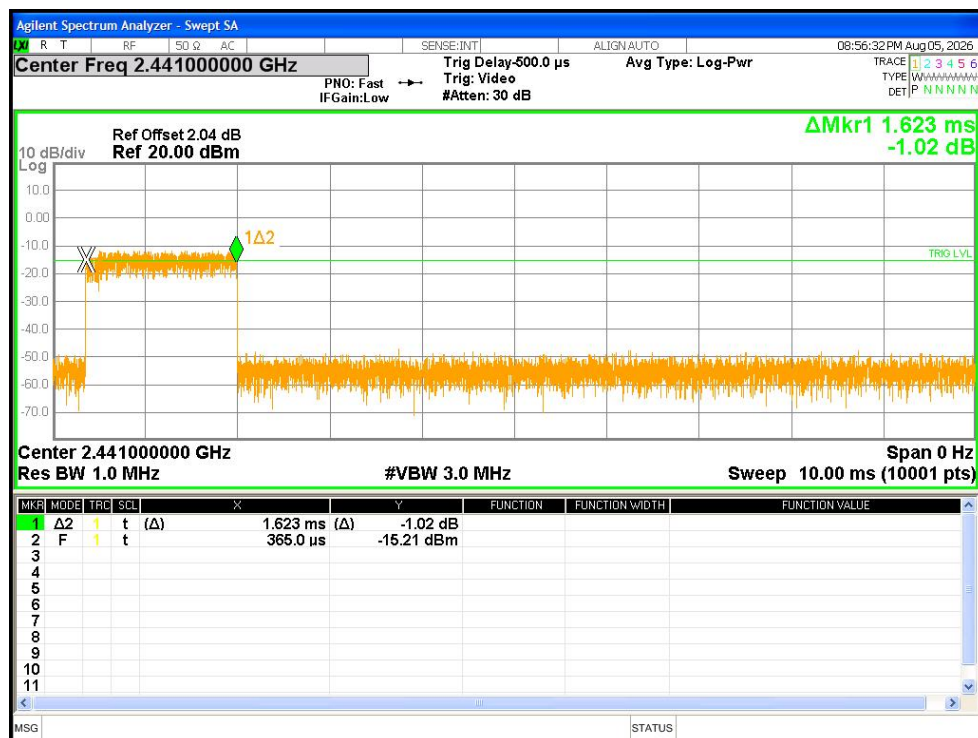
Dwell NVNT 2-DH3 2441MHz Ant1 Accumulated

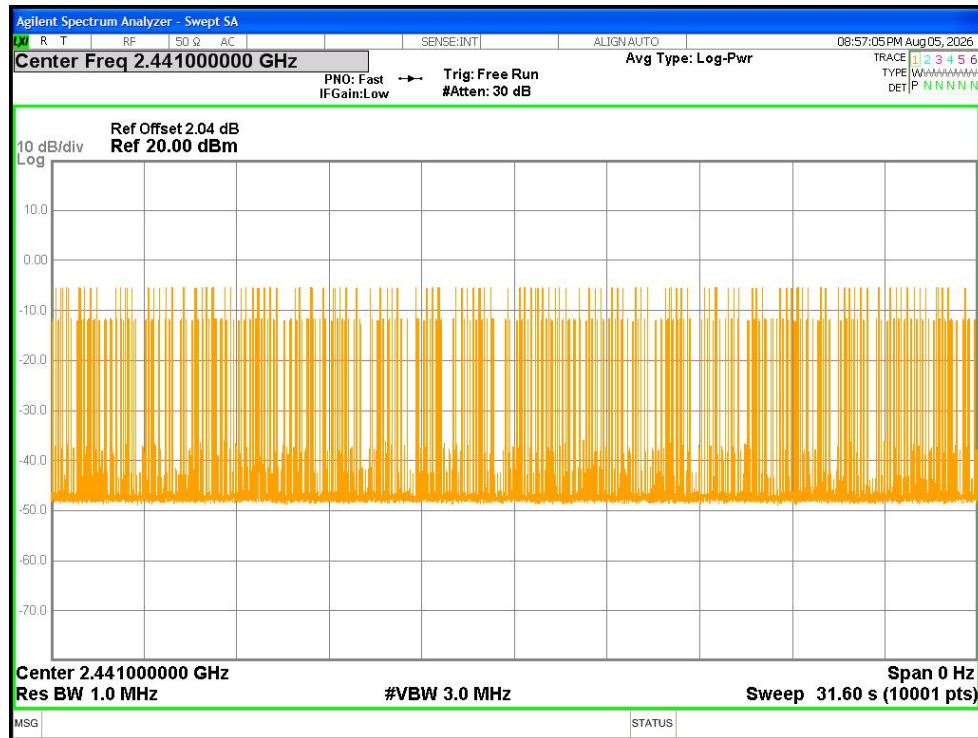
Dwell NVNT 2-DH5 2441MHz Ant1 One Burst

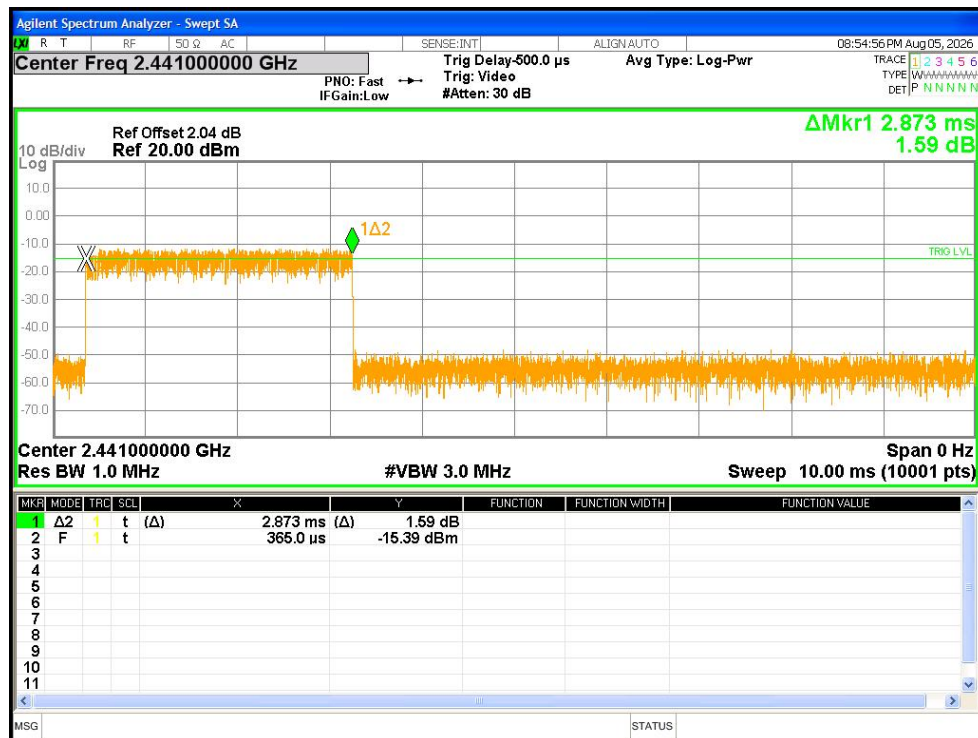
Dwell NVNT 2-DH5 2441MHz Ant1 Accumulated

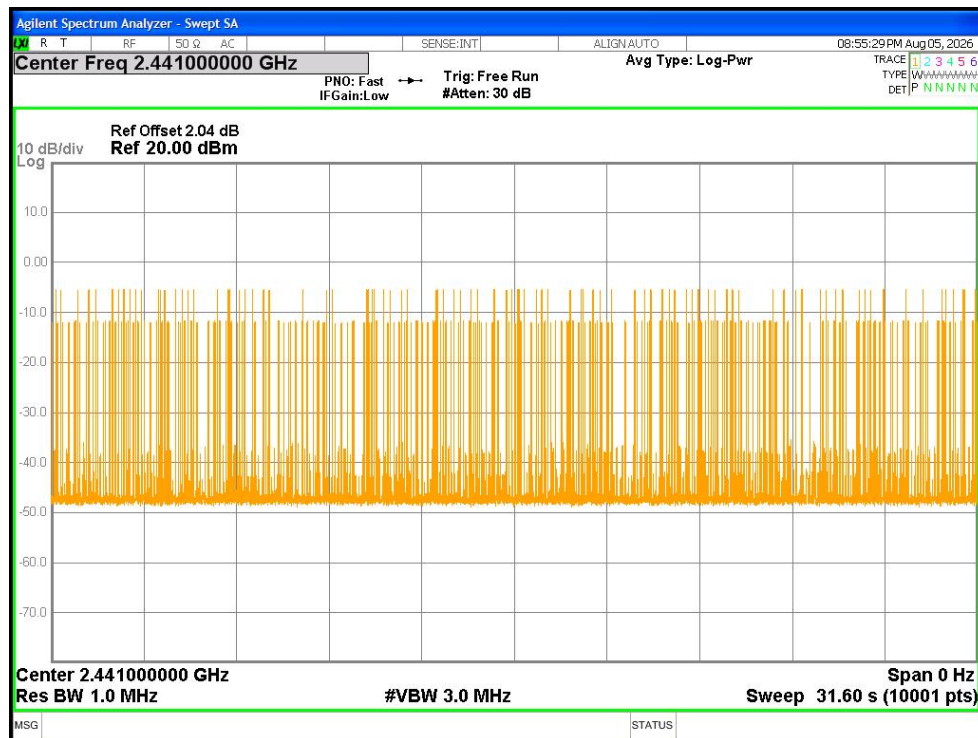
Dwell NVNT 3-DH1 2441MHz Ant1 One Burst

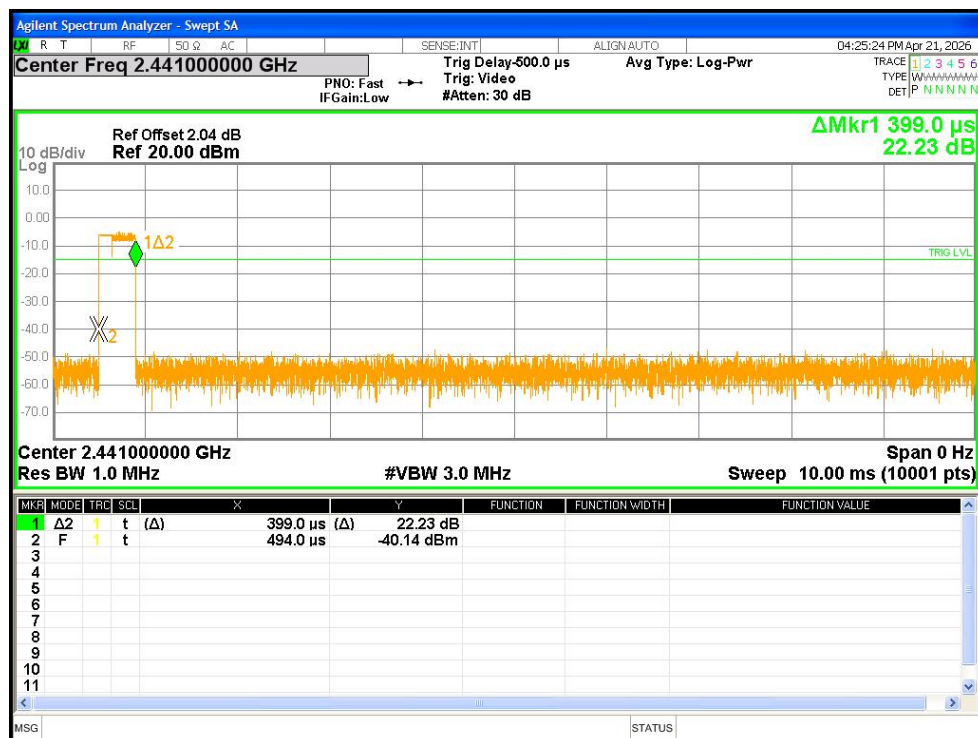
Dwell NVNT 3-DH1 2441MHz Ant1 Accumulated

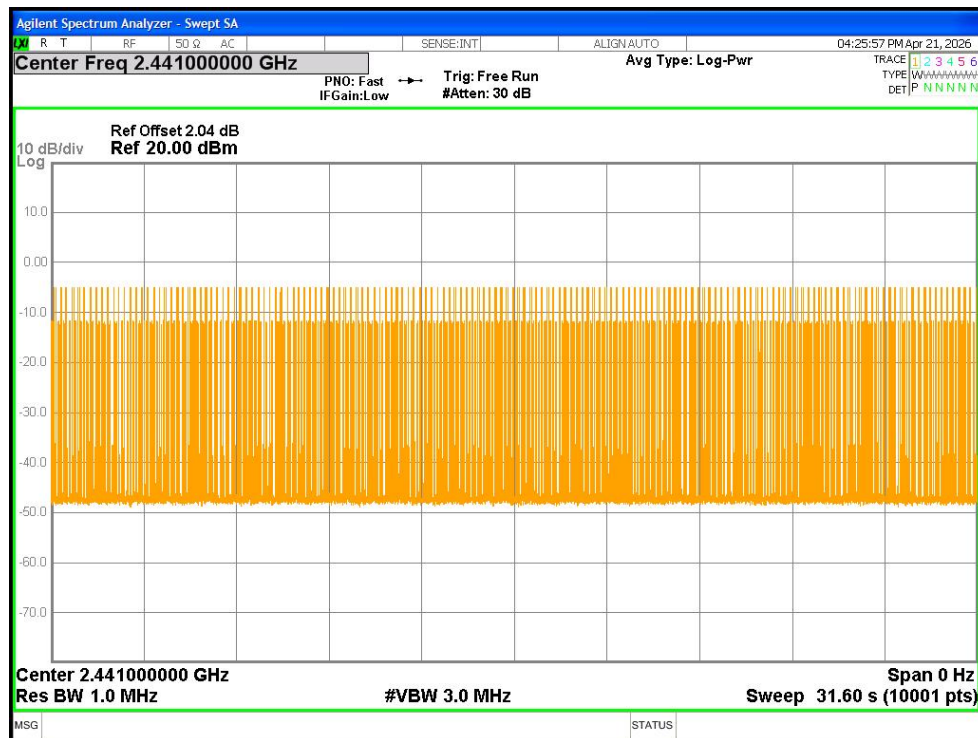
Dwell NVNT 3-DH3 2441MHz Ant1 One Burst

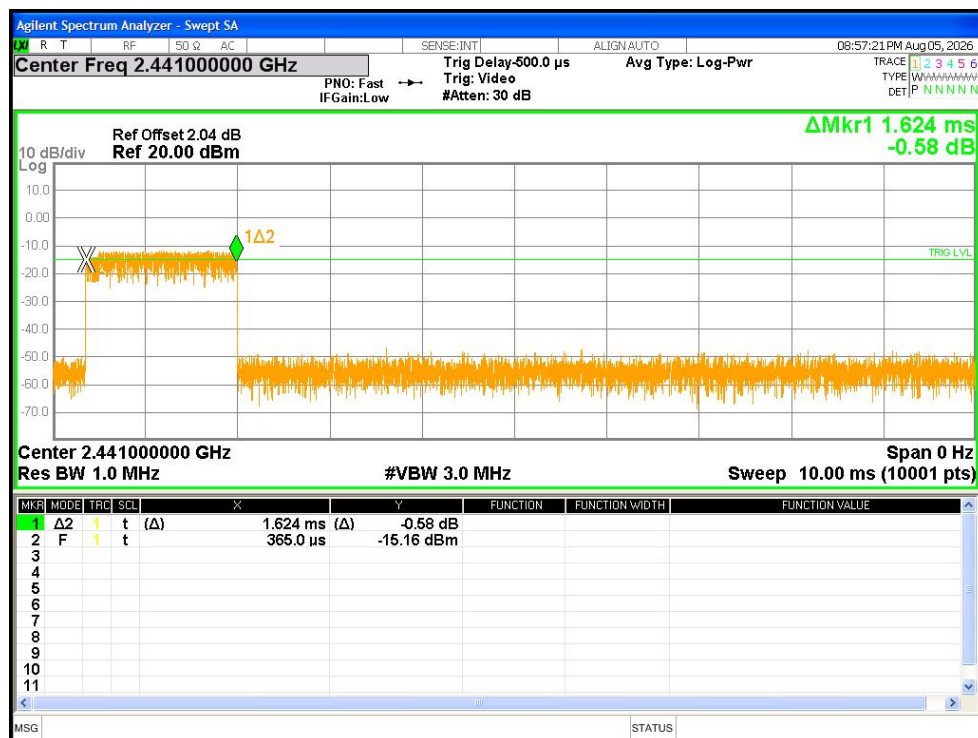
Dwell NVNT 3-DH3 2441MHz Ant1 Accumulated

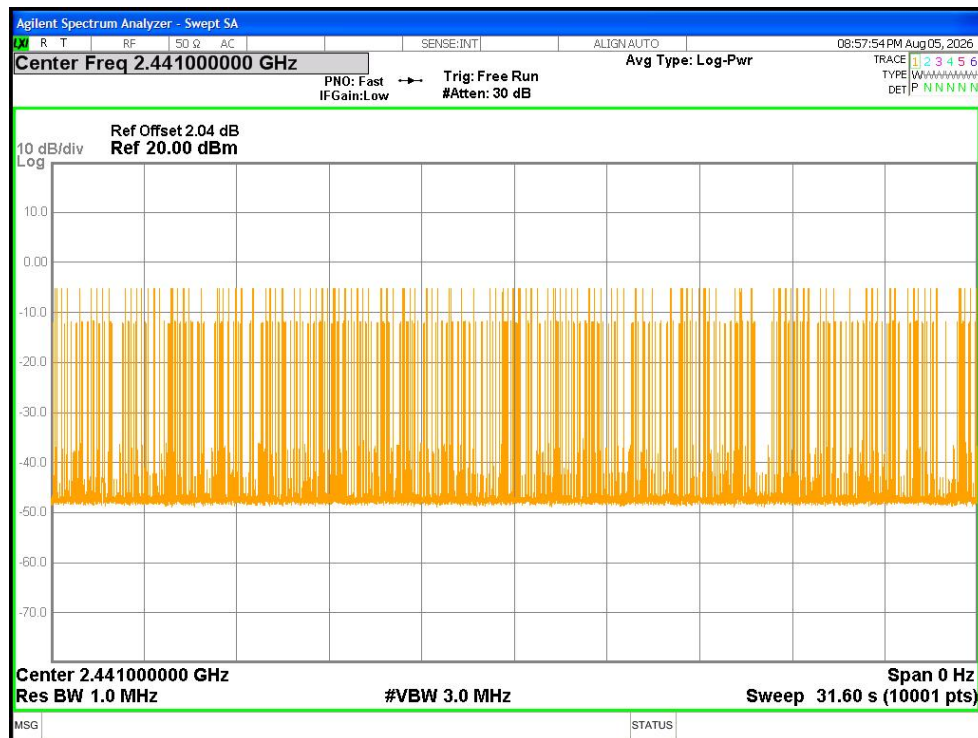
Dwell NVNT 3-DH5 2441MHz Ant1 One Burst

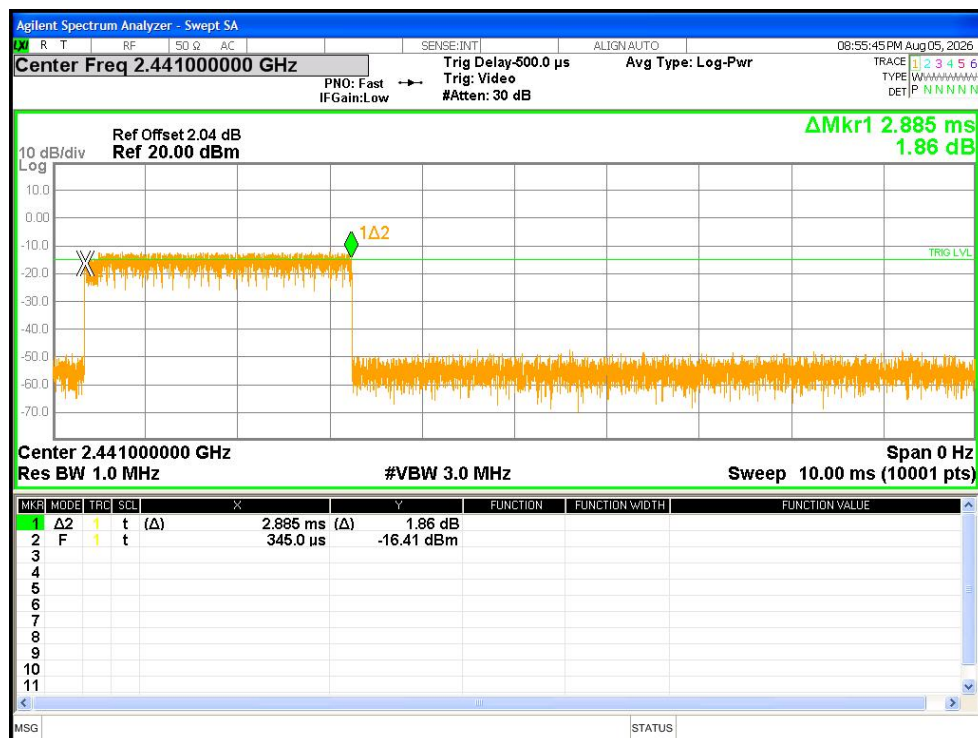
Dwell NVNT 3-DH5 2441MHz Ant1 Accumulated
