## RF Conducted Spurious Emissions

**Appendix C: Photographs of EUT**  
**Model: EXACT-150LT**  
**External Photos**

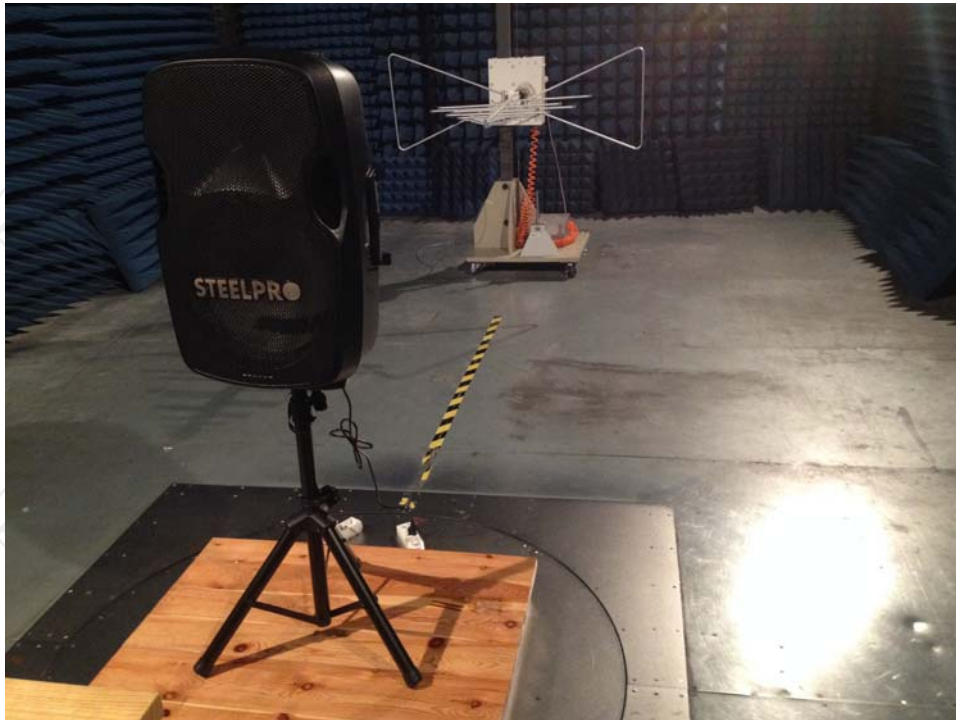
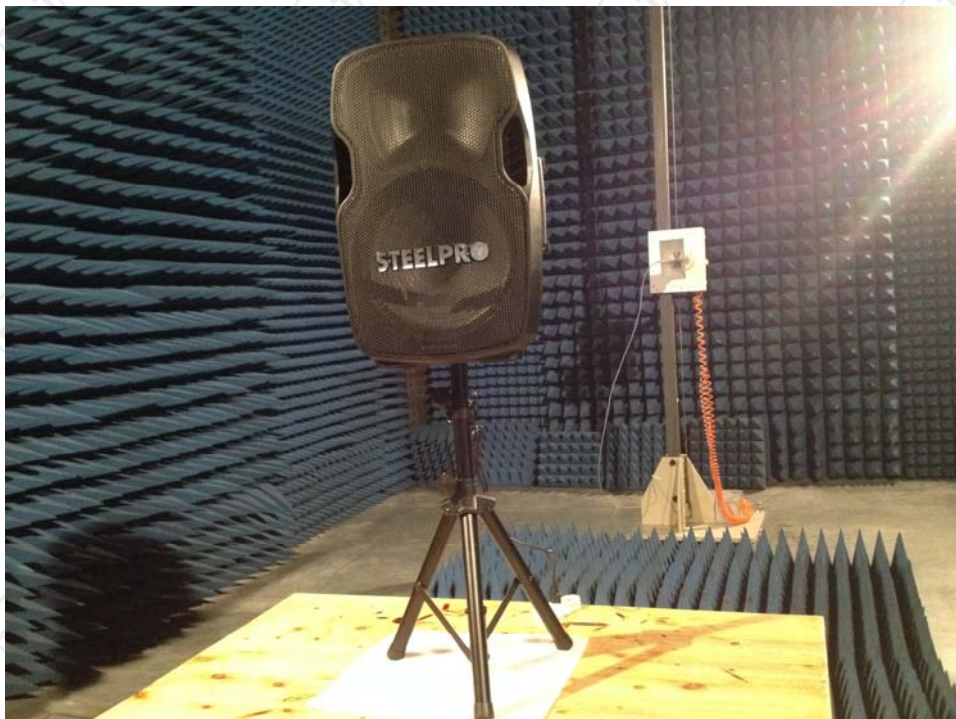
### Radiated Emission

## Appendix B: Photographs of Test Setup
