## Spurious Emissions at Antenna Terminal

### FCC For 90S

#### B26\_1, Normal

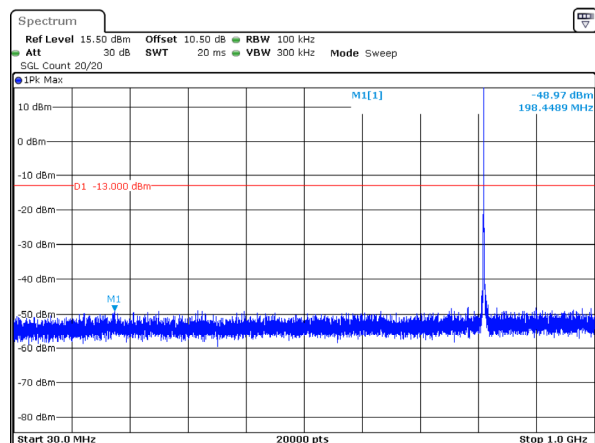
##### 1.4MHz\_Low\_QPSK\_1@0(30MHz~1GHz)

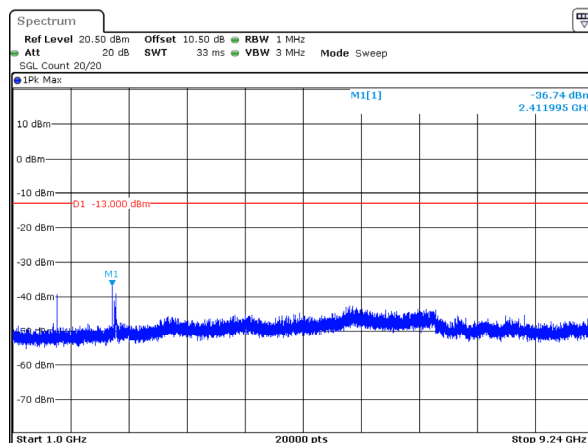
##### 1.4MHz\_Low\_QPSK\_1@0(1GHz~9.24GHz)

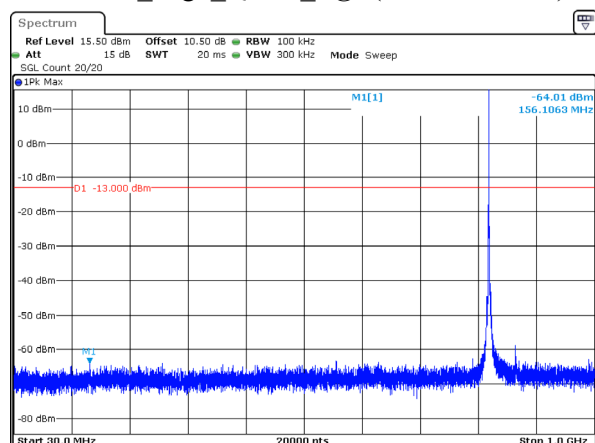
##### 1.4MHz\_High\_QPSK\_1@0(30MHz~1GHz)

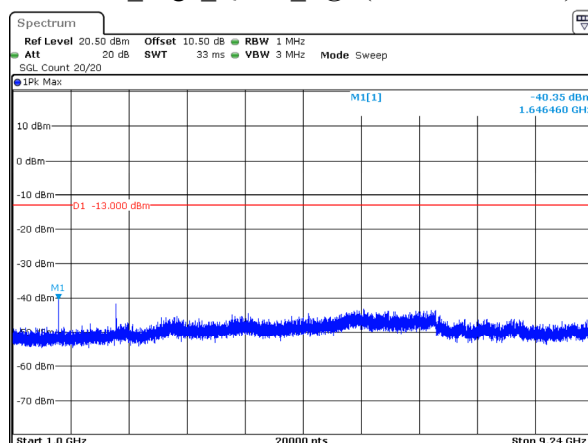
##### 1.4MHz\_High\_QPSK\_1@0(1GHz~9.24GHz)

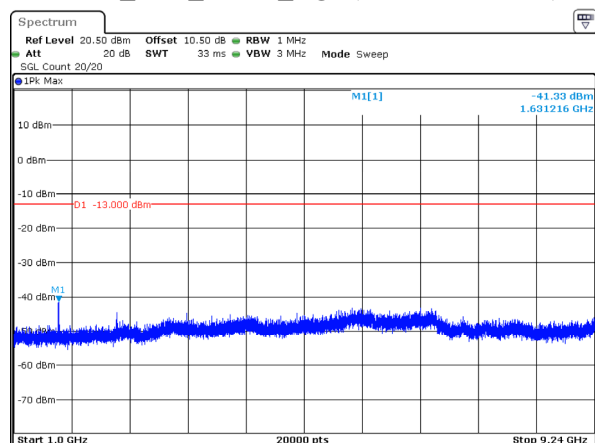
##### 3MHz\_Low\_QPSK\_1@0(1GHz~9.24GHz)

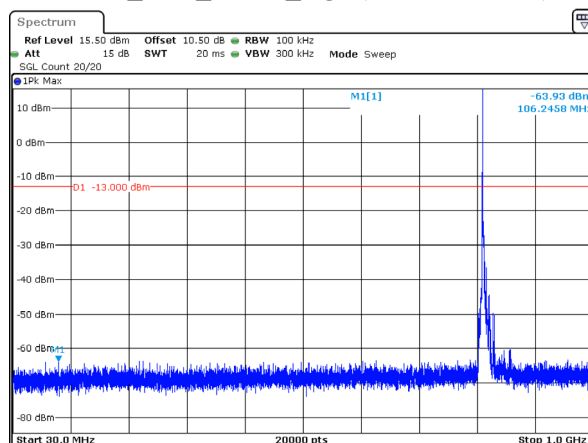
##### 3MHz\_Low\_QPSK\_1@0(30MHz~1GHz)

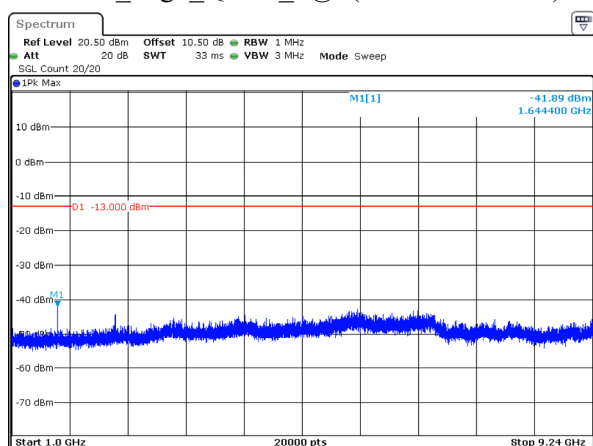
### 3MHz\_High\_QPSK\_1@0(1GHz~9.24GHz)

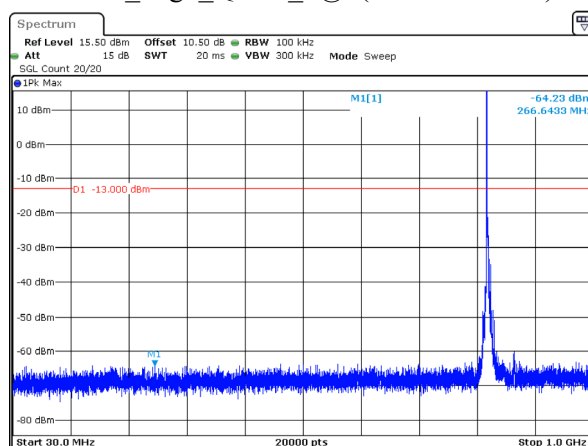
### 3MHz\_High\_QPSK\_1@0(30MHz~1GHz)

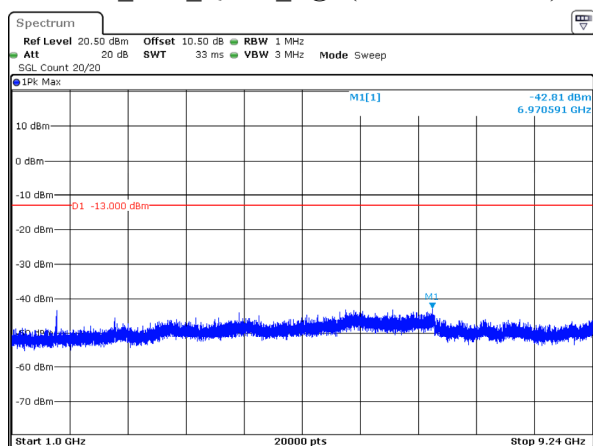
### 5MHz\_Low\_QPSK\_1@0(1GHz~9.24GHz)

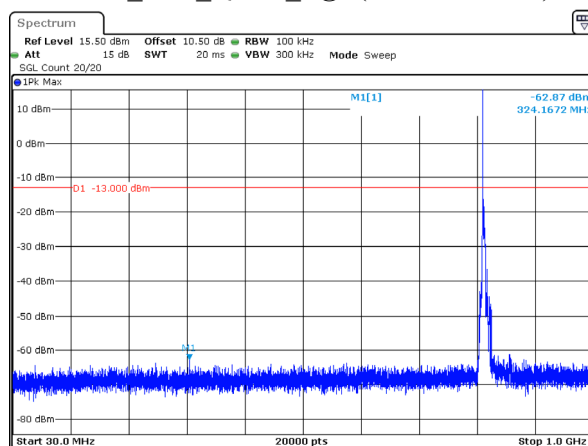
### 5MHz\_Low\_QPSK\_1@0(30MHz~1GHz)

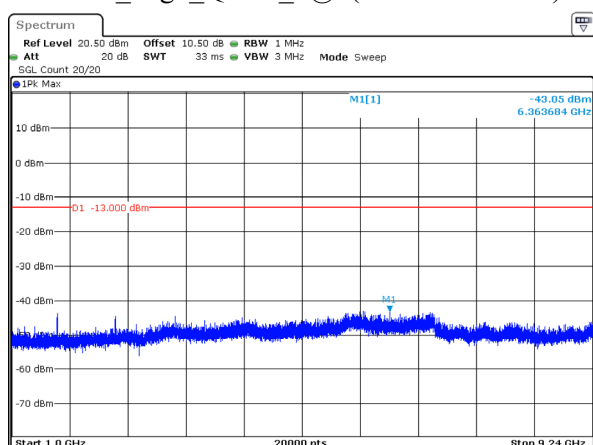
### 5MHz\_High\_QPSK\_1@0(1GHz~9.24GHz)

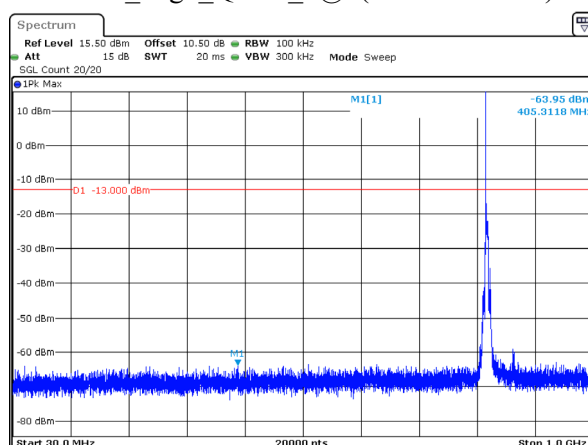
### 5MHz\_High\_QPSK\_1@0(30MHz~1GHz)

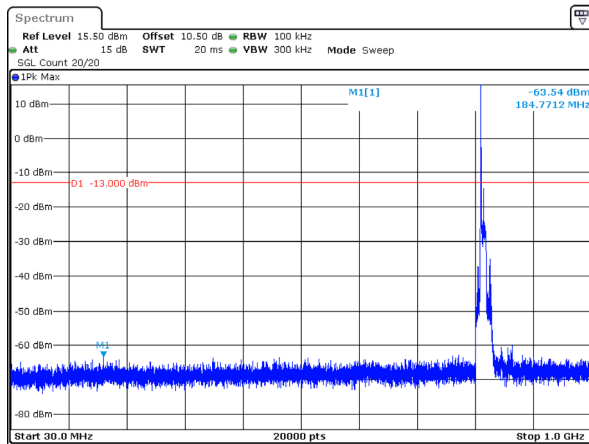
### 10MHz\_Low\_QPSK\_1@0(30MHz~1GHz)

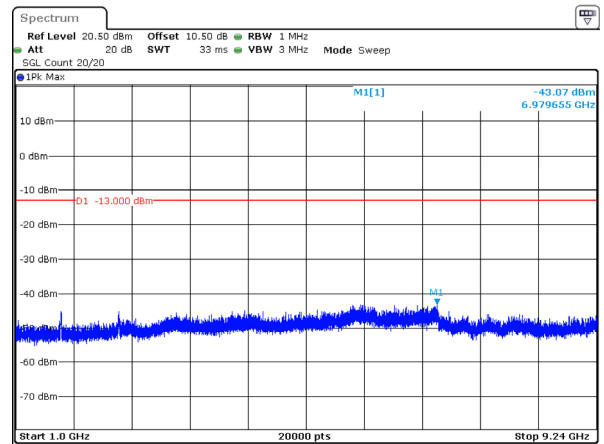
### 10MHz\_Low\_QPSK\_1@0(1GHz~9.24GHz)

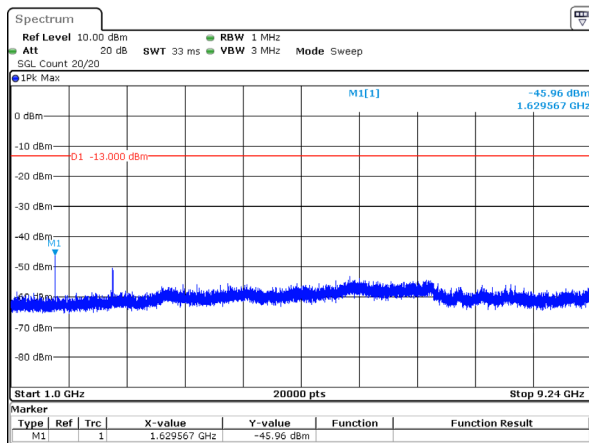
### 15MHz\_Low\_QPSK\_1@0(1GHz~9.24GHz)

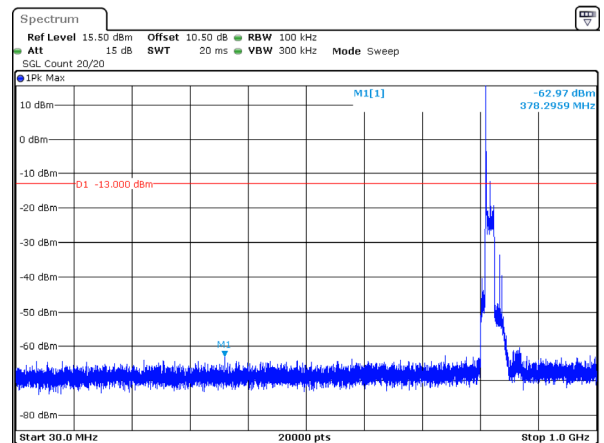
### 15MHz\_Low\_QPSK\_1@0(30MHz~1GHz)

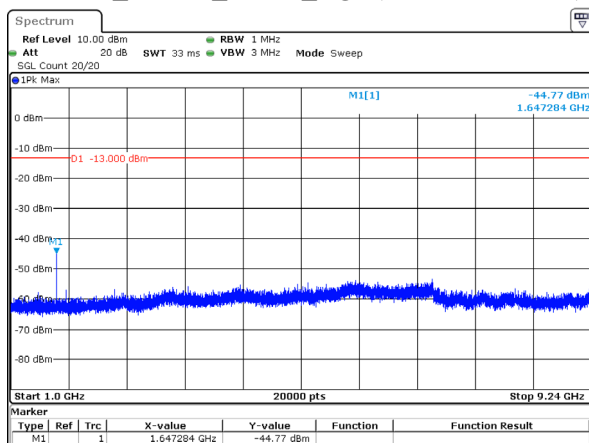
### 1.4MHz\_Middle\_QPSK\_1@0(1GHz~9.24GHz)

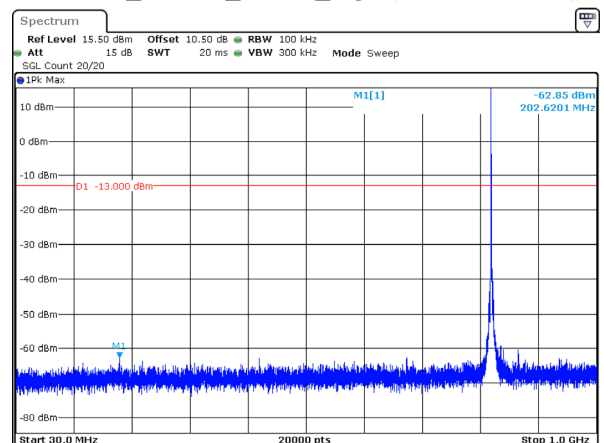
### 1.4MHz\_Middle\_QPSK\_1@0(30MHz~1GHz)

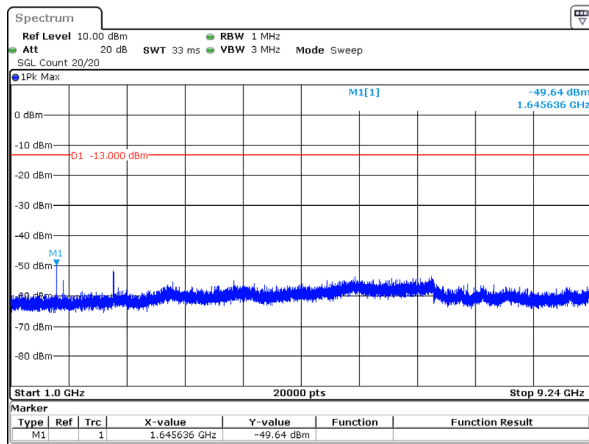
### 3MHz\_Middle\_QPSK\_1@0(1GHz~9.24GHz)

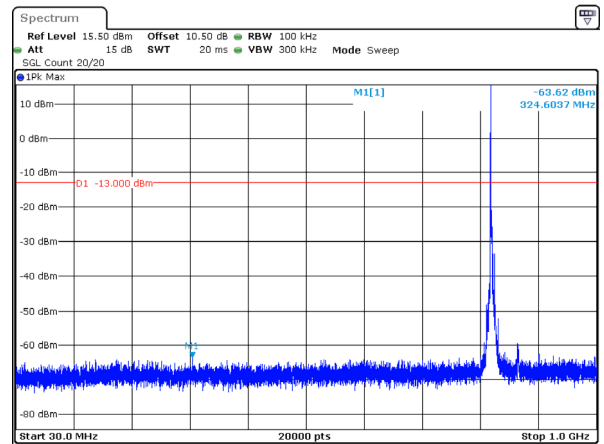
### 3MHz\_Middle\_QPSK\_1@0(30MHz~1GHz)

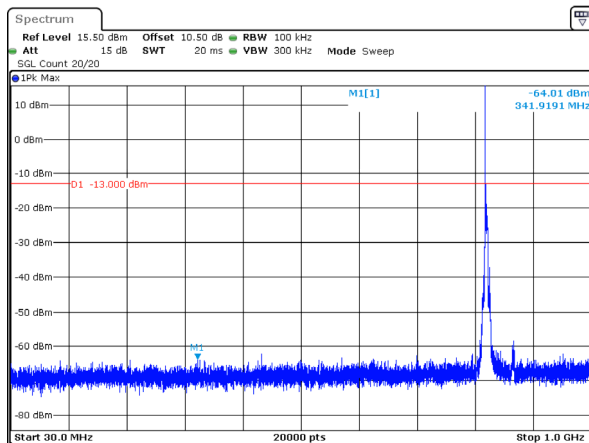
### 5MHz\_Middle\_QPSK\_1@0(30MHz~1GHz)

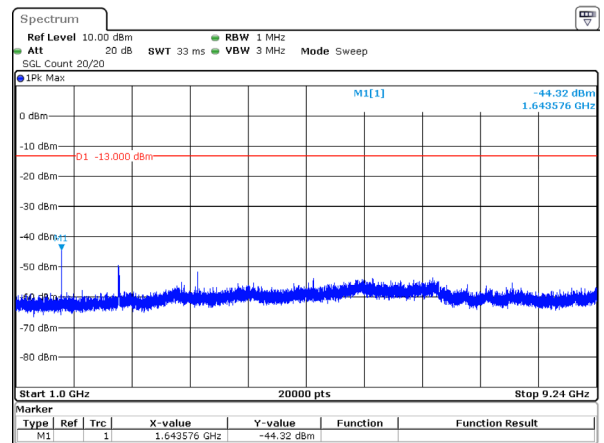
### 5MHz\_Middle\_QPSK\_1@0(1GHz~9.24GHz)

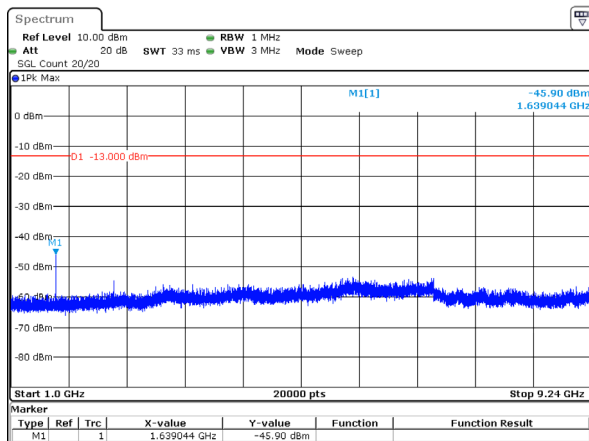
### 10MHz\_Middle\_QPSK\_1@0(1GHz~9.24GHz)

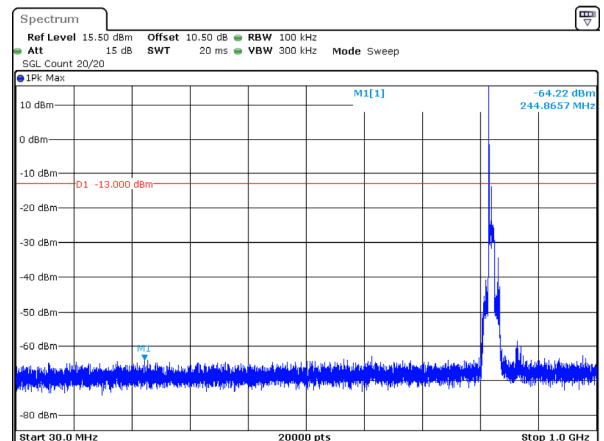
### 10MHz\_Middle\_QPSK\_1@0(30MHz~1GHz)

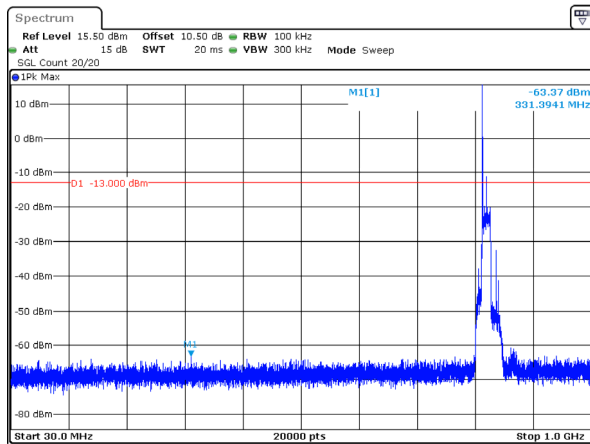
15MHz\_Middle\_QPSK\_1@0(30MHz~1GHz)

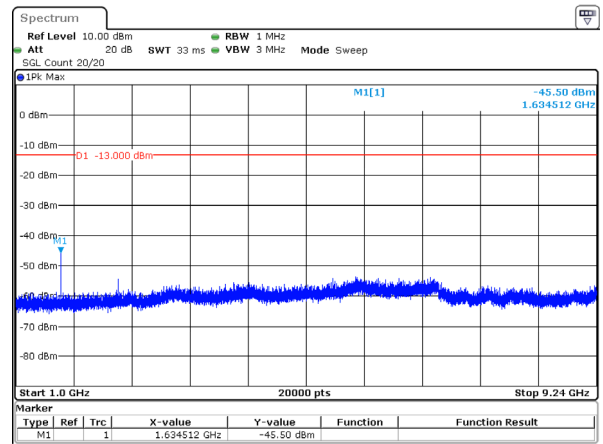
15MHz\_Middle\_QPSK\_1@0(1GHz~9.24GHz)
