# Test Setup Photos

**EUT Name:** Localizer

**EUT Model:** HB100

**FCC ID:** 2AJT8-HB100

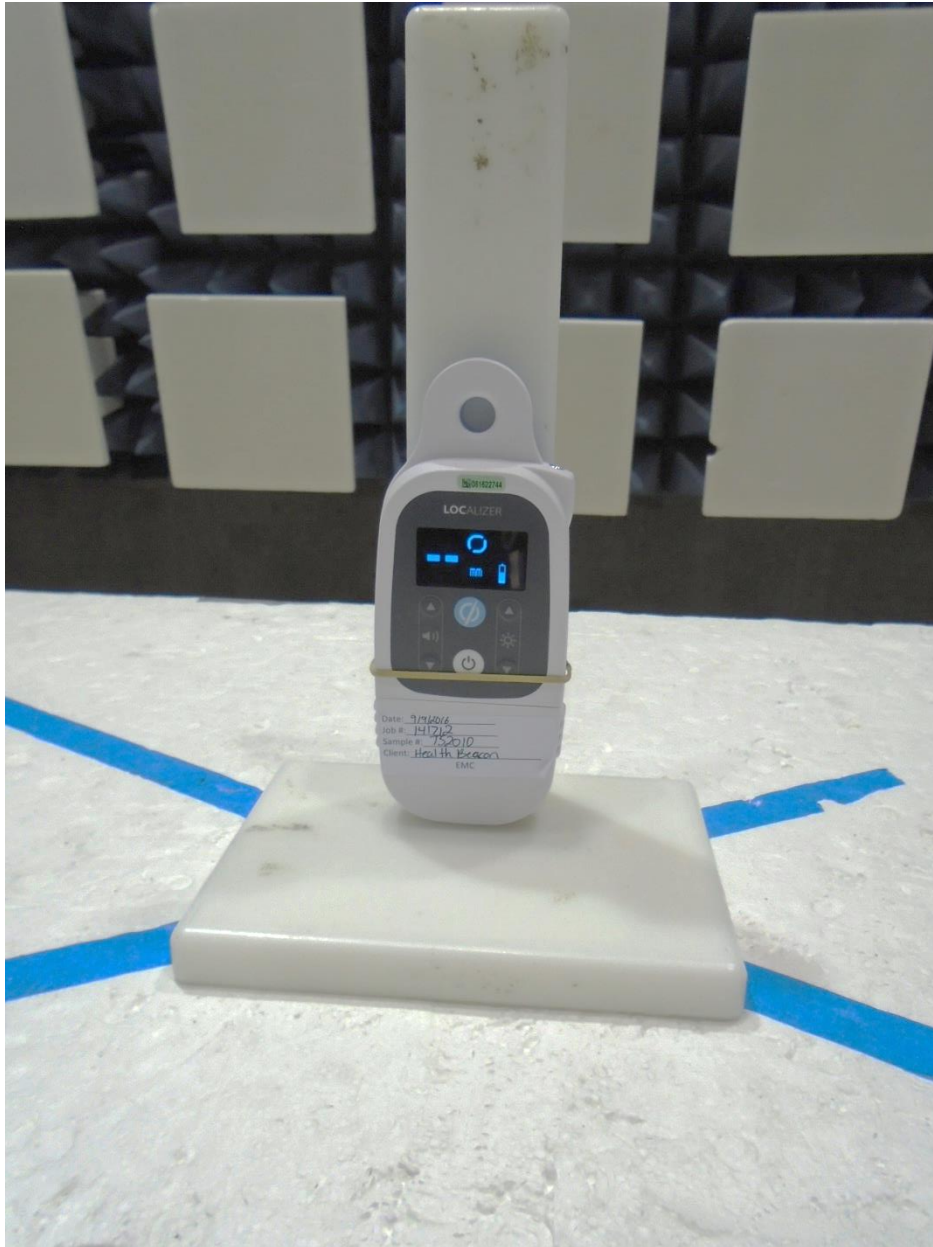
Figure 1: Radiated Emissions; Loop Antenna – Orientation 1

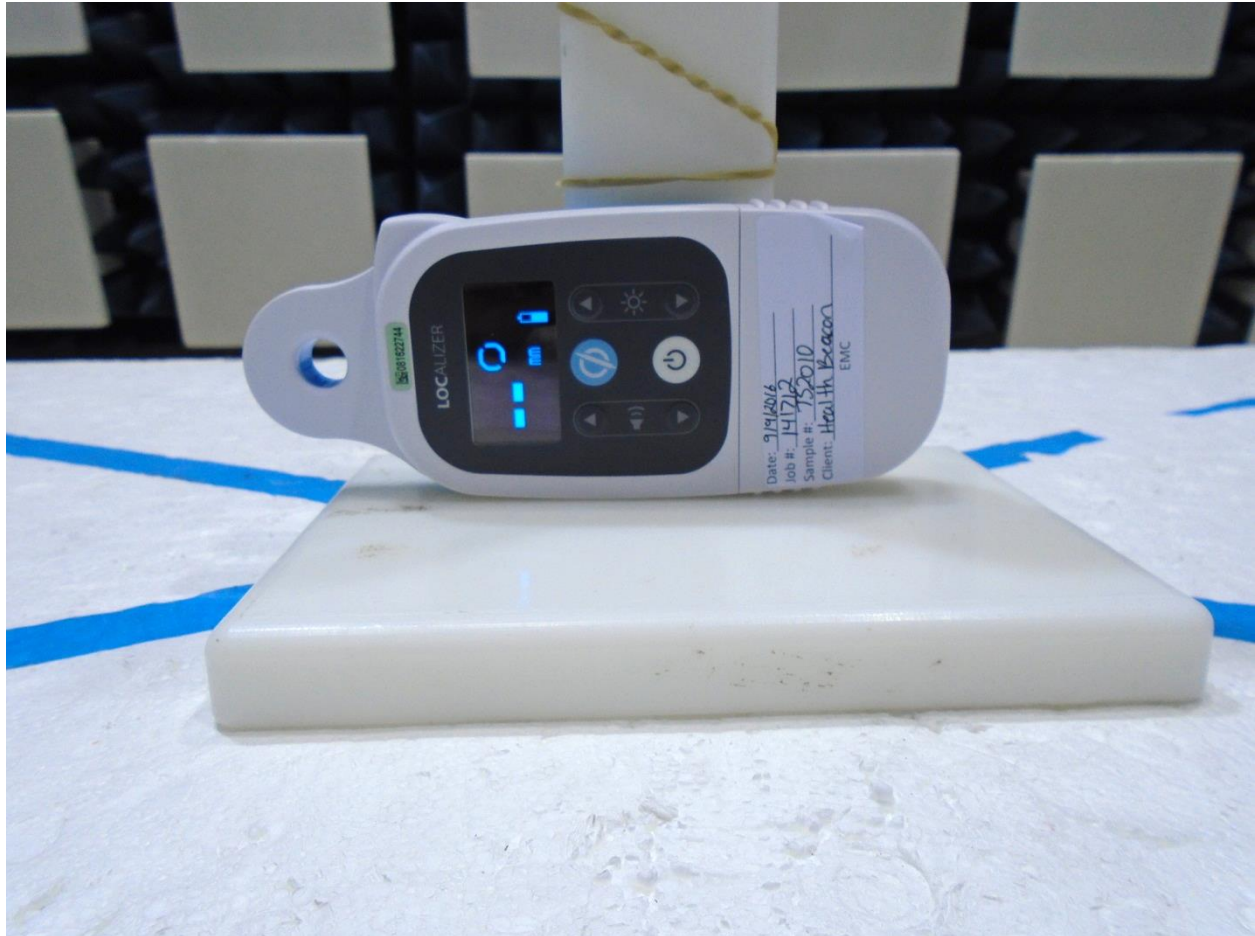
Figure 3: Radiated Emissions; Loop antenna – Orientation 2  
(Highest emissions below 30 MHz from this orientation).

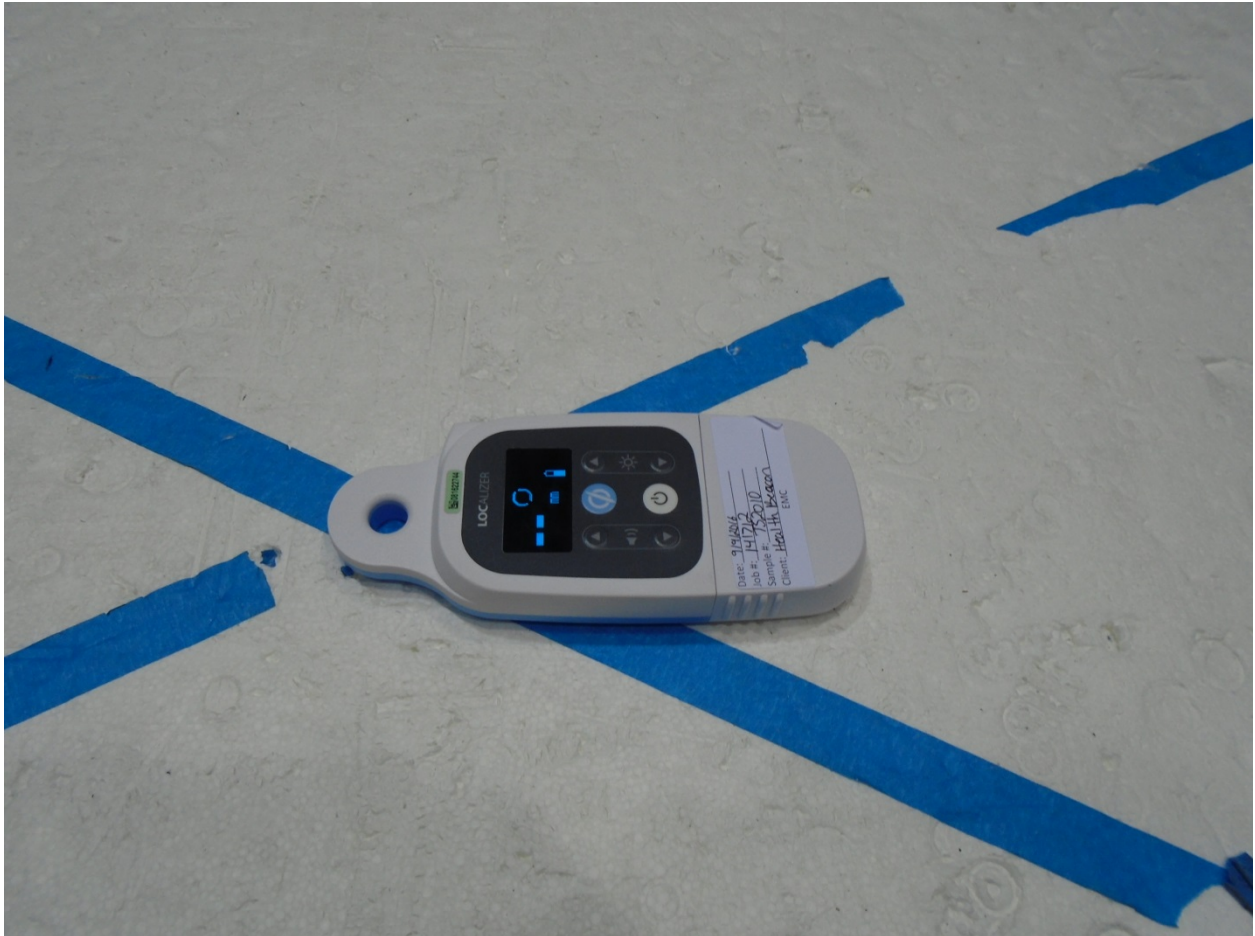
Figure 5: Radiated Emissions; Loop Antenna – Orientation 3

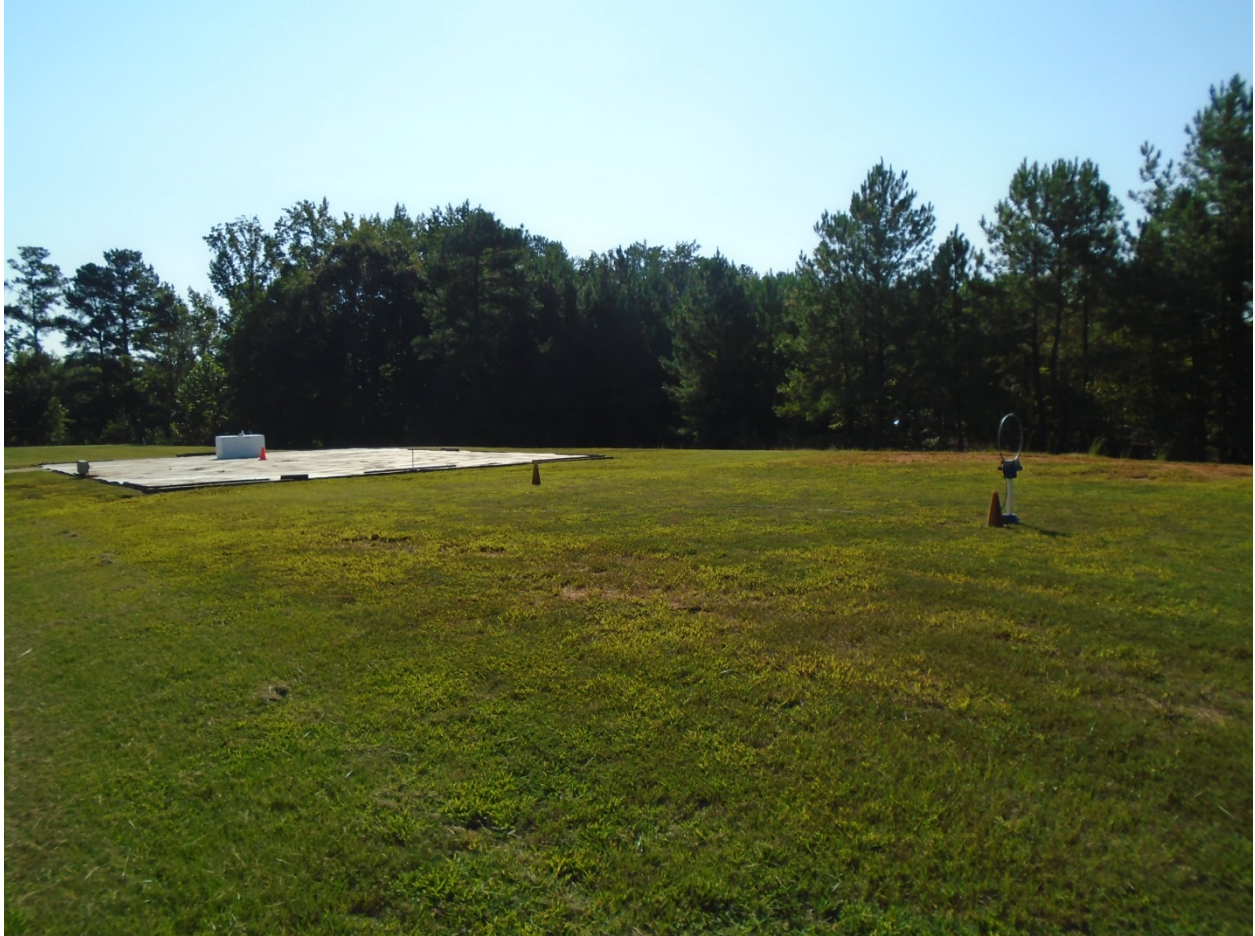
Figure 11: Radiated Emissions below 30 MHz – OATS measurement at 30m

Note: At this distance, there were no measureable signals.

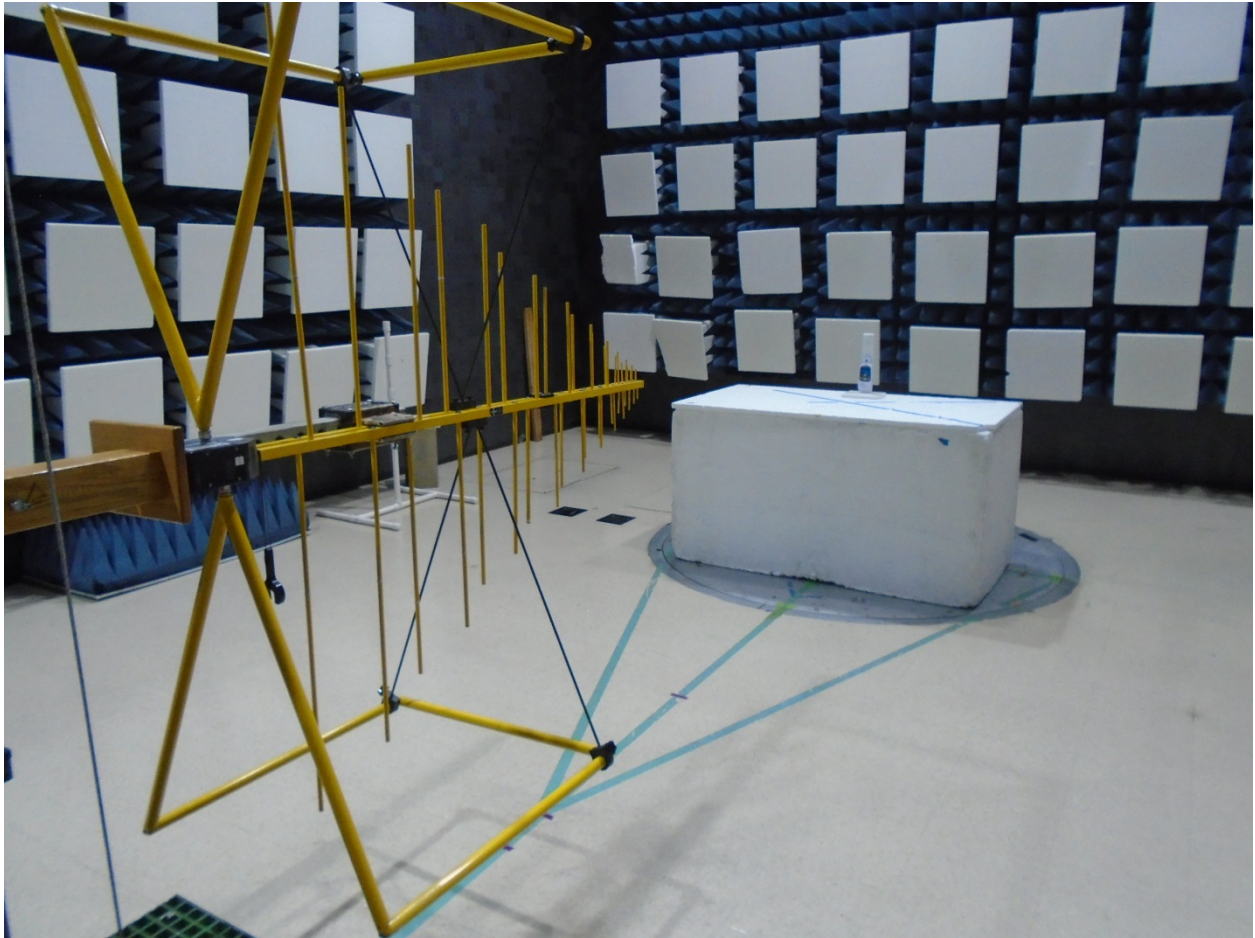
Figure 12: Radiated Emissions above 30 MHz.  
(Highest emissions above 30 MHz were from this orientation).
