## -6dB Bandwidth

## APPENDIX II:PHOTOS OF TEST SETUP

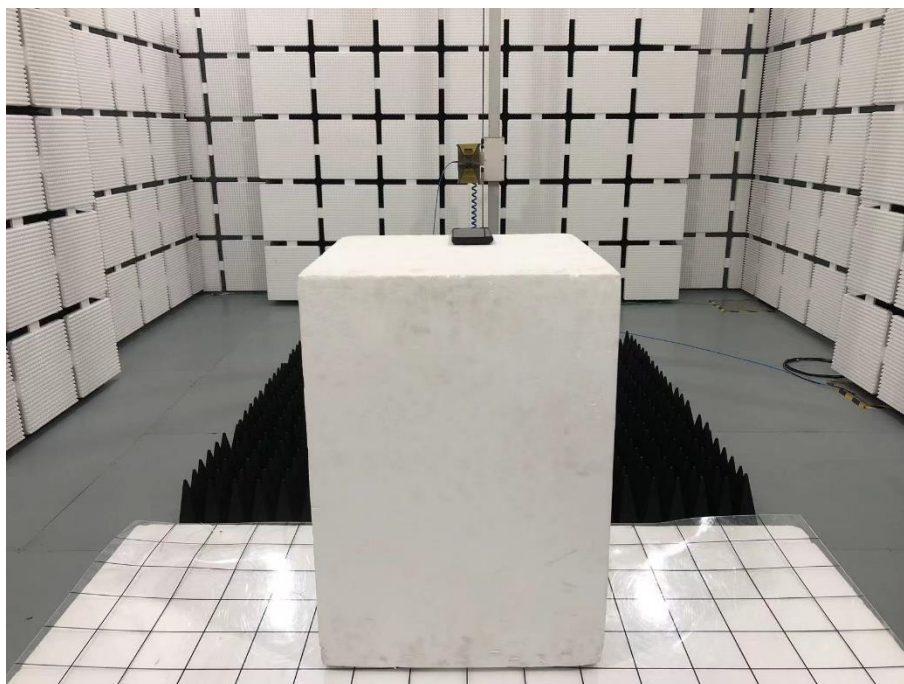
**Radiated Spurious Emission Test Setup Photo - Above 1GHz**
