## Appendix I: Reference level measurement

14. TEST SETUP PHOTO

External Photos  
M/N: Defunc TRUE LITE

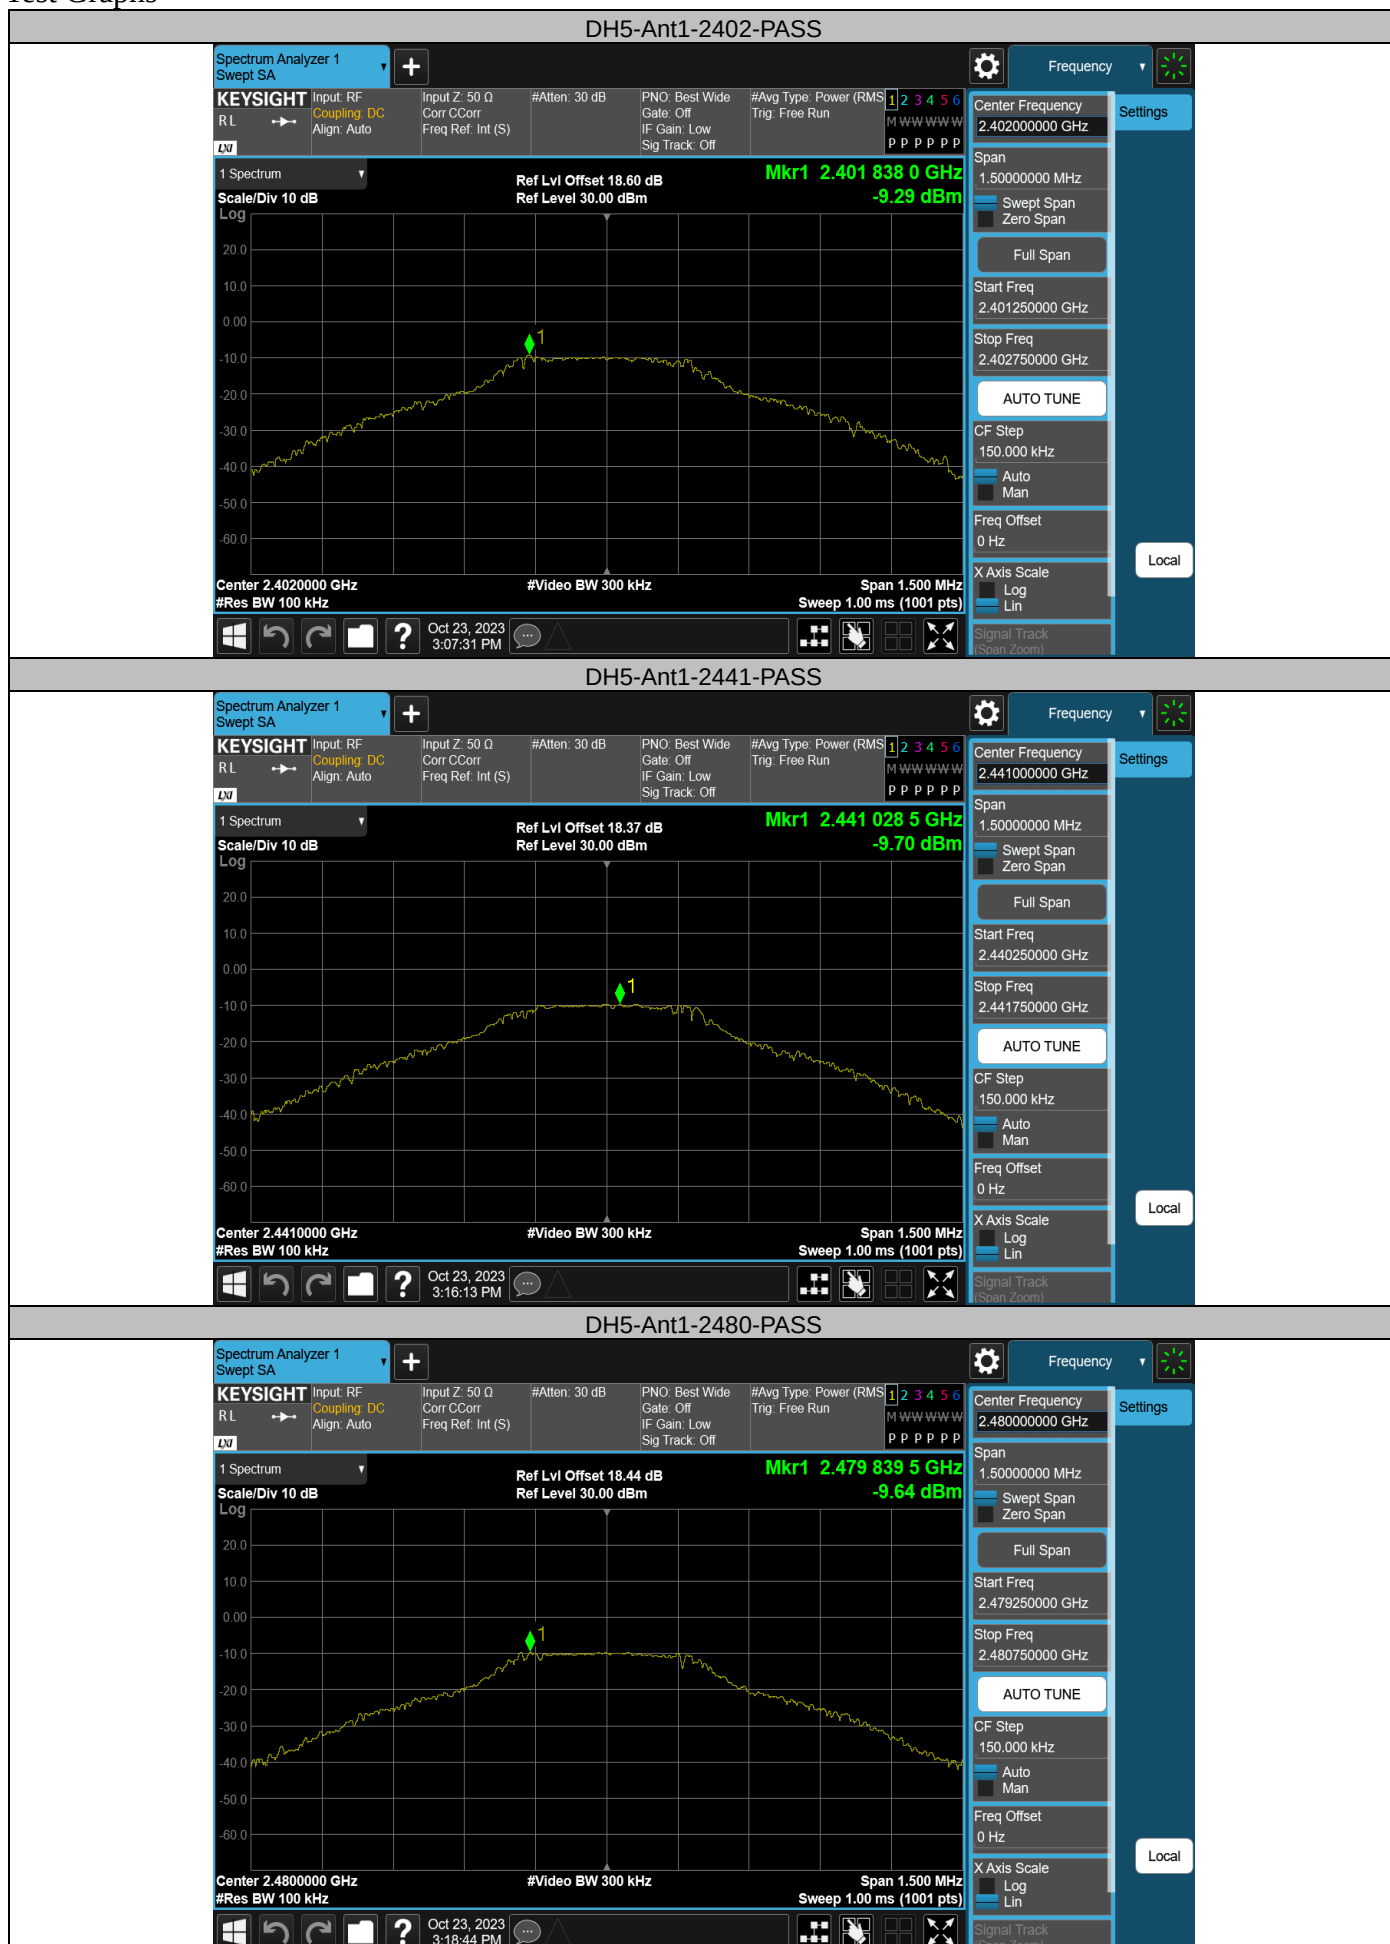
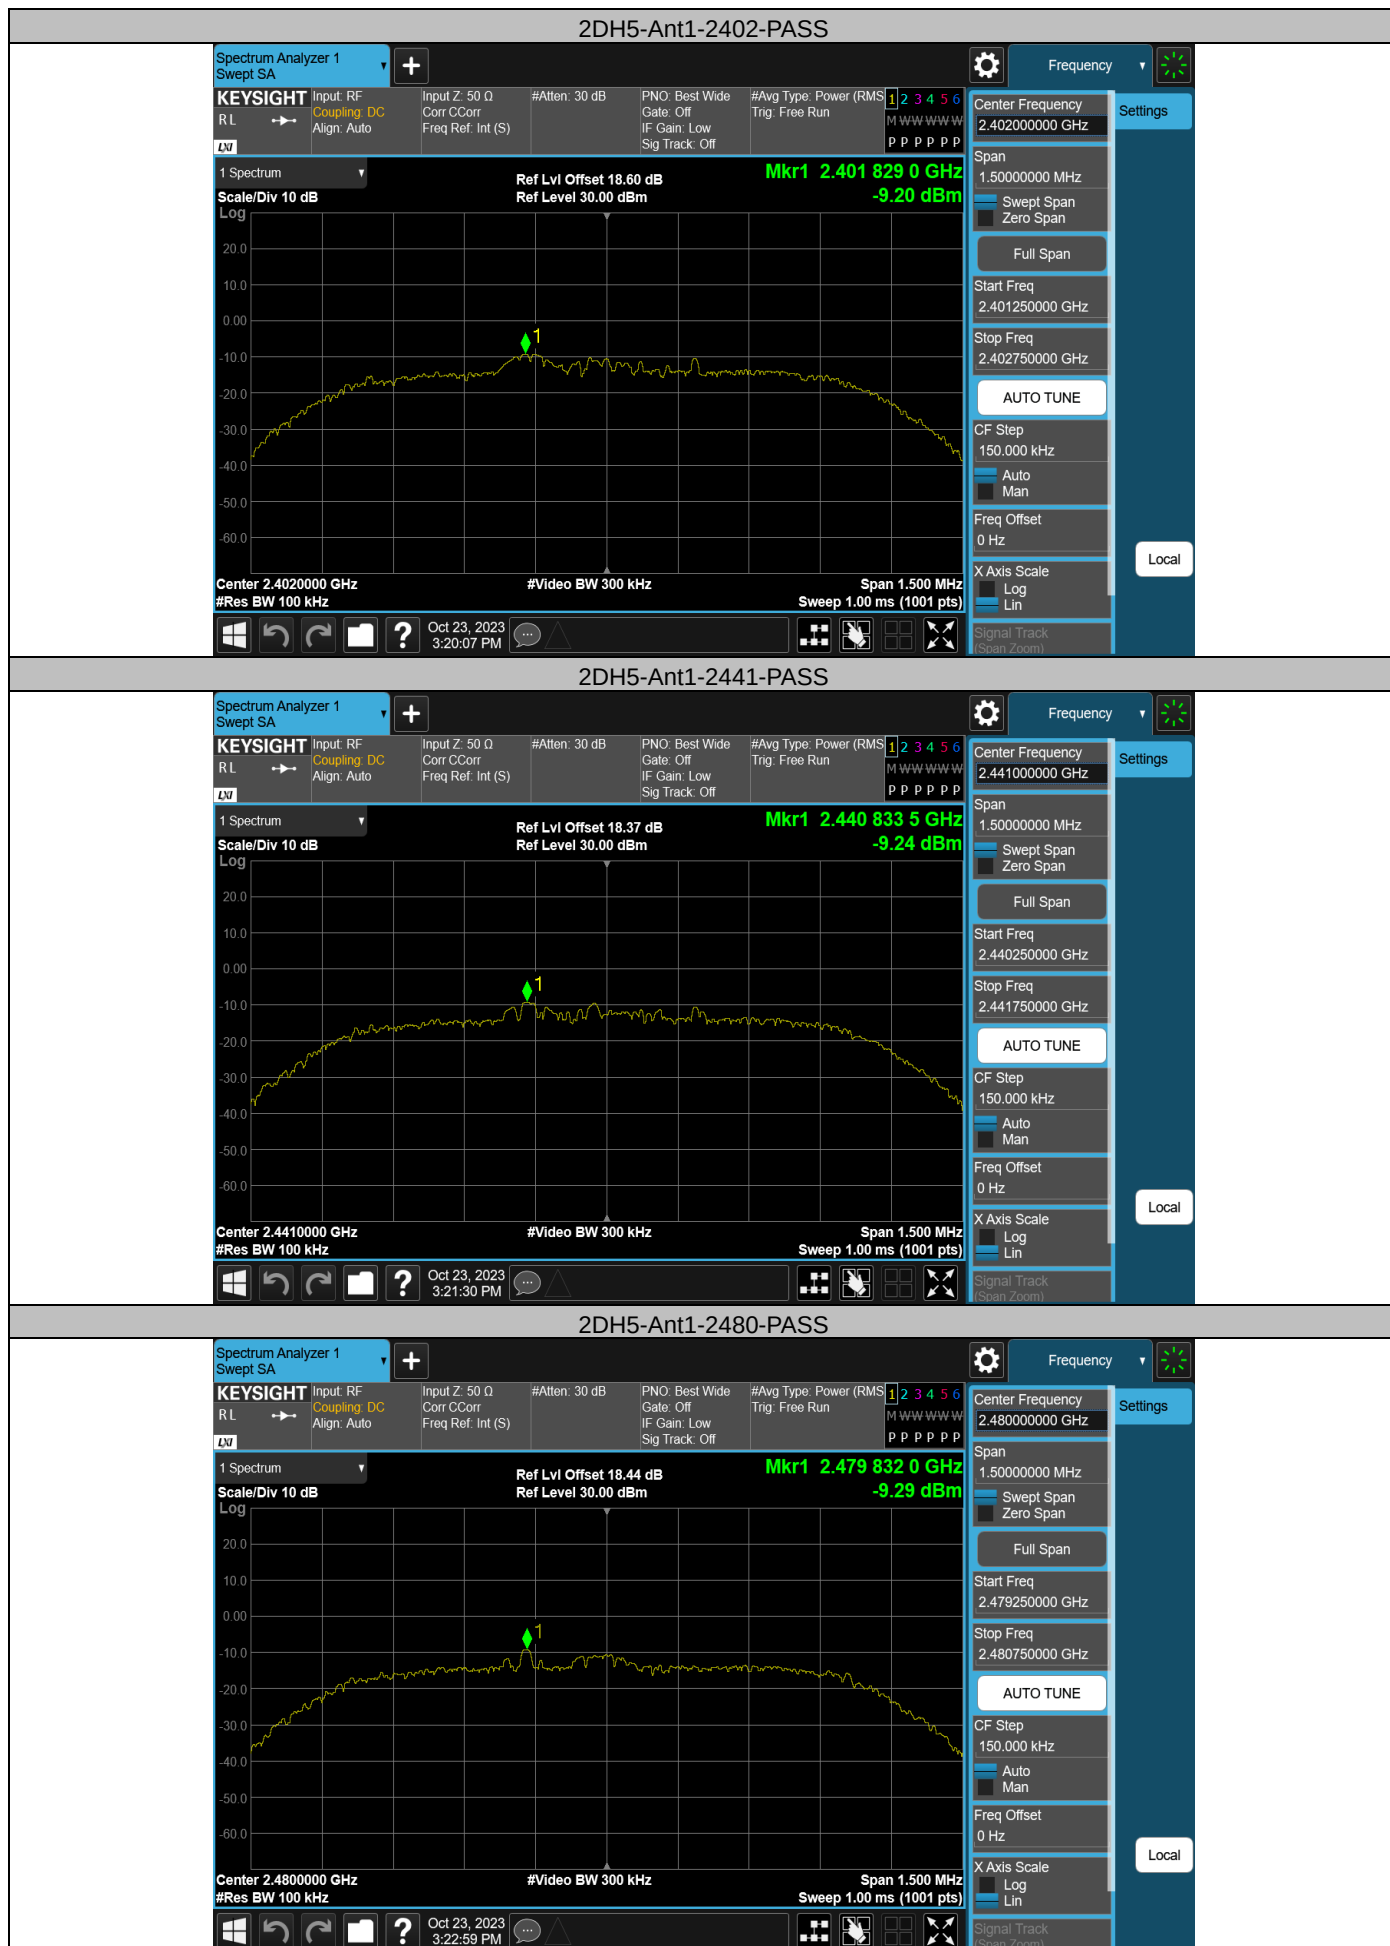
Left earbud

| TestMode | Antenna | Freq(MHz) | Max.Point[MHz] | Result[dBm] |
| DH5 | Ant1 | 2402 | 2401.84 | -9.29 |
| DH5 | Ant1 | 2441 | 2441.03 | -9.70 |
| DH5 | Ant1 | 2480 | 2479.84 | -9.64 |
| 2DH5 | Ant1 | 2402 | 2401.83 | -9.20 |
| 2DH5 | Ant1 | 2441 | 2440.83 | -9.24 |
| 2DH5 | Ant1 | 2480 | 2479.83 | -9.29 |

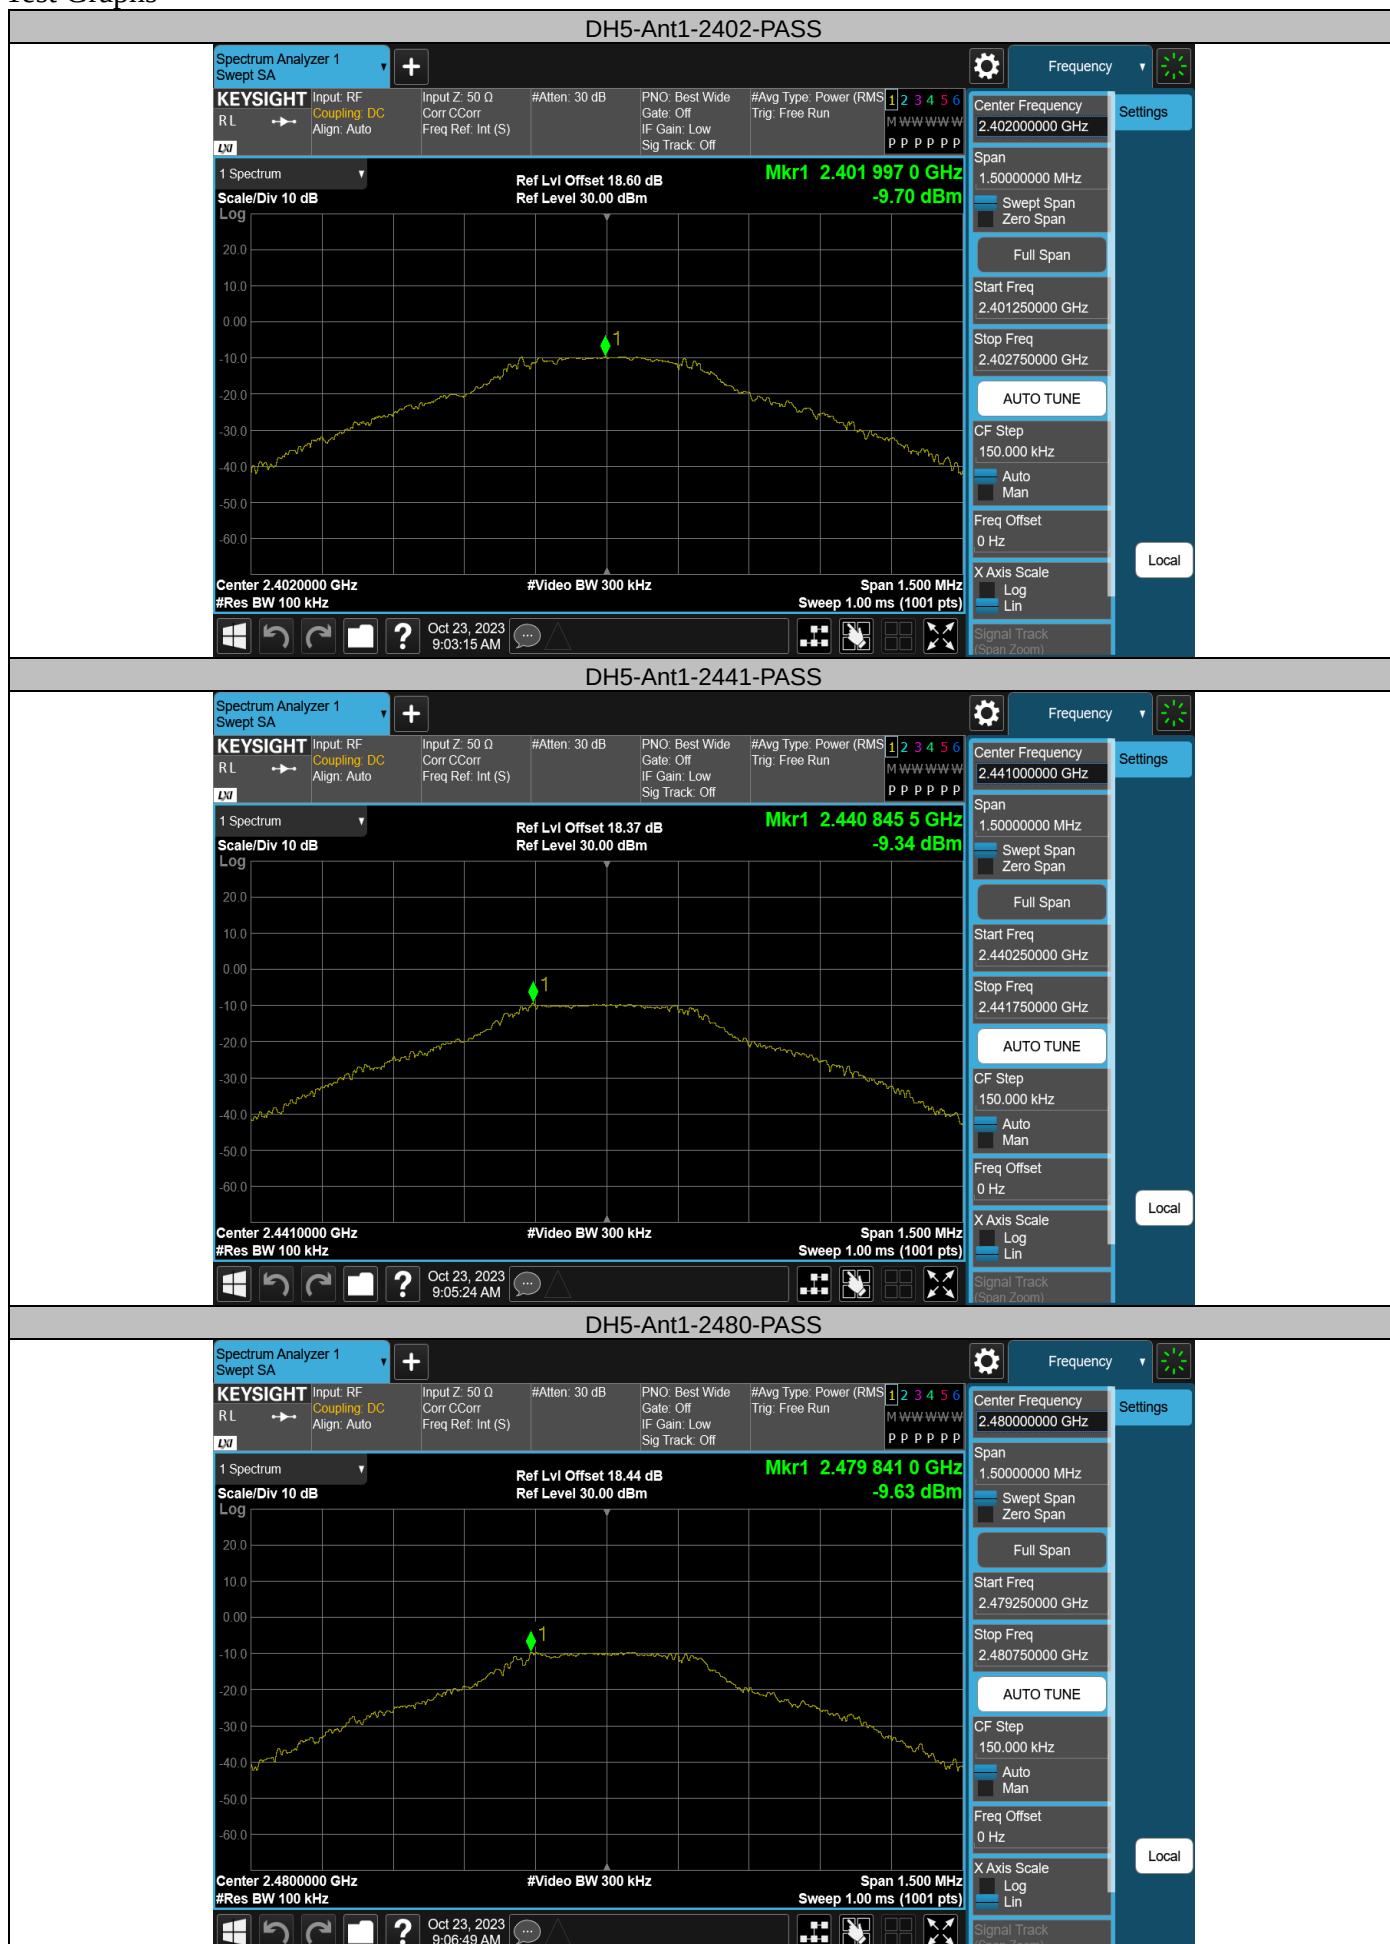
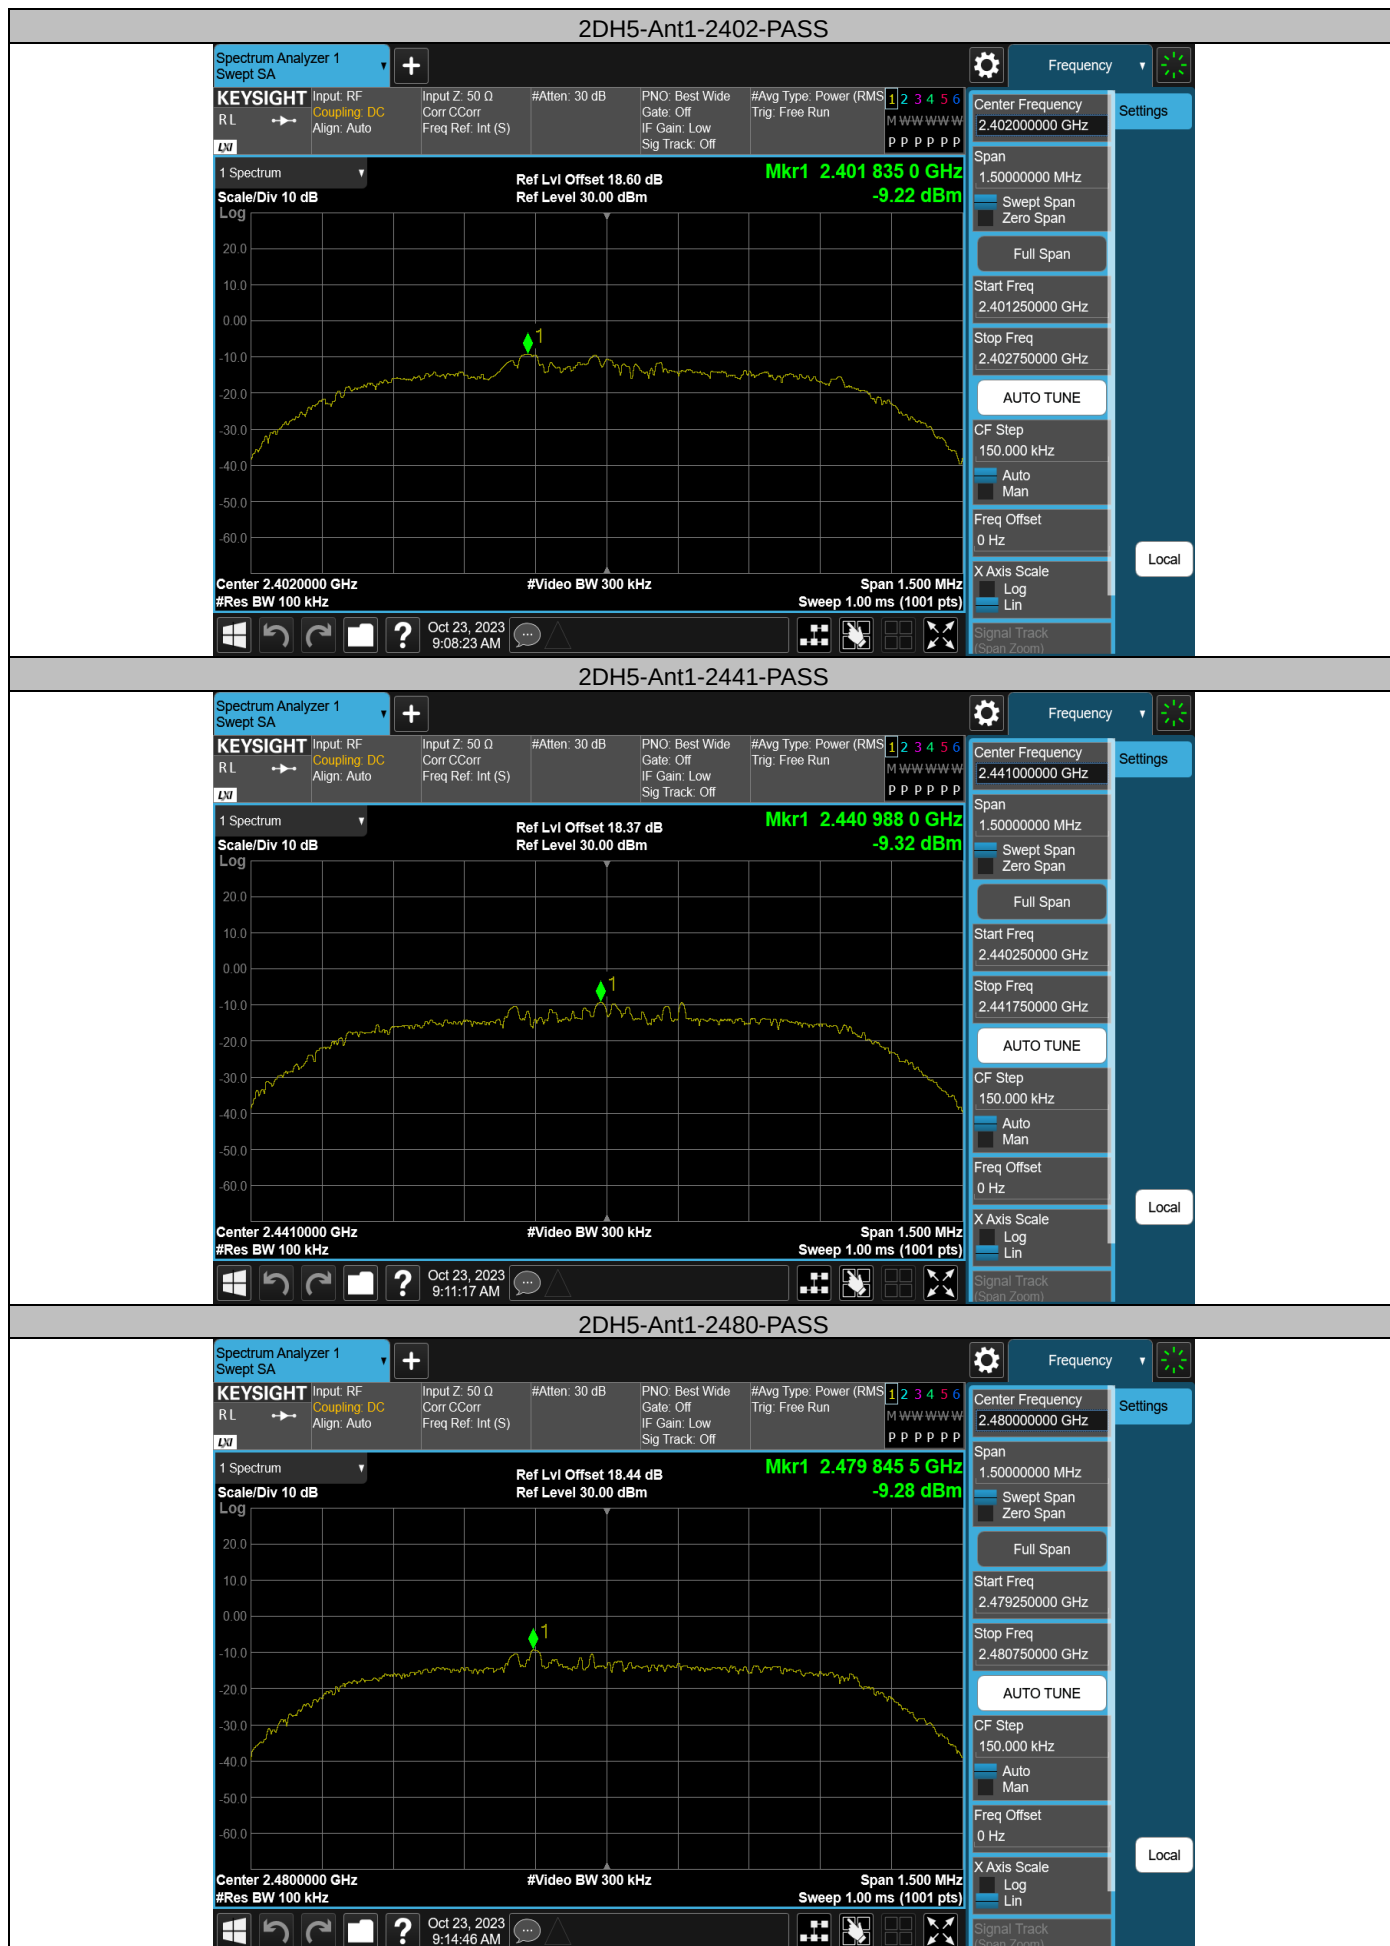
## Right earbud

| TestMode | Antenna | Freq(MHz) | Max.Point[MHz] | Result[dBm] |
| DH5 | Ant1 | 2402 | 2402.00 | -9.70 |
| DH5 | Ant1 | 2441 | 2440.85 | -9.34 |
| DH5 | Ant1 | 2480 | 2479.84 | -9.63 |
| 2DH5 | Ant1 | 2402 | 2401.84 | -9.22 |
| 2DH5 | Ant1 | 2441 | 2440.99 | -9.32 |
| 2DH5 | Ant1 | 2480 | 2479.85 | -9.28 |

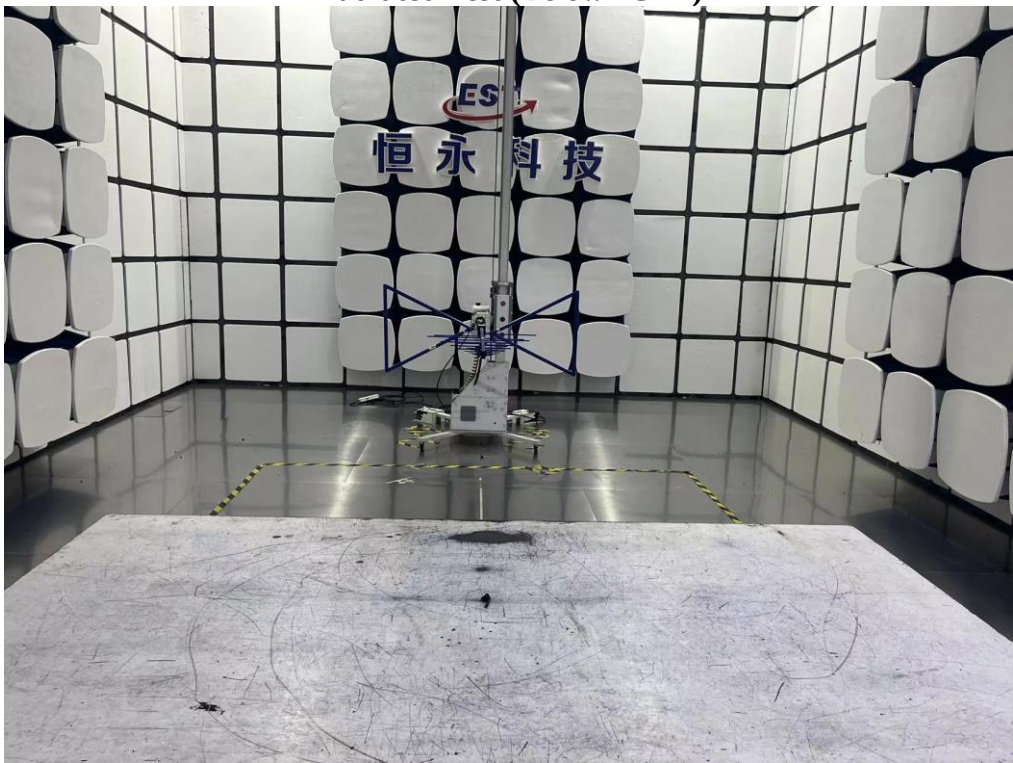
Radiated Test (Below 1GHz)

Left earbud

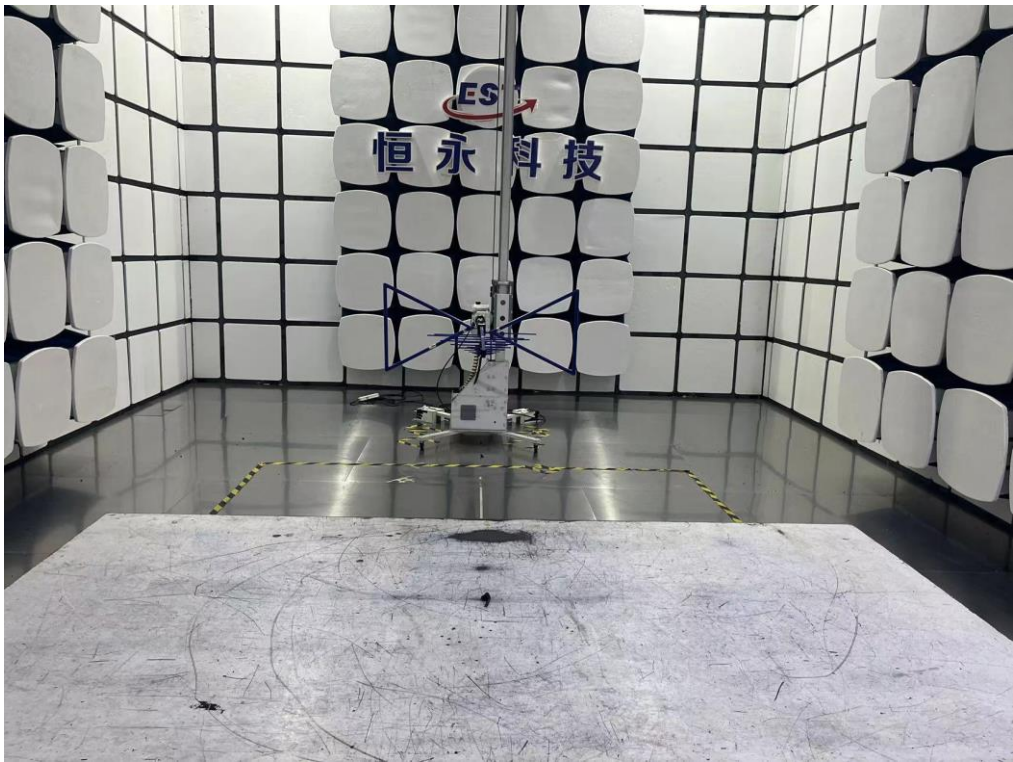
Right earbud

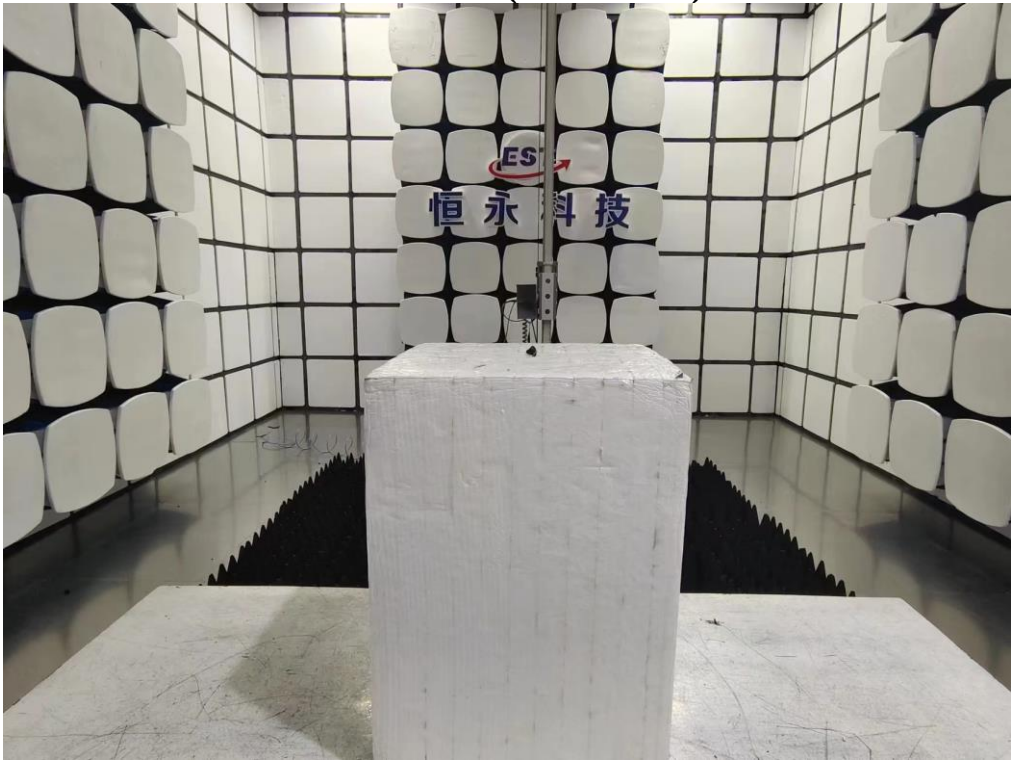
Radiated Test (Above 1GHz)

Left earbud

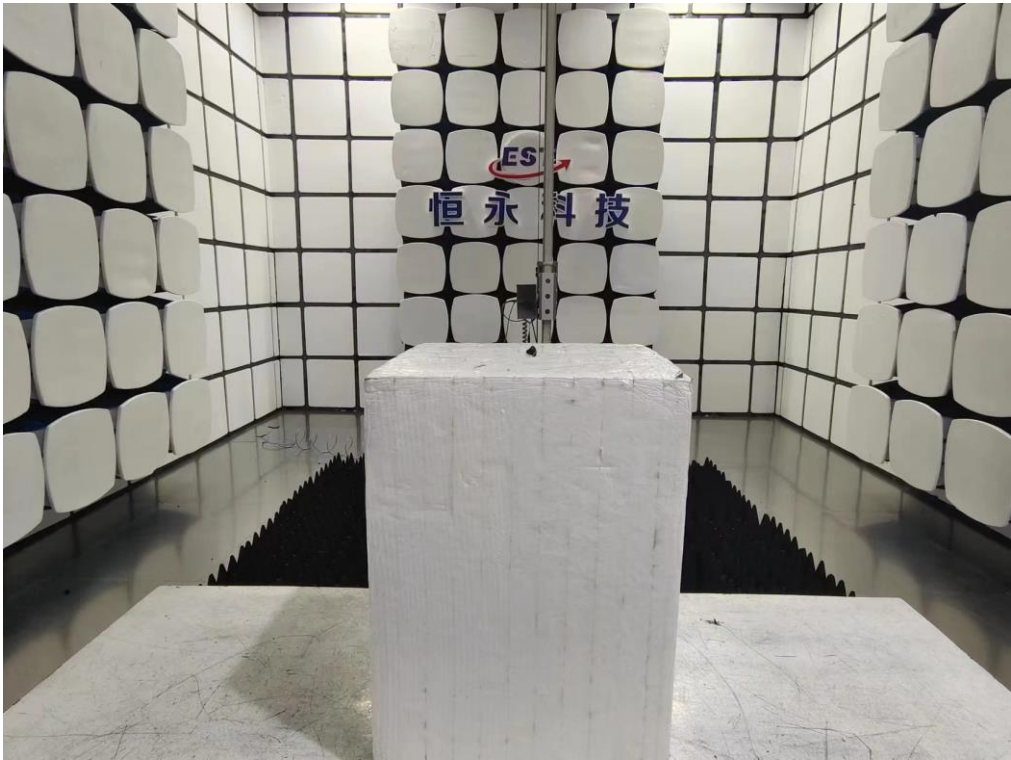
Right earbud

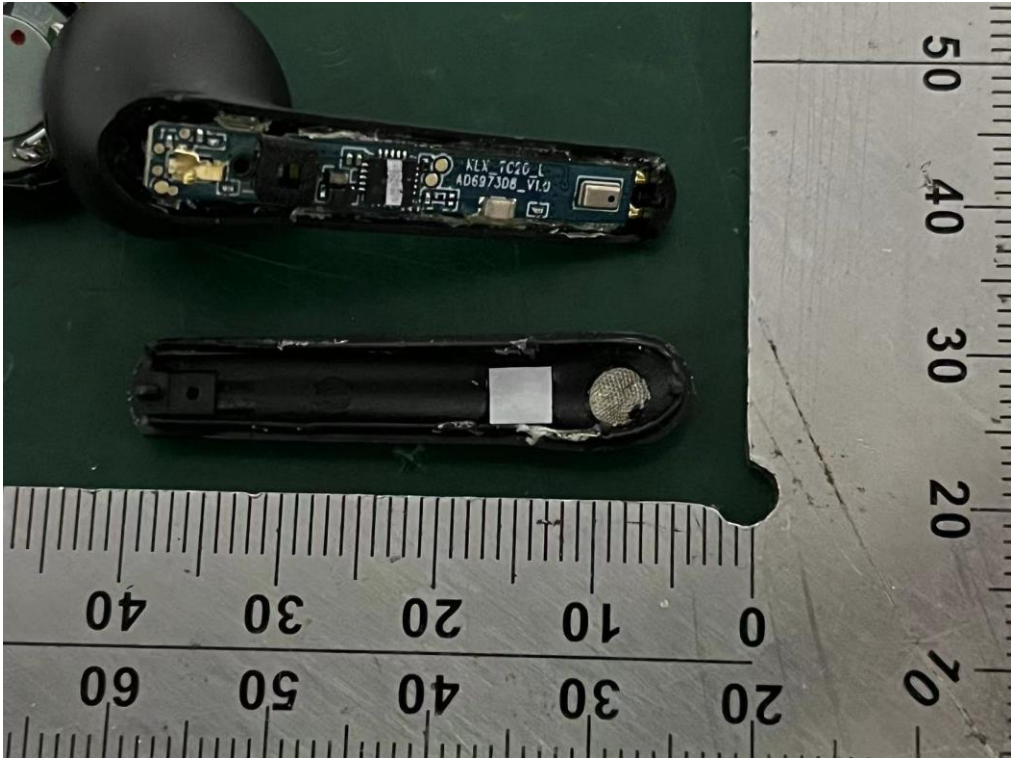
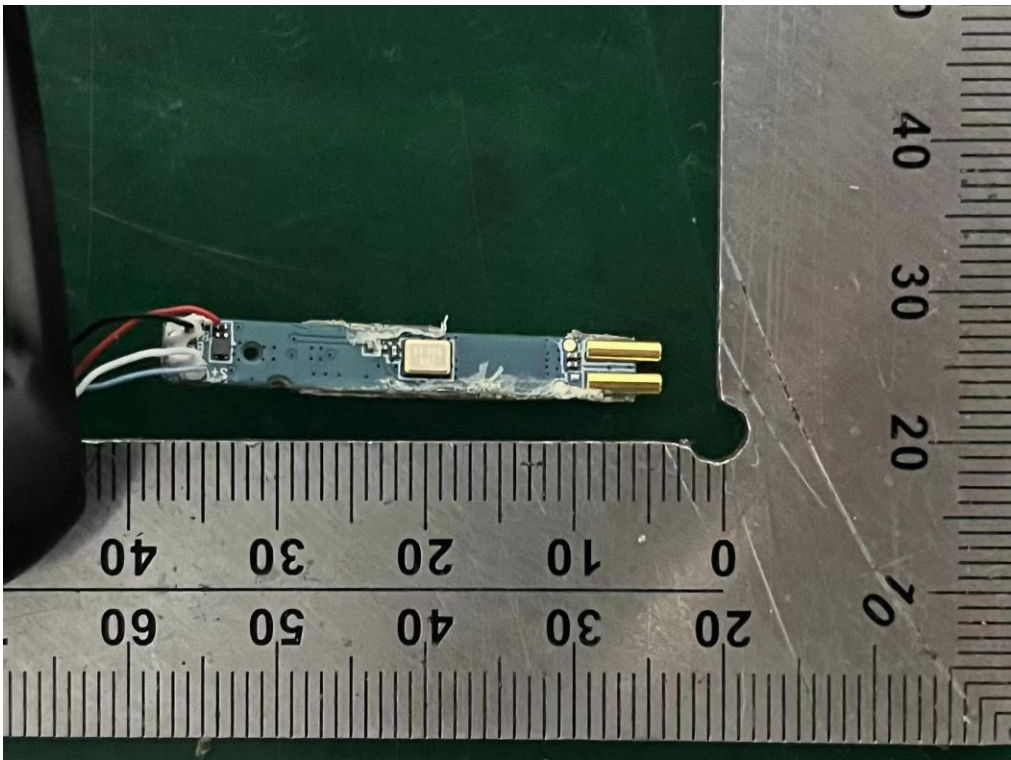
Internal Photos  
M/N: Defunc TRUE LITE

Left earbuds  
Antenna

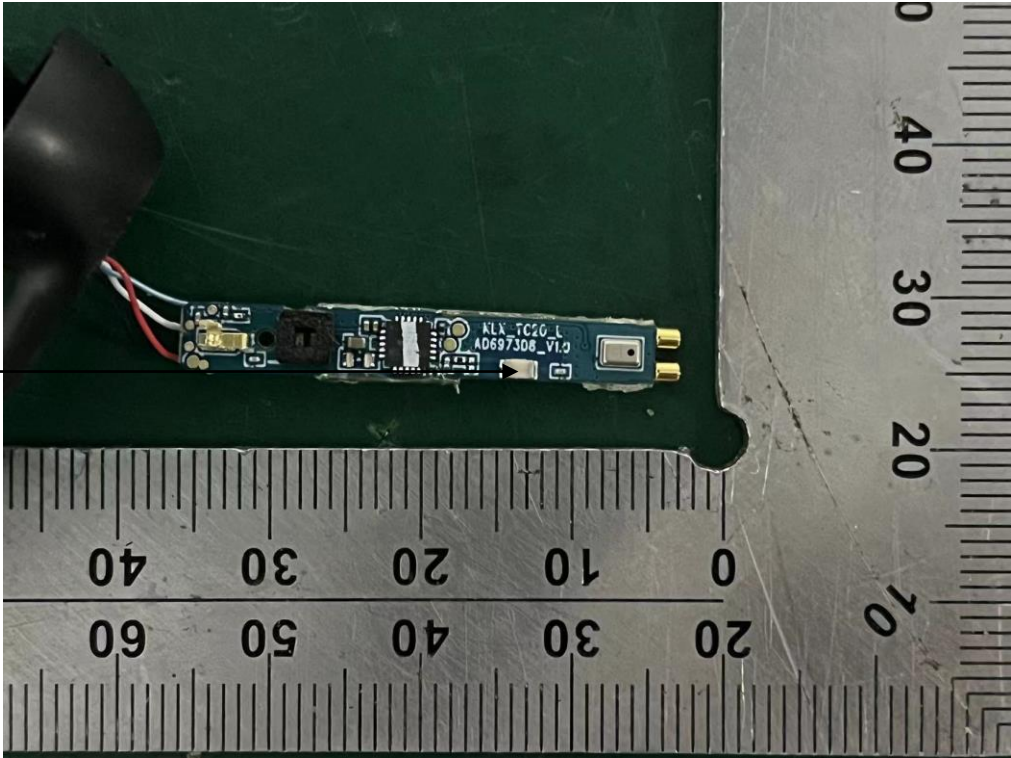
**Internal Photos**  
M/N: Defunc TRUE LITE

Right earbuds  
Antenna
