### **APPENDIX 3: Photographs of Test Setup**

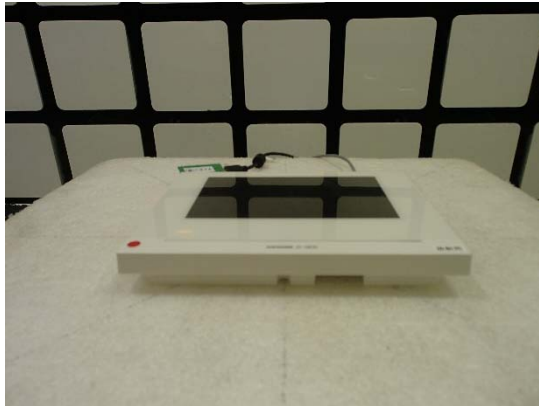
**X-axis**

Below 1 GHz (Horizontal: Z-axis / Vertical: Z-axis)  
Above 1 GHz (Horizontal: X-axis / Vertical: Y-axis)

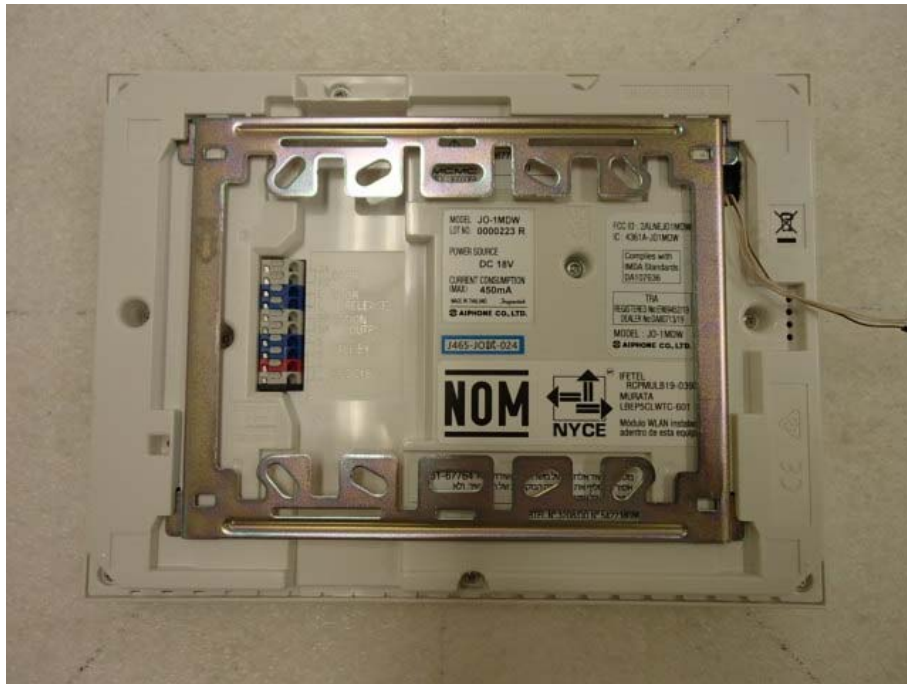
With Metal frame

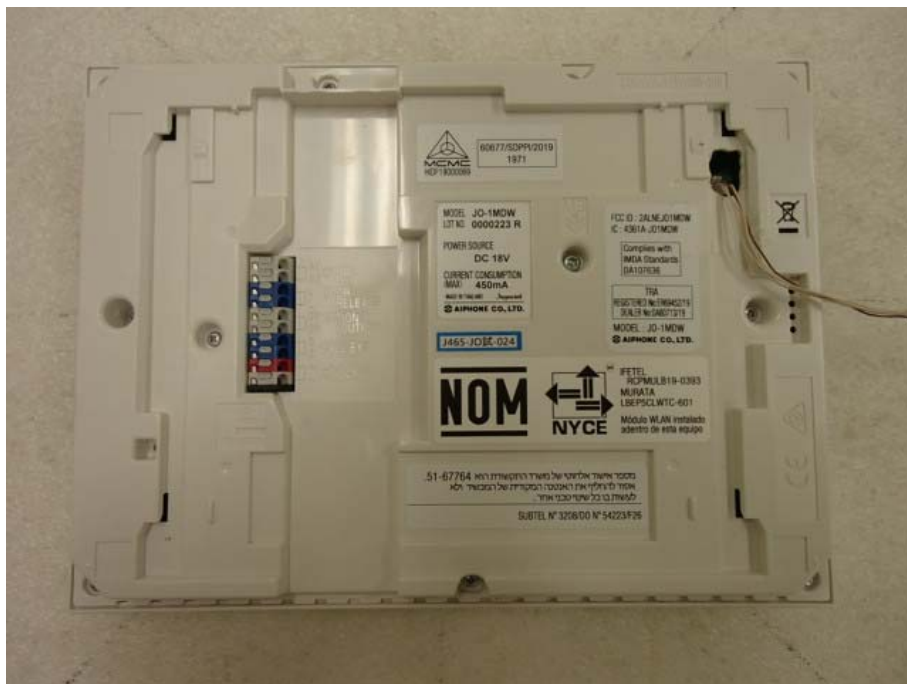
Without Metal frame (Worst)
