## Tx. Spurious NVNT n40 2422MHz Ant2 Ref

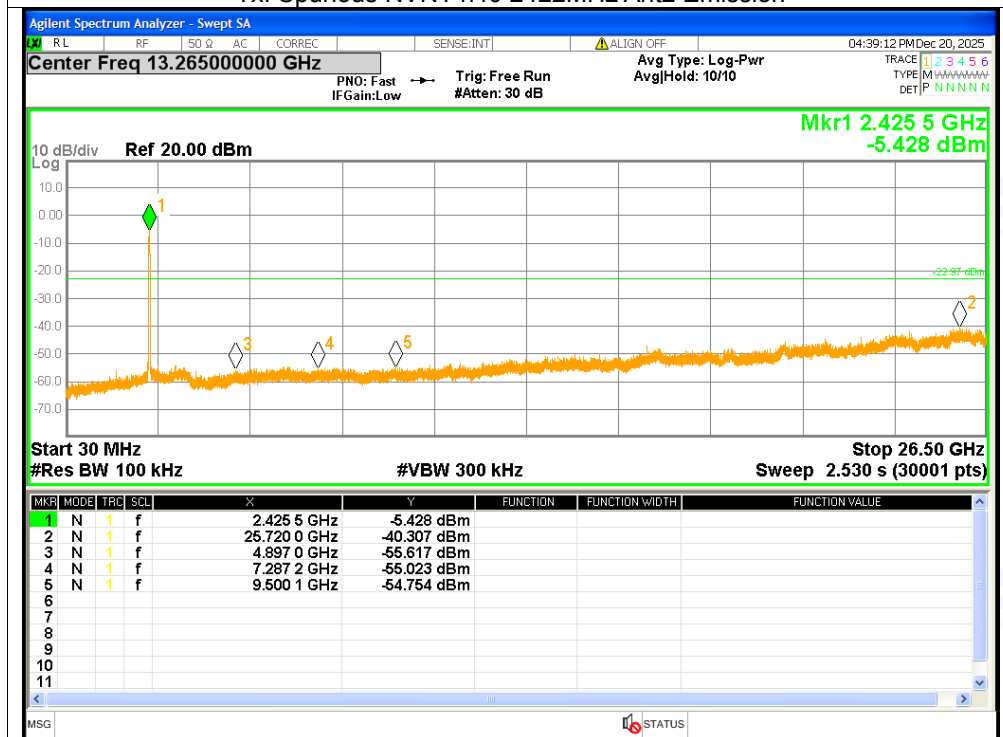
## Tx. Spurious NVNT n40 2422MHz Ant2 Emission

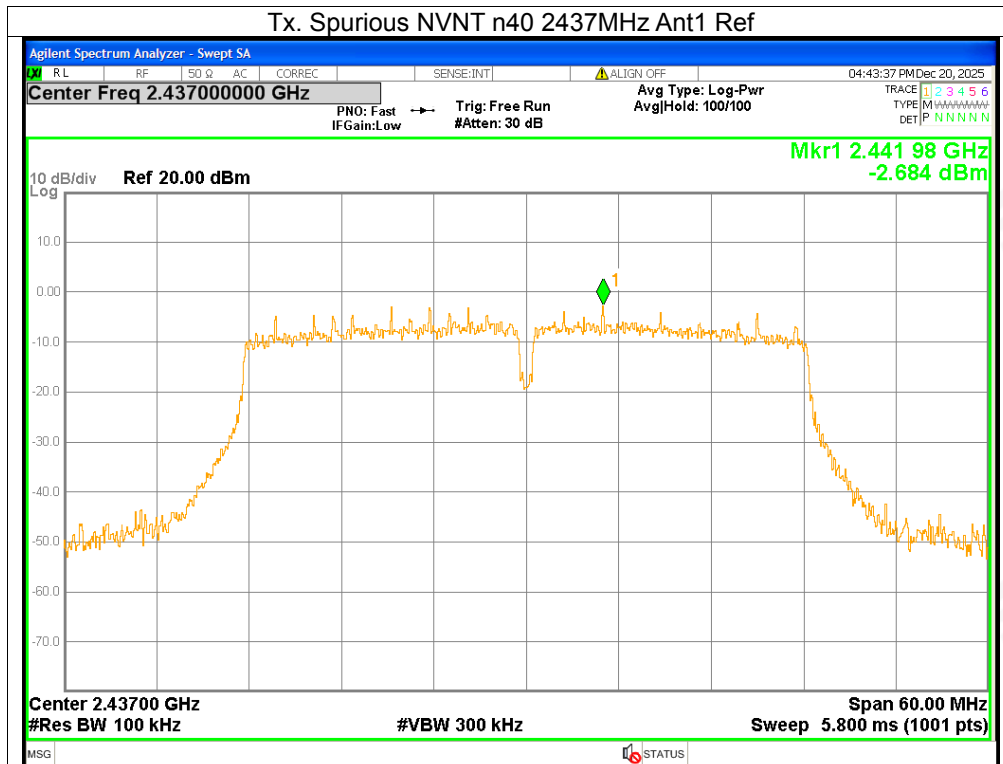
## Tx. Spurious NVNT n40 2437MHz Ant1 Ref

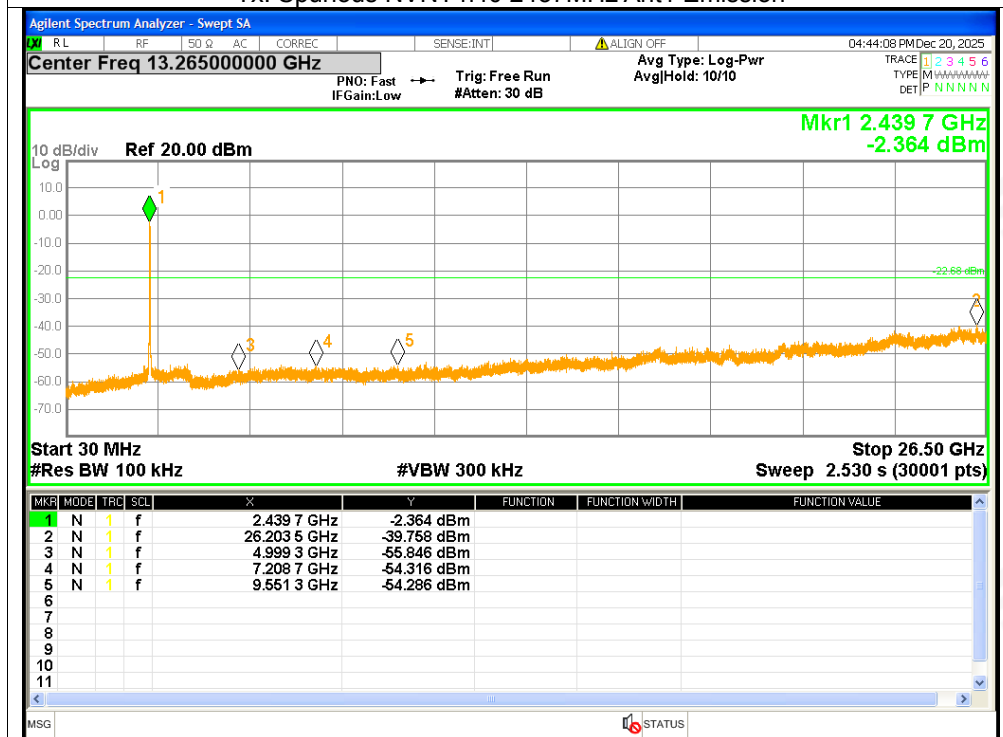
## Tx. Spurious NVNT n40 2437MHz Ant1 Emission

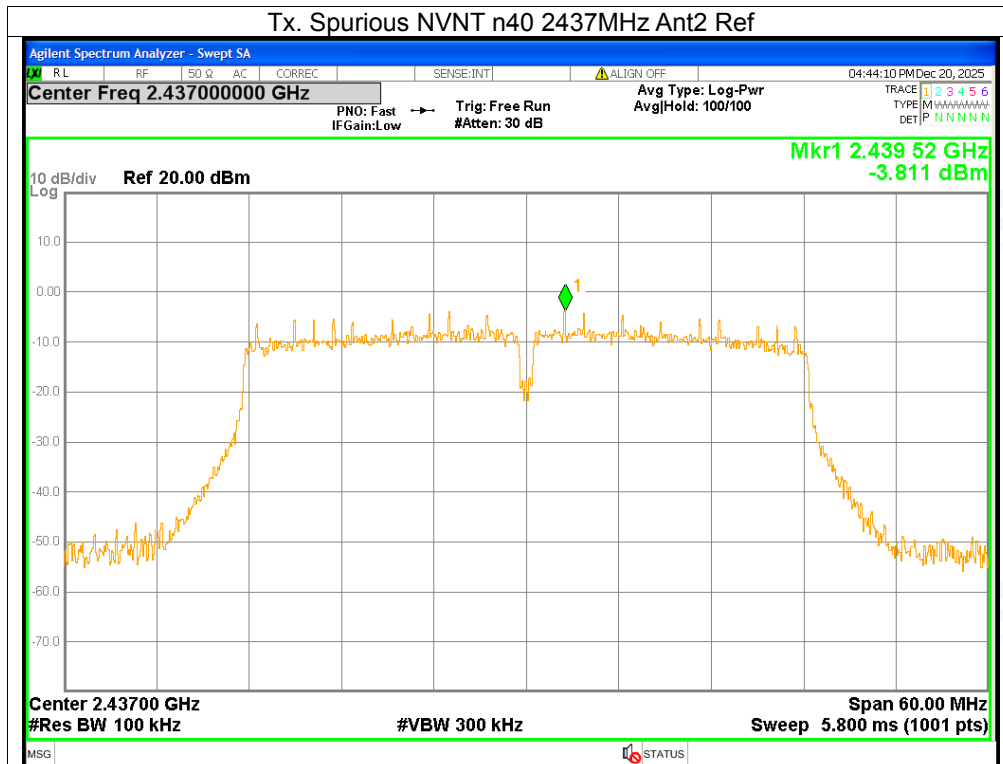
## Tx. Spurious NVNT n40 2437MHz Ant2 Ref

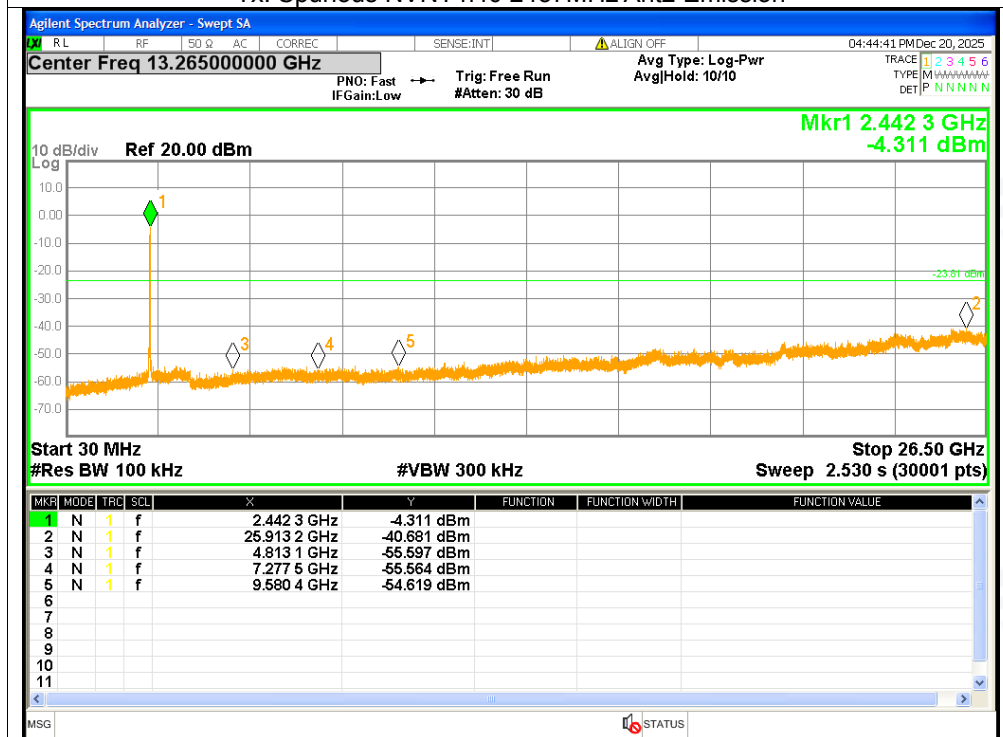
## Tx. Spurious NVNT n40 2437MHz Ant2 Emission

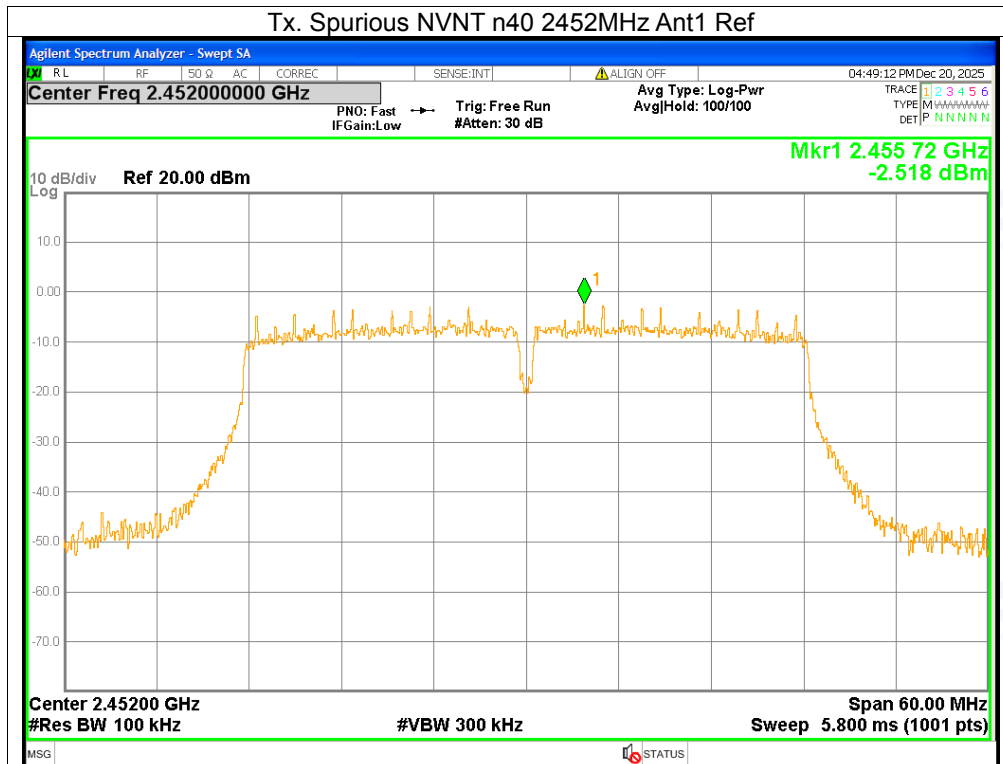
## Tx. Spurious NVNT n40 2452MHz Ant1 Ref

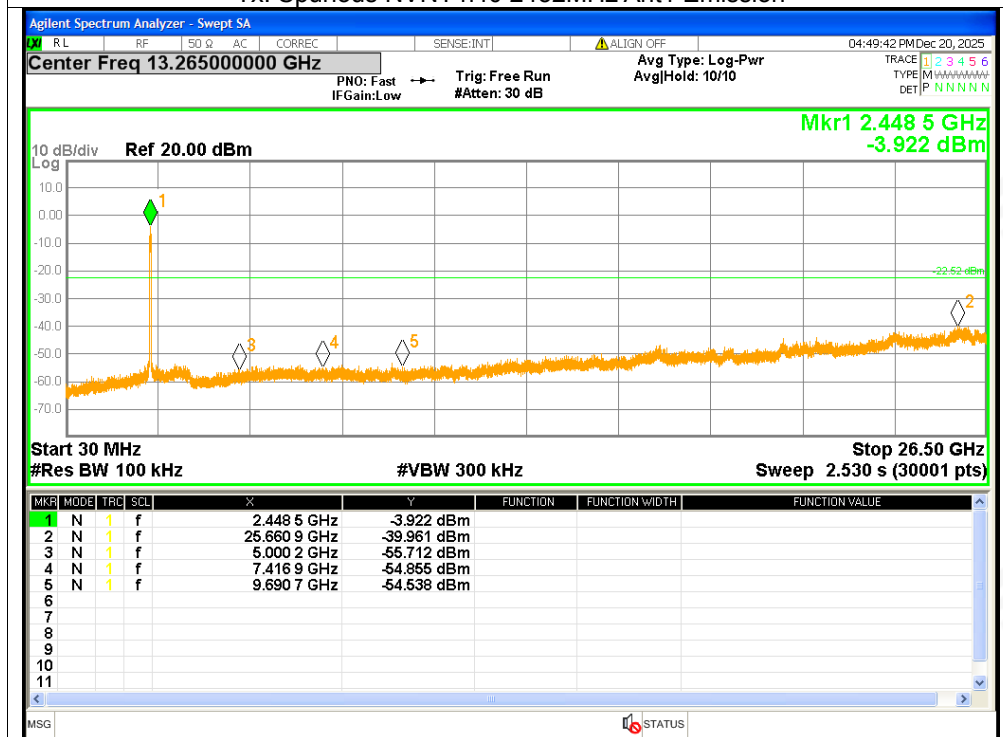
## Tx. Spurious NVNT n40 2452MHz Ant1 Emission
