### **APPENDIX 3: Photographs of test setup**

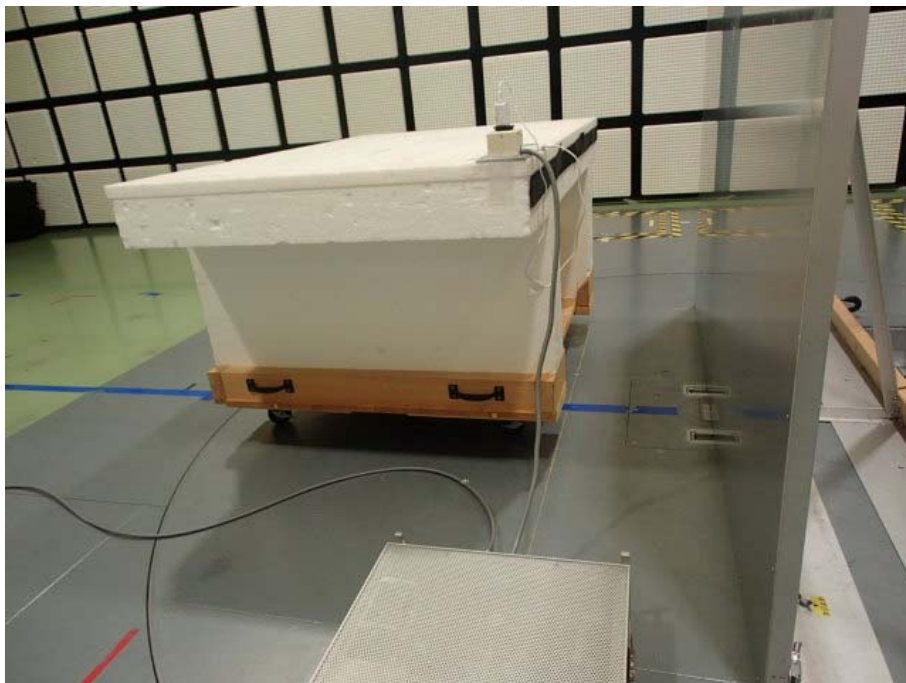
#### **Conducted Emission**

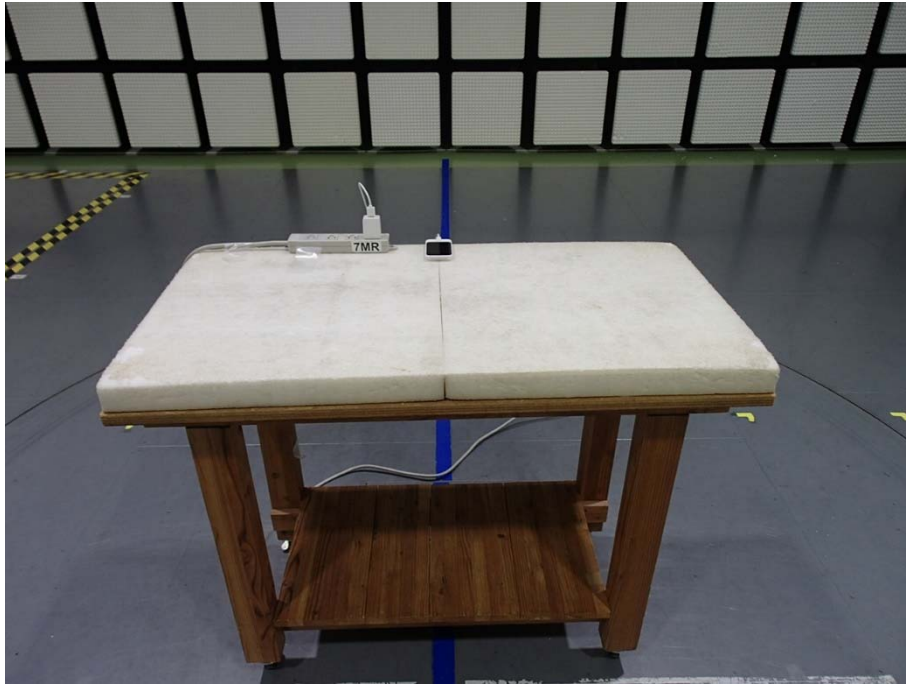
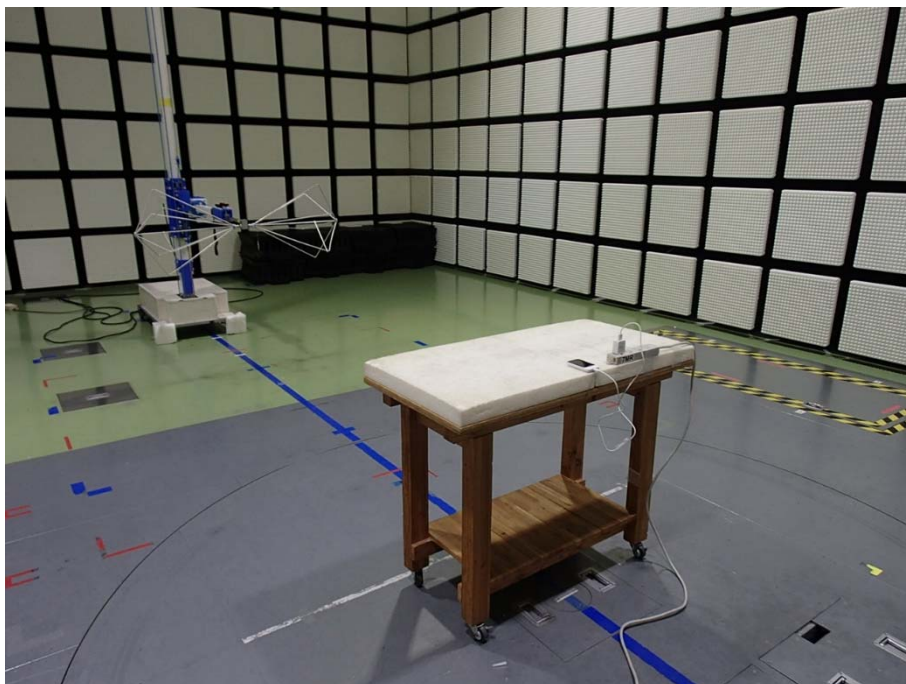
**Radiated Spurious Emission**  
(Below 1 GHz)

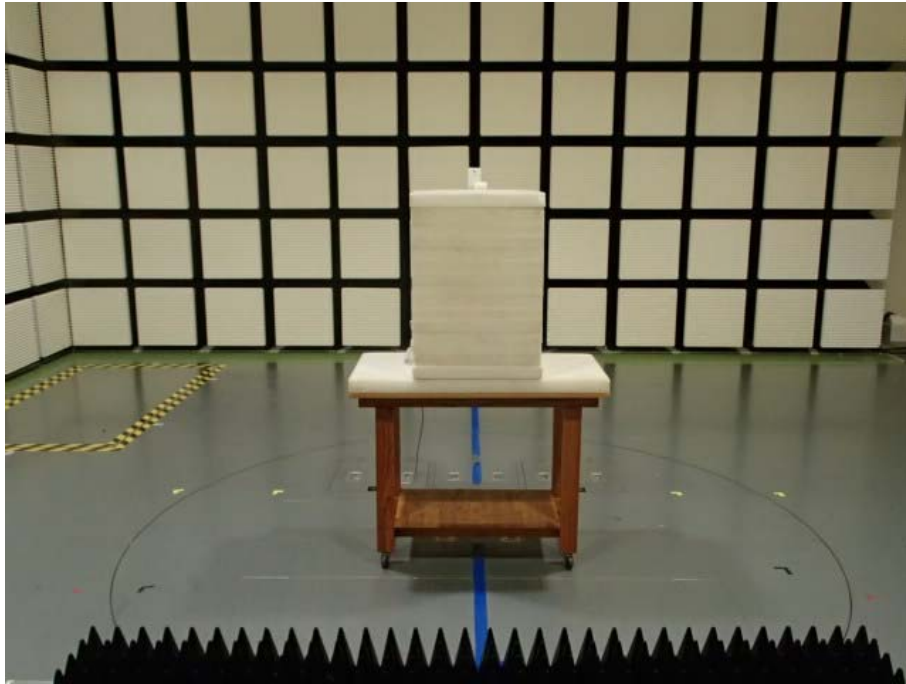
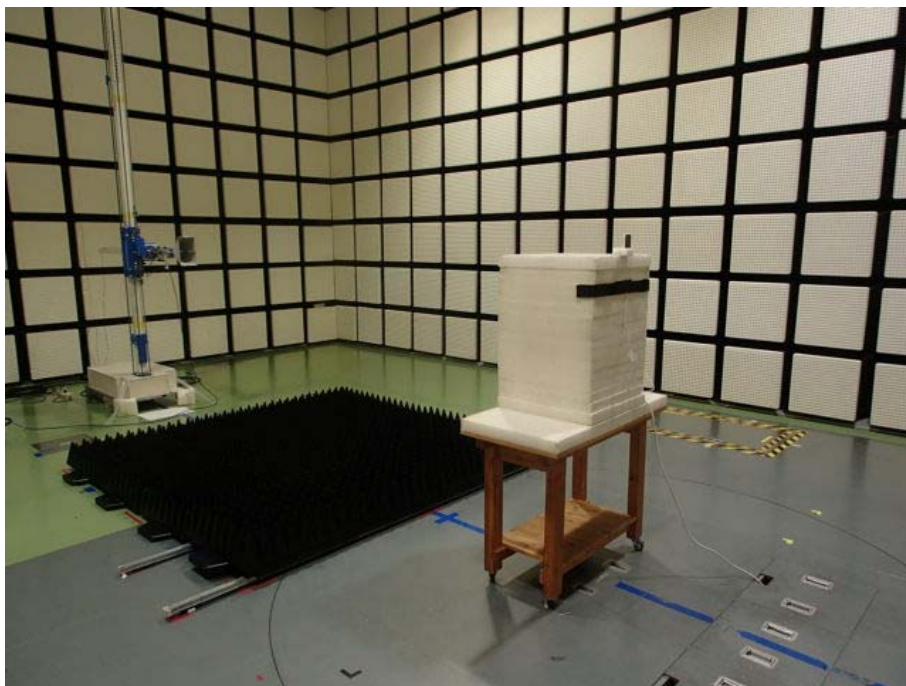
**Radiated Spurious Emission**  
(Above 1 GHz)

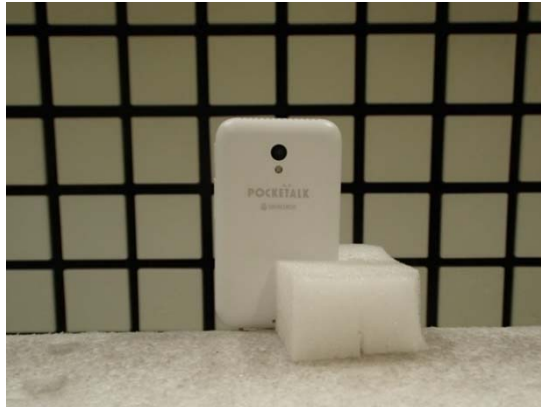
**Y-axis**

**Above 1 GHz (Horizontal: Y-axis/ Vertical: Z-axis)**
