## Appendix B: photographs of test setup

Reference to the test report no. BLA-EMC-202507-A3001

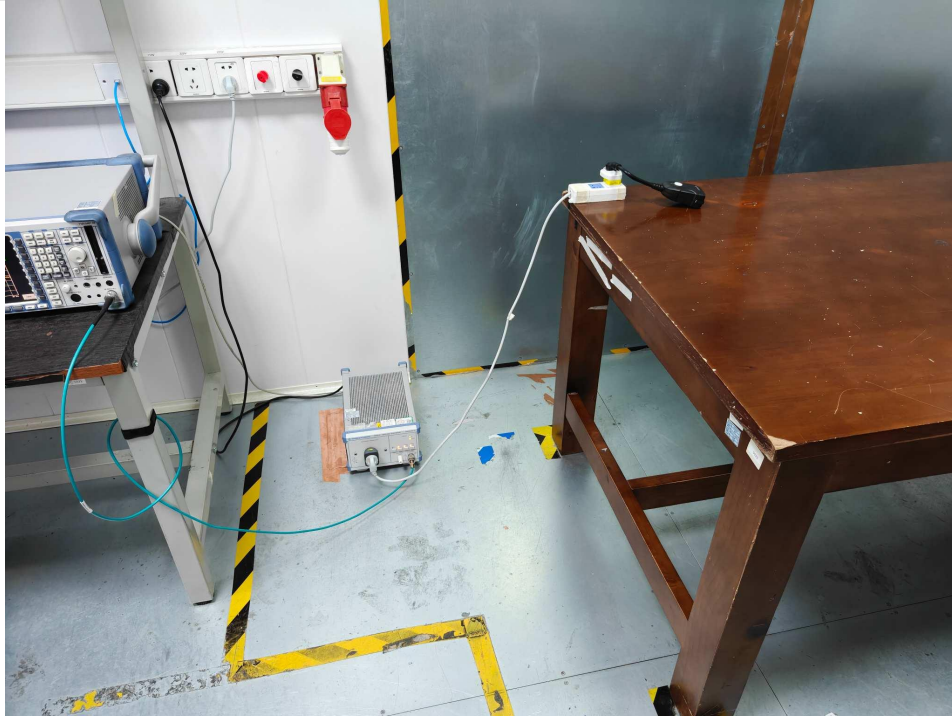
Conducted emissions at AC power line (150kHz-30MHz)

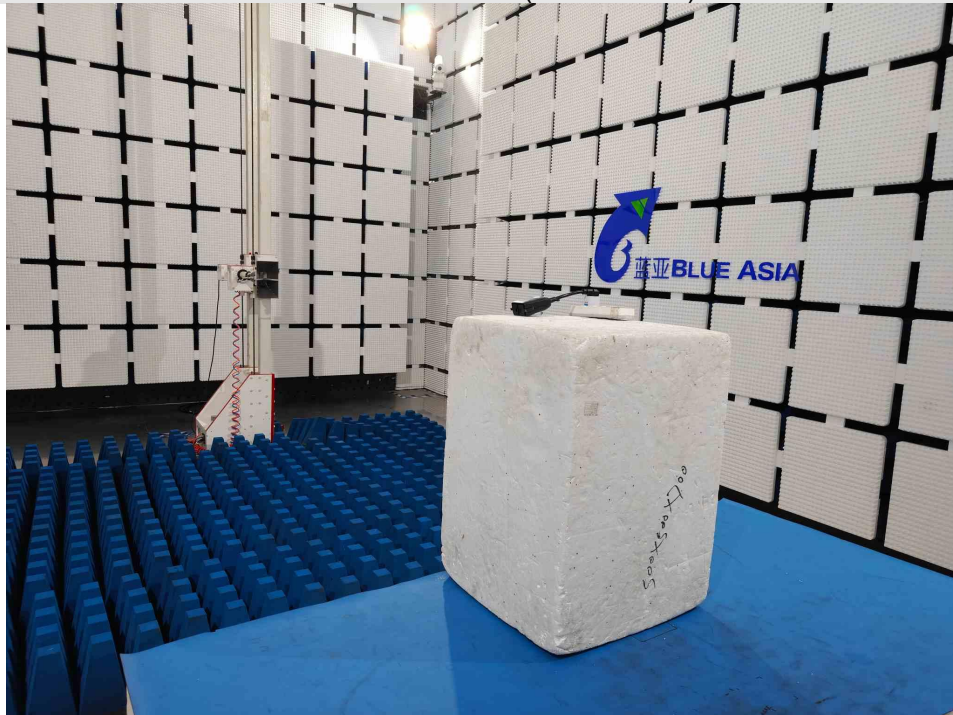
Radiated Emissions (above 1GHz)
