## APPENDIX A: PHOTOGRAPHS OF TEST SETUP

Reference to the test report No. BLA-EMC-202402-A3401

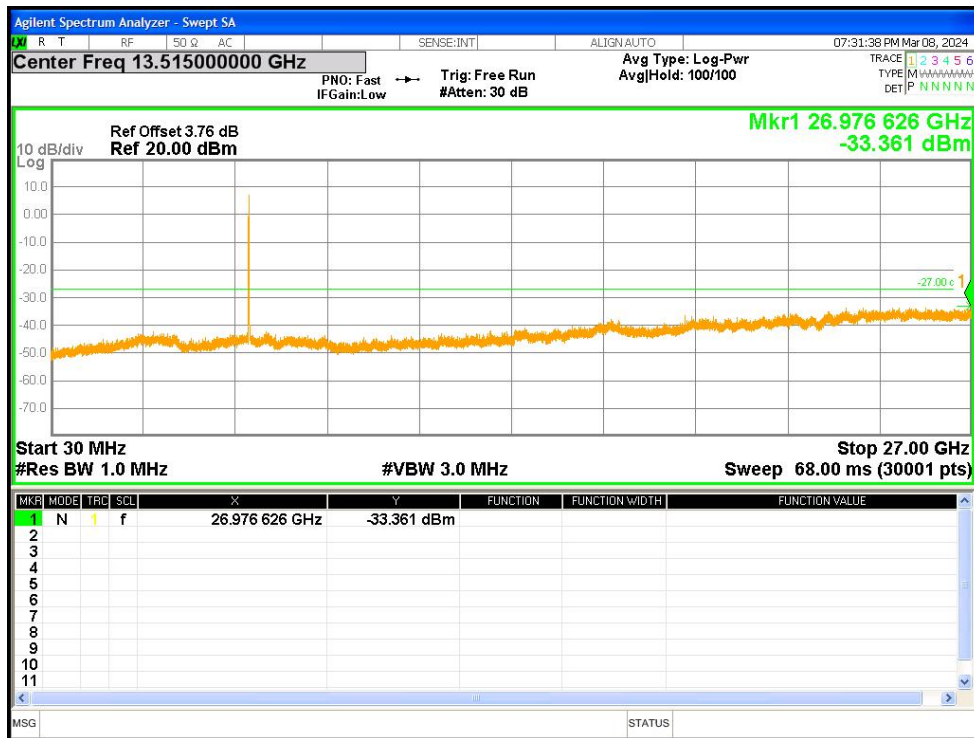
Tx. Spurious NVNT n20 5825MHz Ant2 Emission

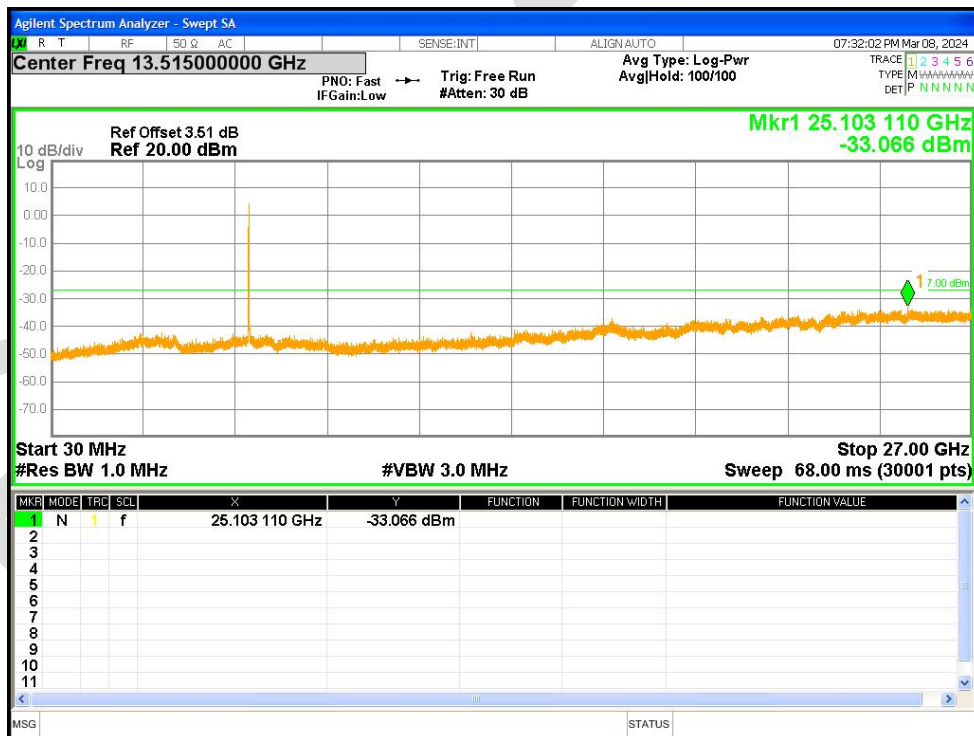
Tx. Spurious NVNT n40 5755MHz Ant1 Emission

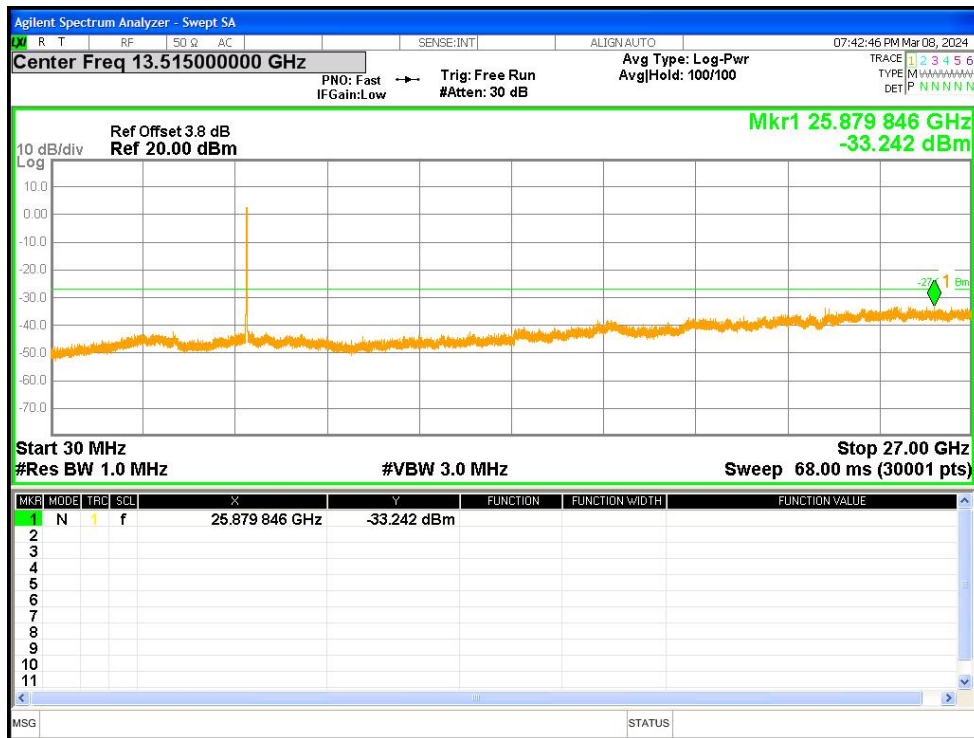
Tx. Spurious NVNT n40 5755MHz Ant2 Emission

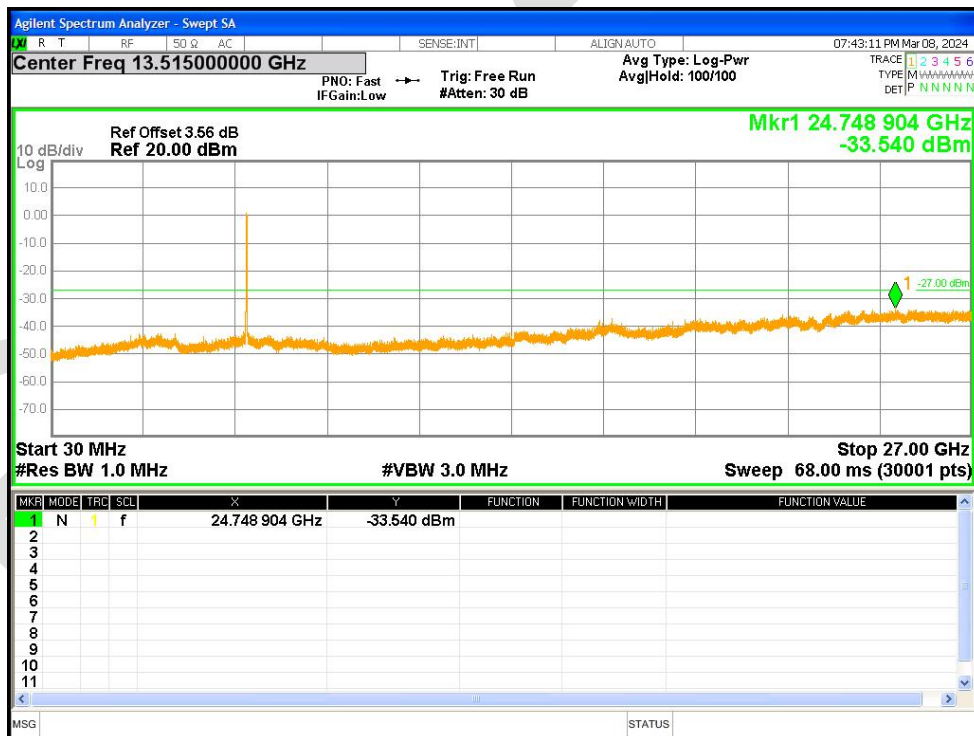
Tx. Spurious NVNT n40 5795MHz Ant1 Emission

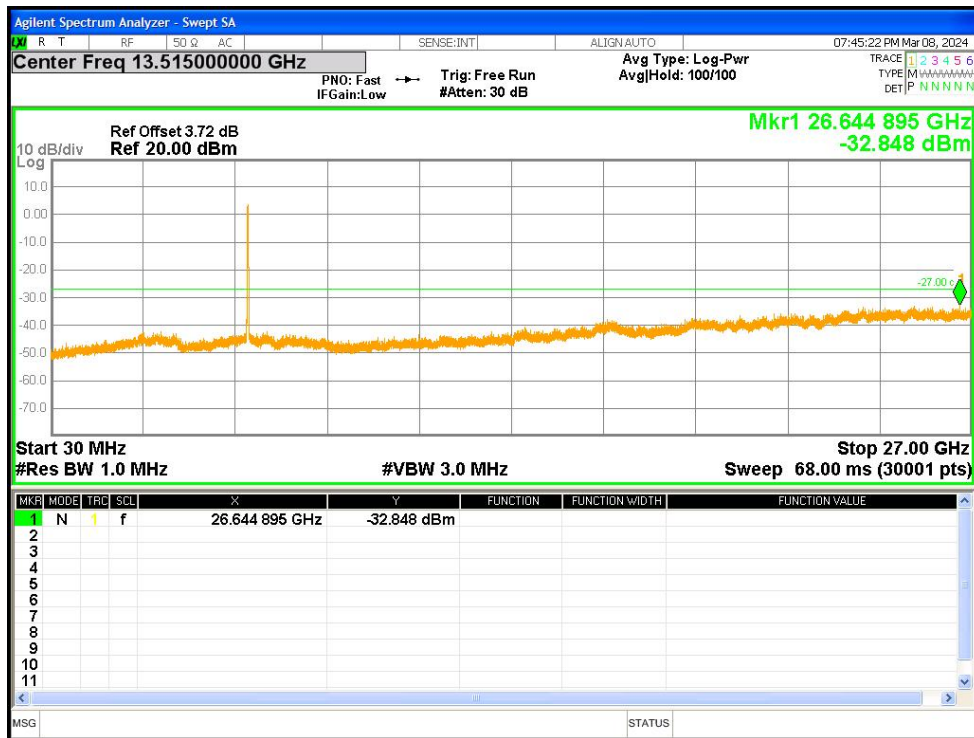
Tx. Spurious NVNT n40 5795MHz Ant2 Emission
