## APPENDIX A: PHOTOGRAPHS OF TEST SETUP

Reference to the test report No. BLA-EMC-202402-A3501

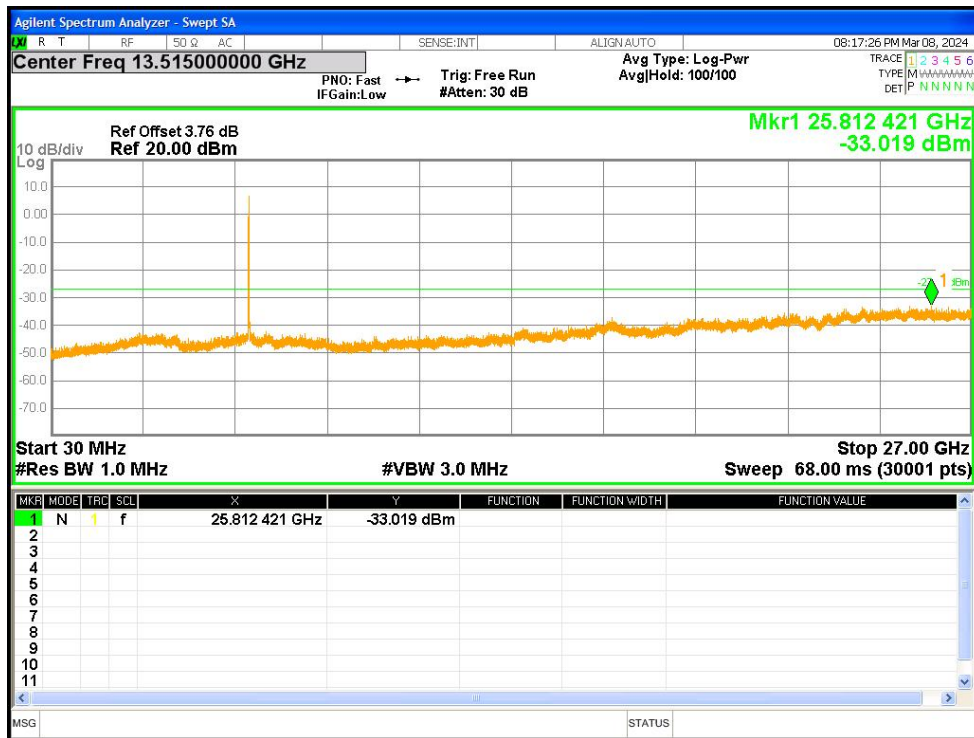
Tx. Spurious NVNT n20 5825MHz Ant2 Emission

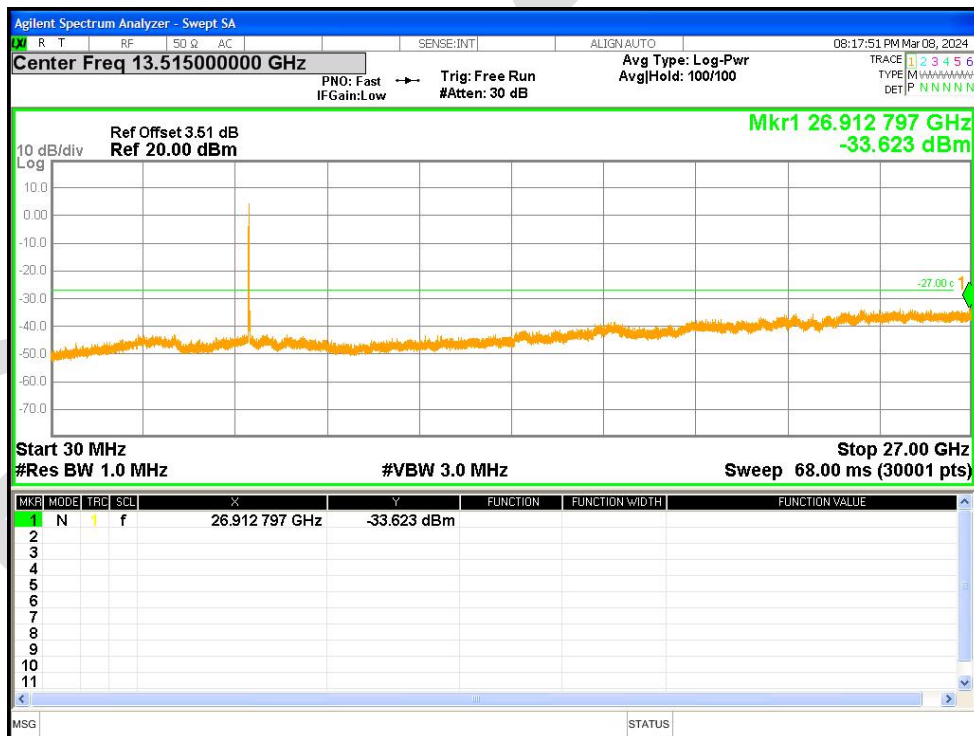
Tx. Spurious NVNT n40 5755MHz Ant1 Emission

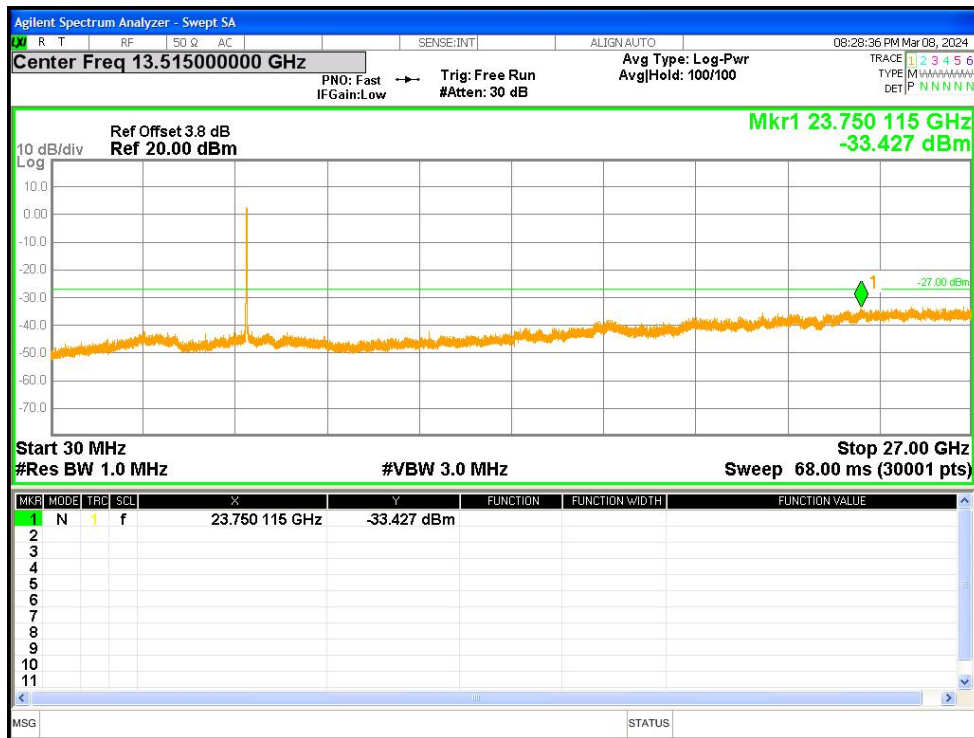
Tx. Spurious NVNT n40 5755MHz Ant2 Emission

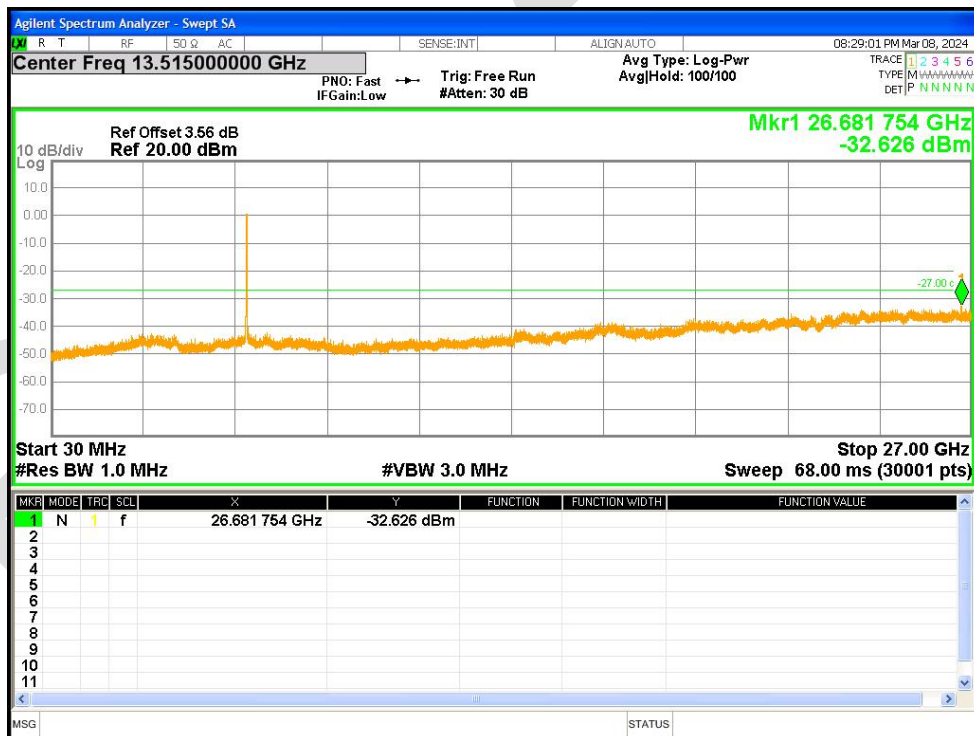
Tx. Spurious NVNT n40 5795MHz Ant1 Emission

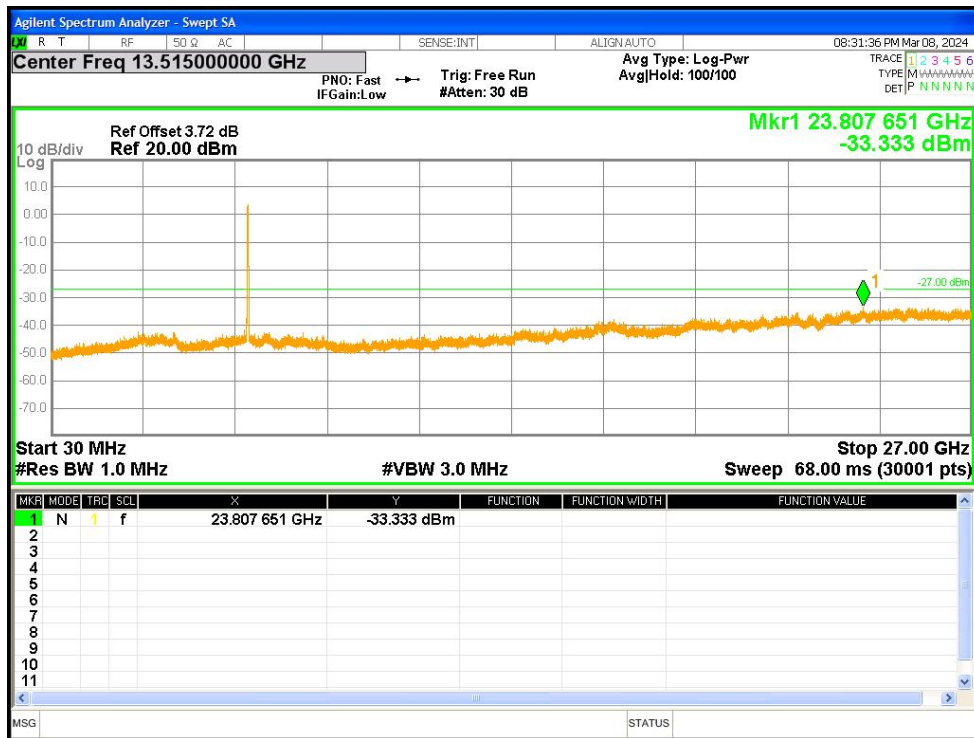
Tx. Spurious NVNT n40 5795MHz Ant2 Emission

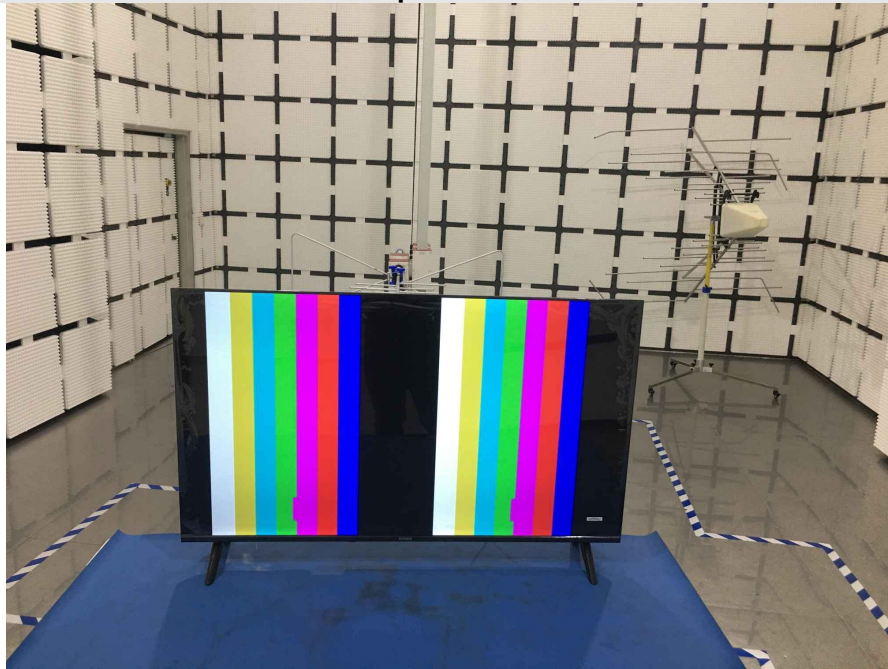
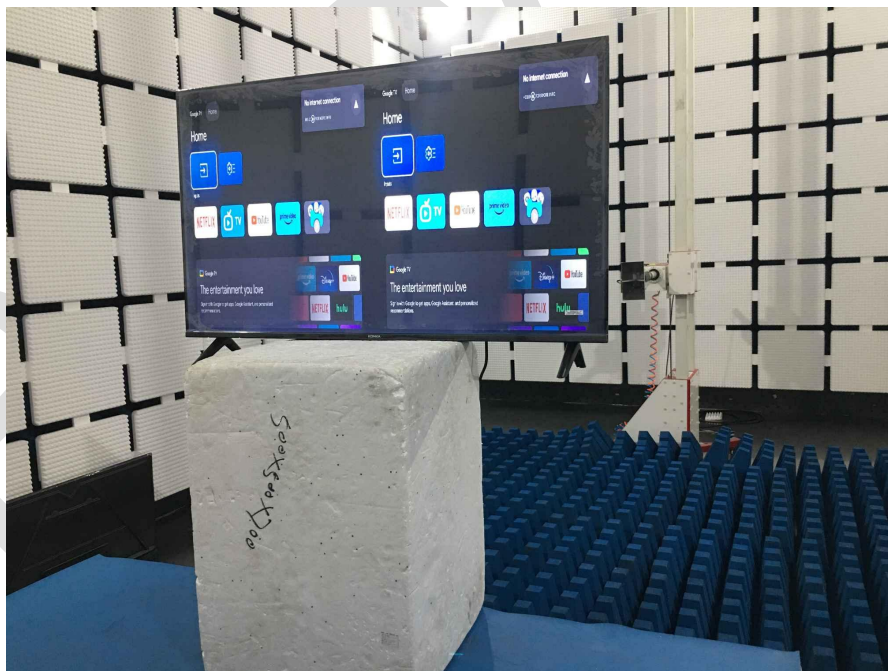
### Radiated Spurious Emissions

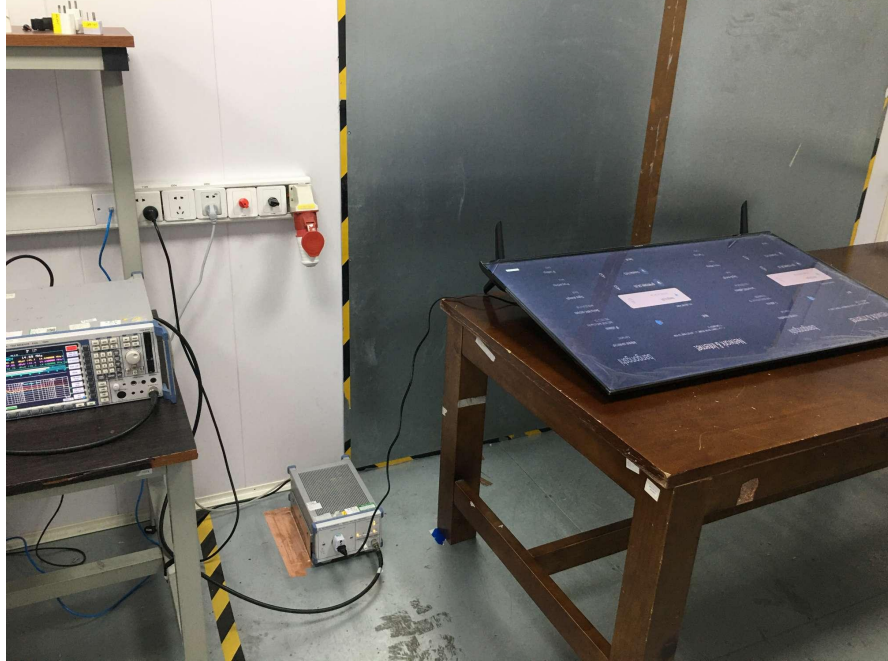
**Conducted Emissions at AC Power Line (150kHz-30MHz)**
