## Appendix B: photographs of test setup

## Appendix C: photographs of EUT

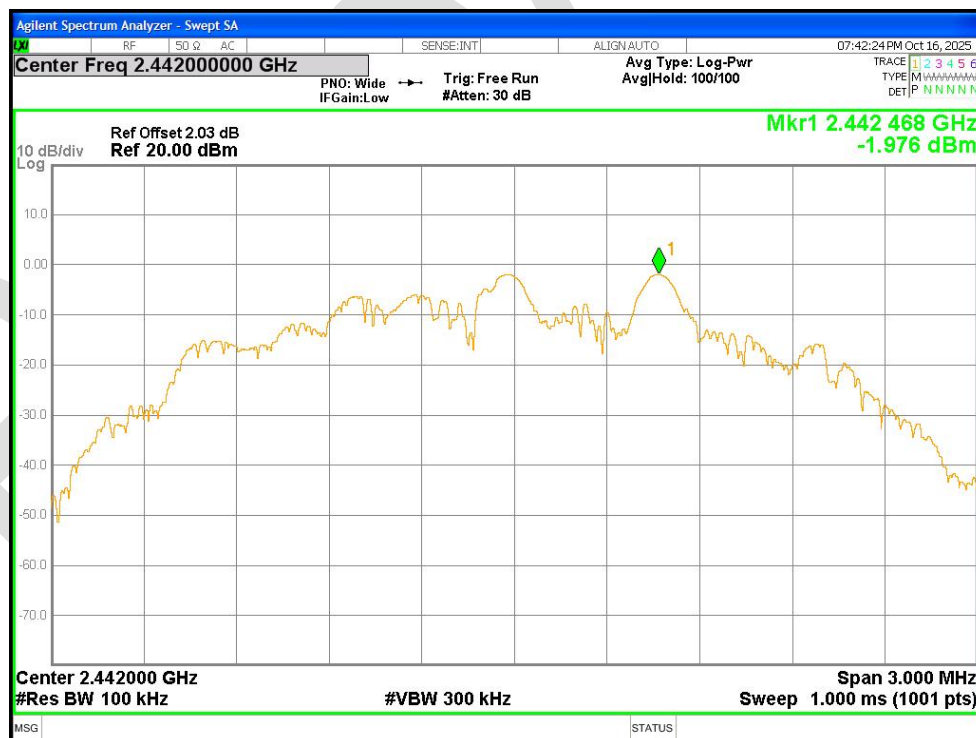
Tx. Spurious NVNT BLE 2M 2442MHz Ant1 Emission

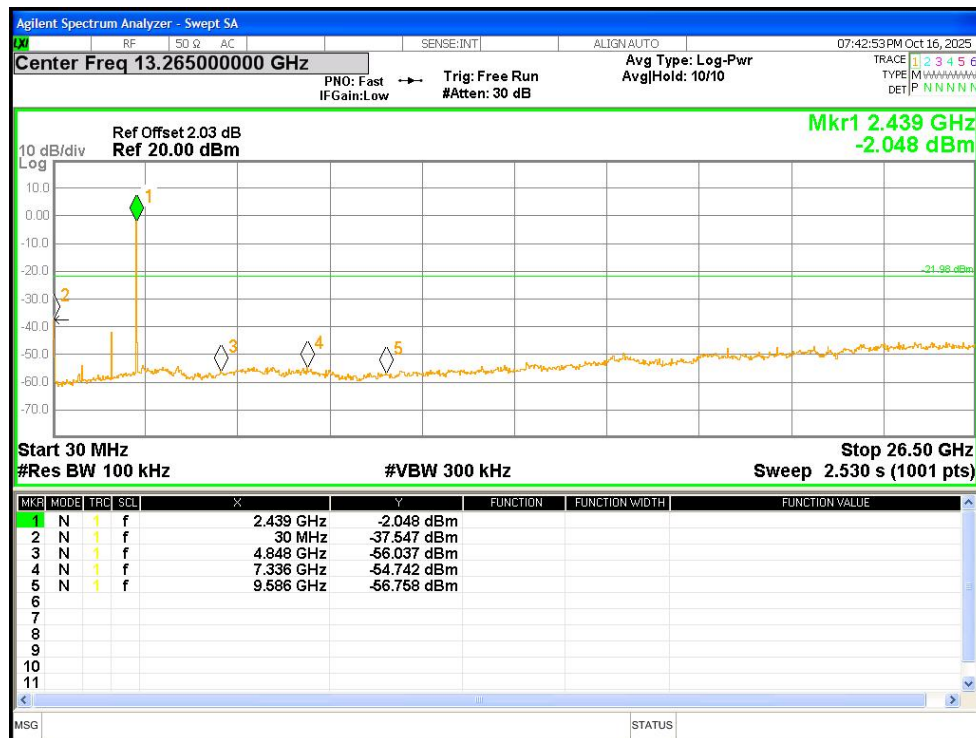
Tx. Spurious NVNT BLE 2M 2480MHz Ant1 Ref

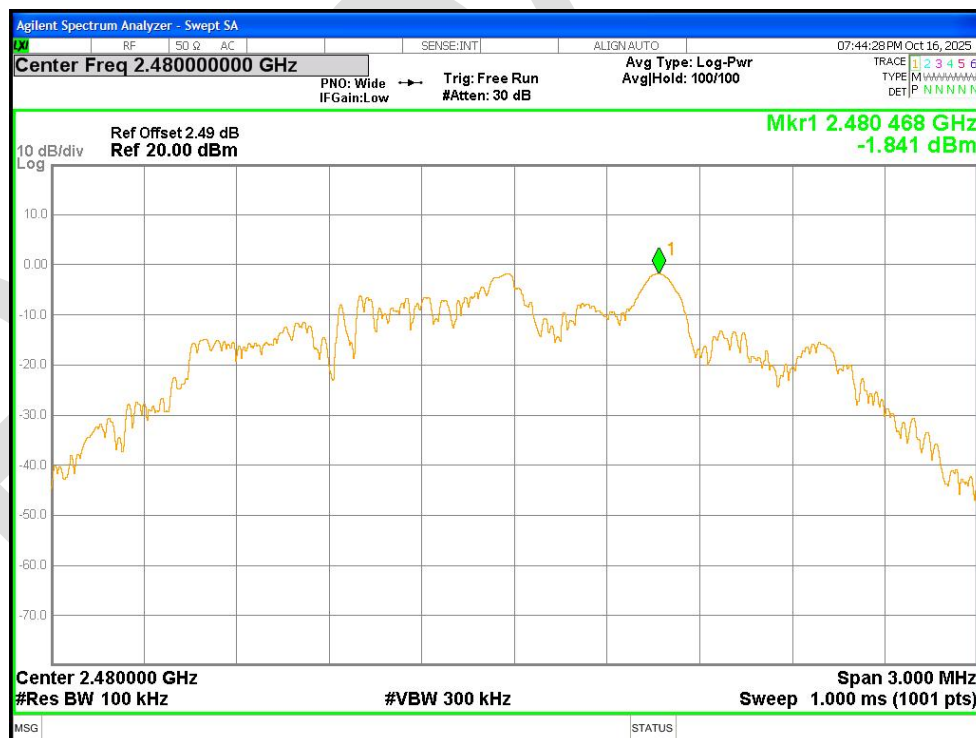
Tx. Spurious NVNT BLE 2M 2480MHz Ant1 Emission

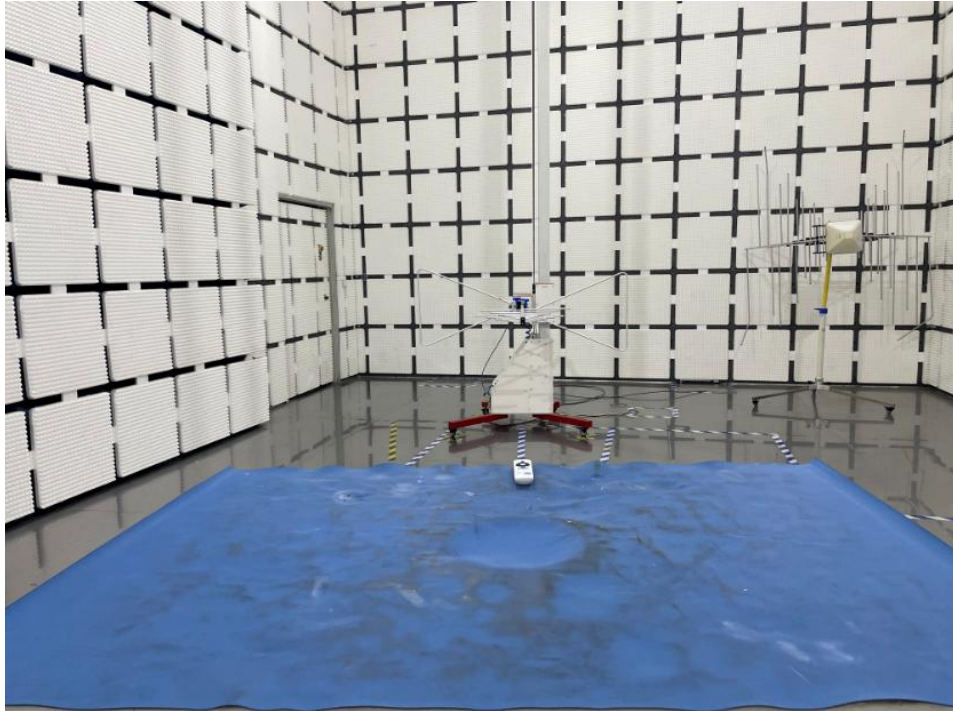
Radiated Emissions (30MHz-1GHz)

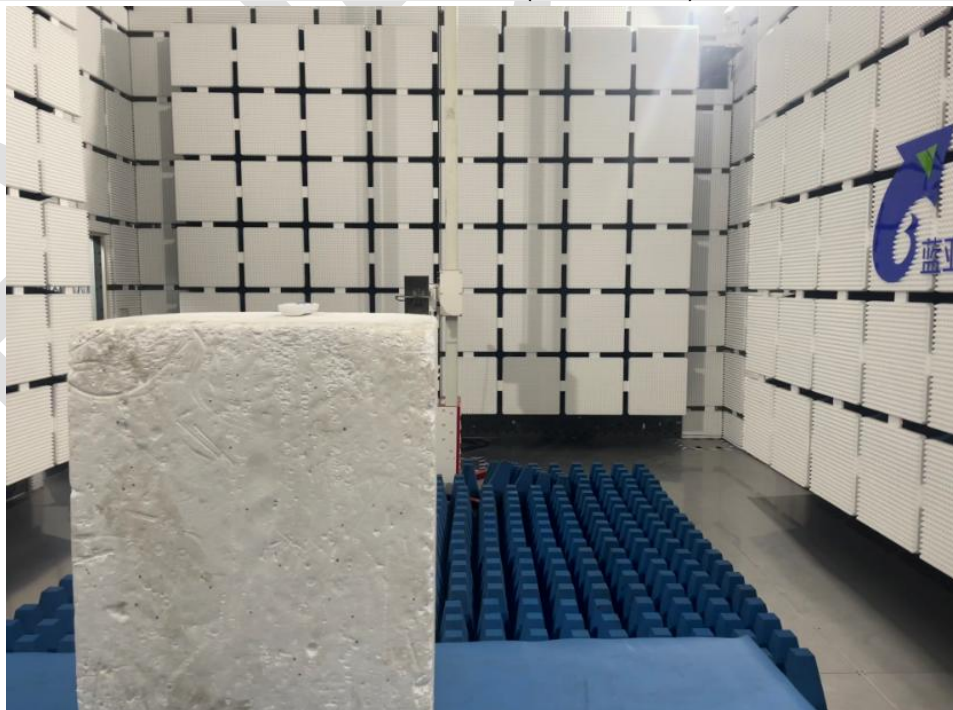
Radiated Emissions (above 1GHz)
