Hopping Mode

## 5.10 Spurious RF Conducted Emissions

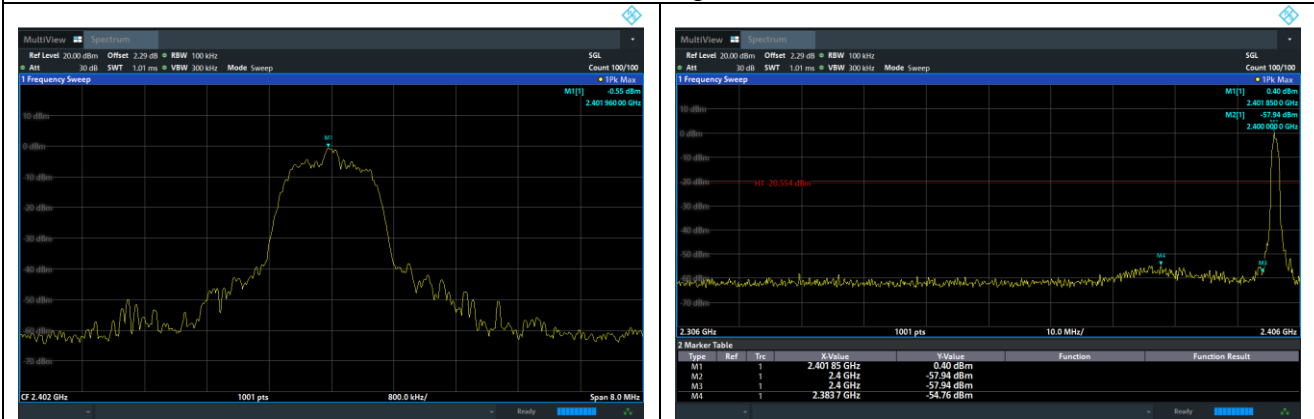
8DPSK: Band Edge, Left Side

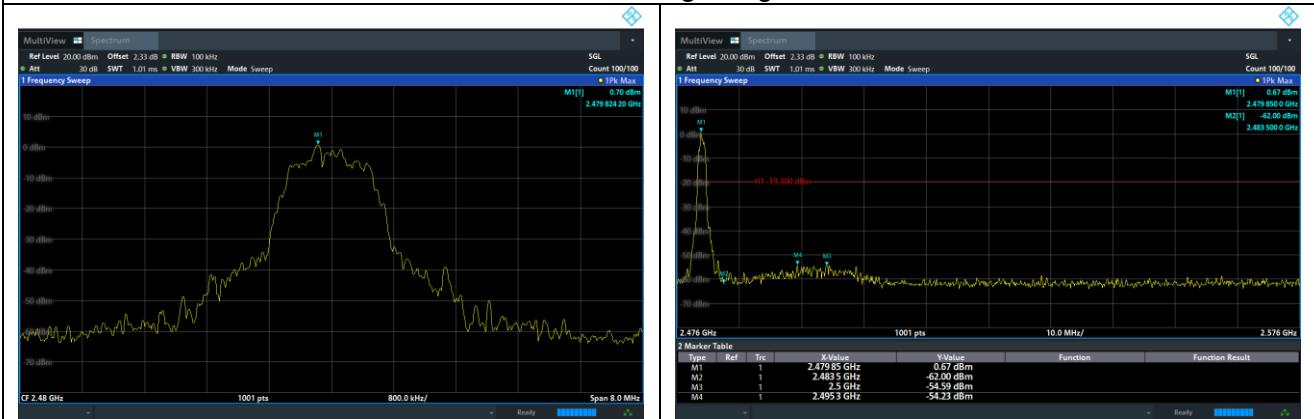
8DPSK: Band Edge, Right Side

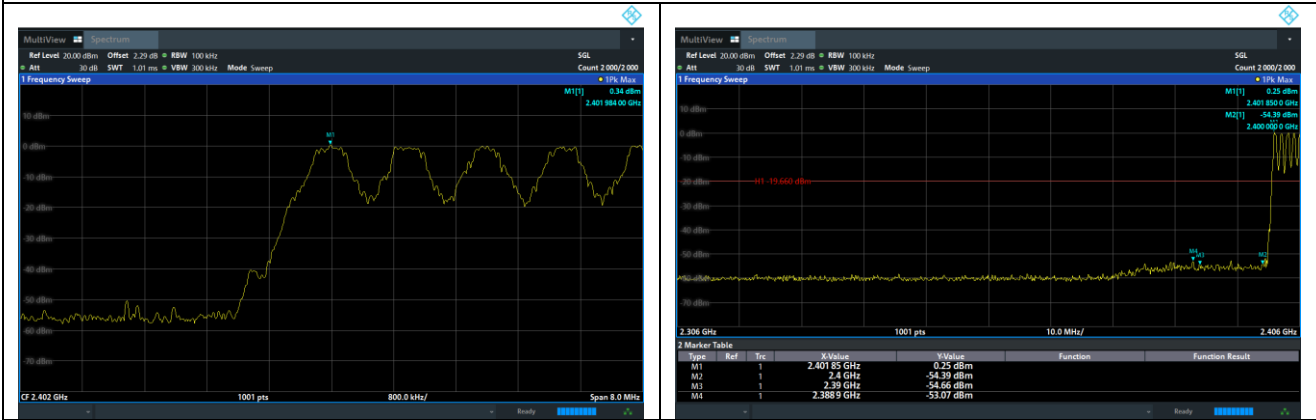
GFSK: Band Edge, Left Side

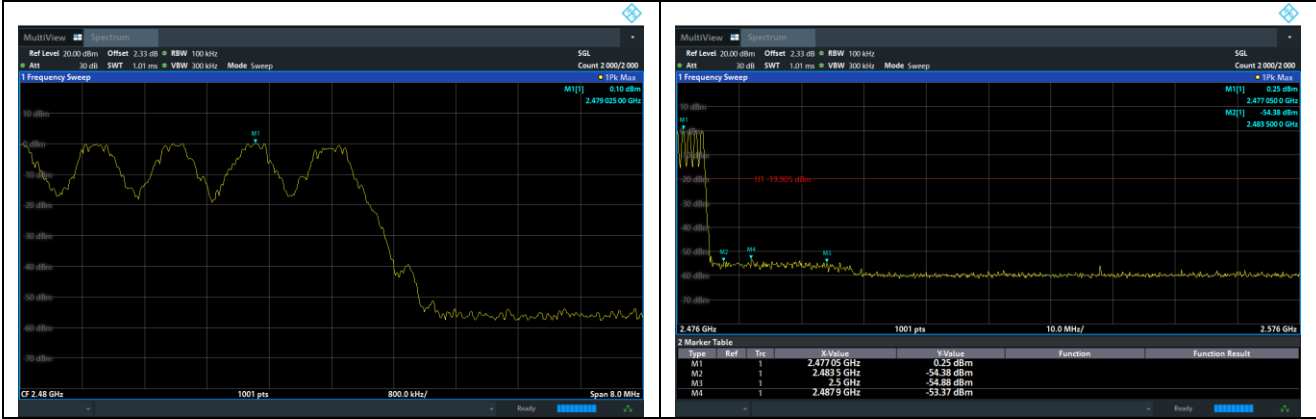
GFSK: Band Edge, Right Side

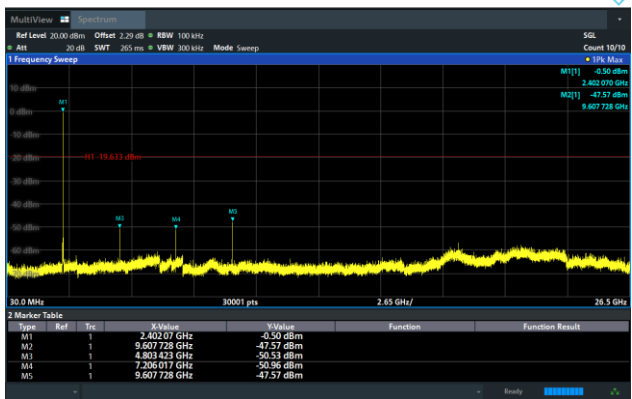
GFSK on Channel 00

- 1: The measurement frequency range is from 9kHz to the 10th harmonic of the fundamental frequency. The lowest, middle and highest channels are tested to verify the spurious emissions and band edge measurement data.
- 2: The worst mode is GFSK mode, and the report only show the worst mode data.

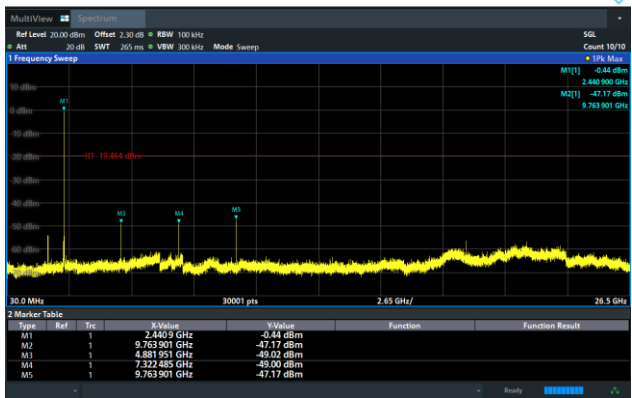
GFSK on Channel 39

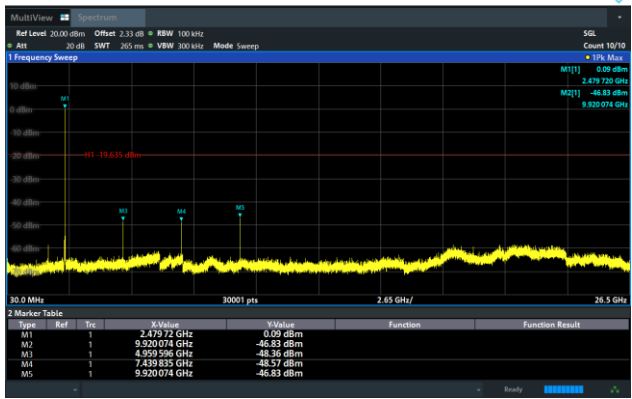
GFSK on Channel 78

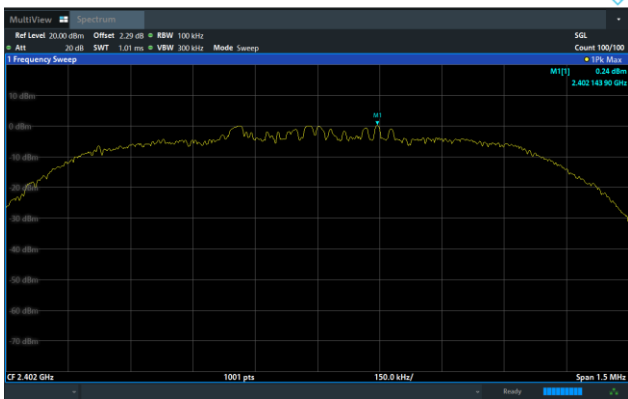
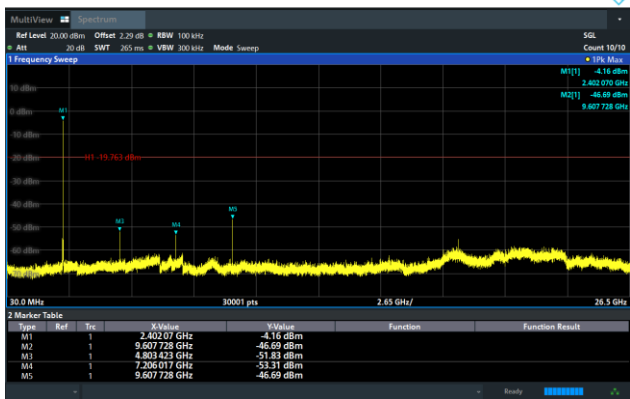
$\pi/4$ -DQPSK on Channel 00

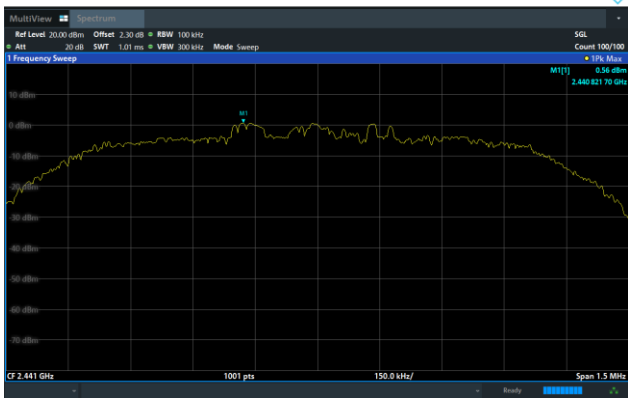
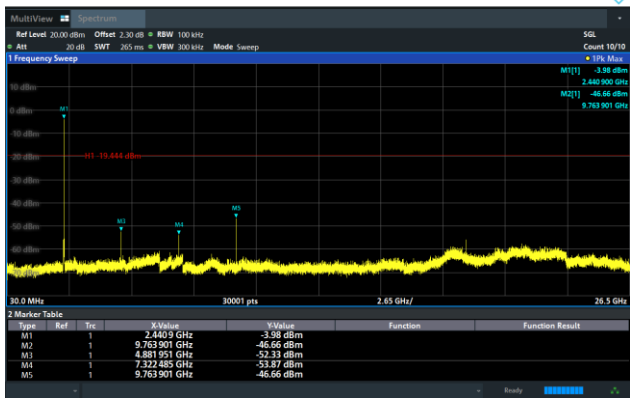
$\pi/4$ -DQPSK on Channel 39

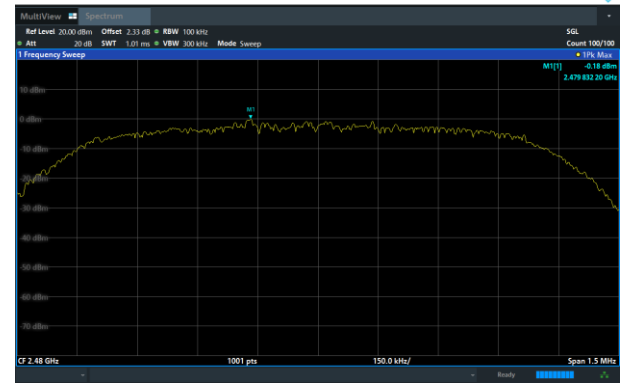
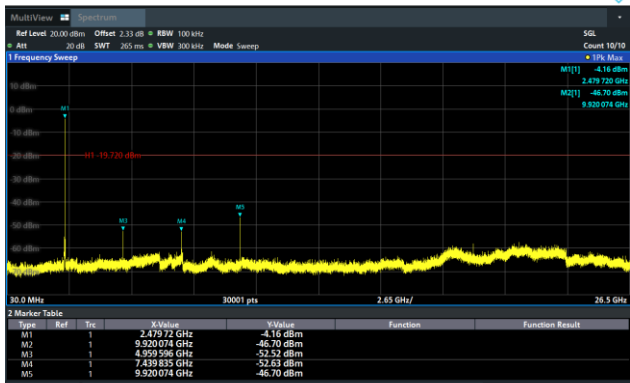
$\pi/4$ -DQPSK on Channel 78

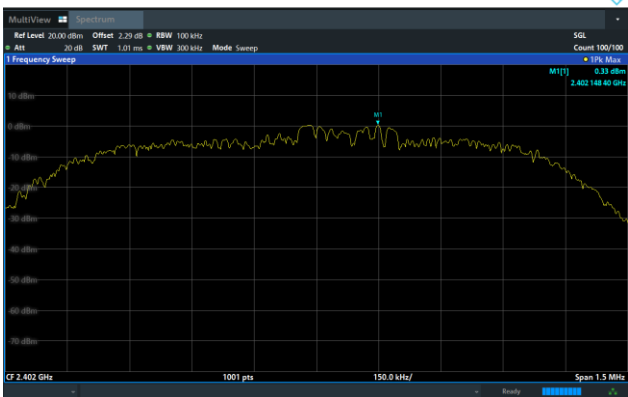
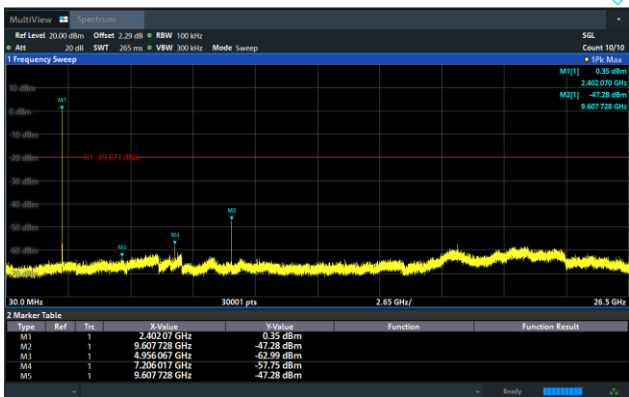
8DPSK on Channel 00

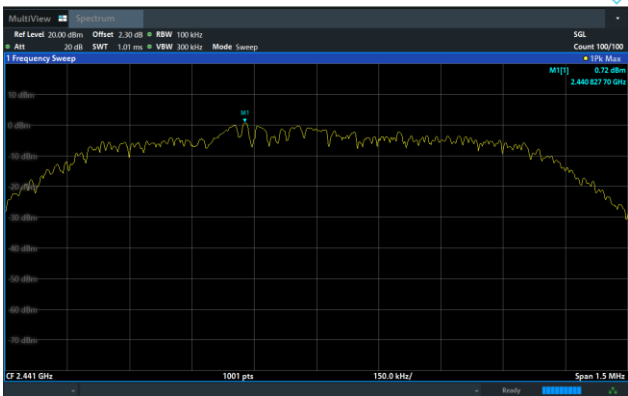
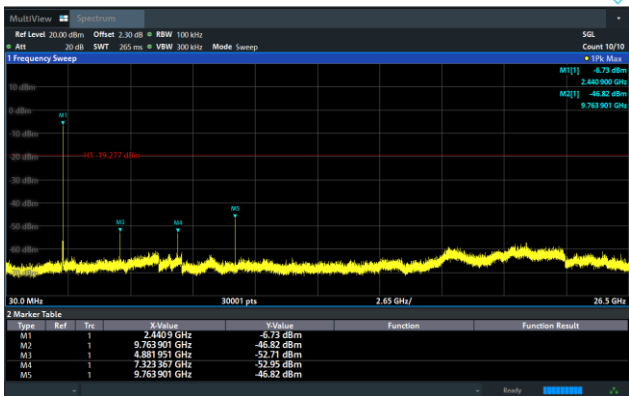
8DPSK on Channel 39

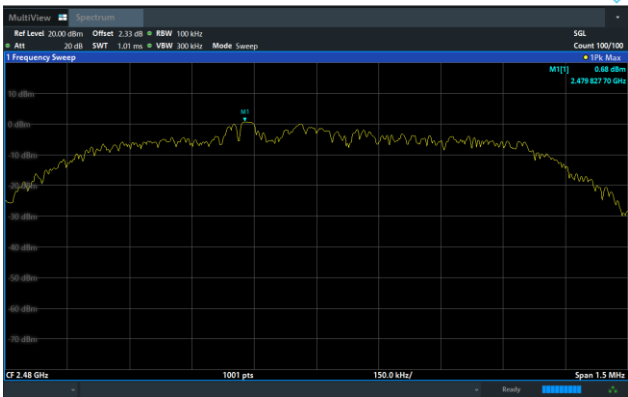
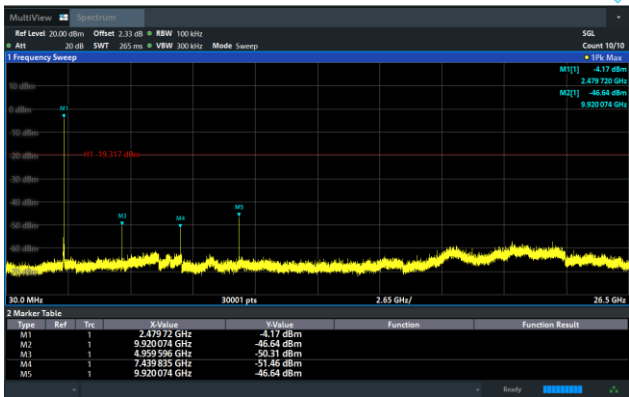
8DPSK on Channel 78

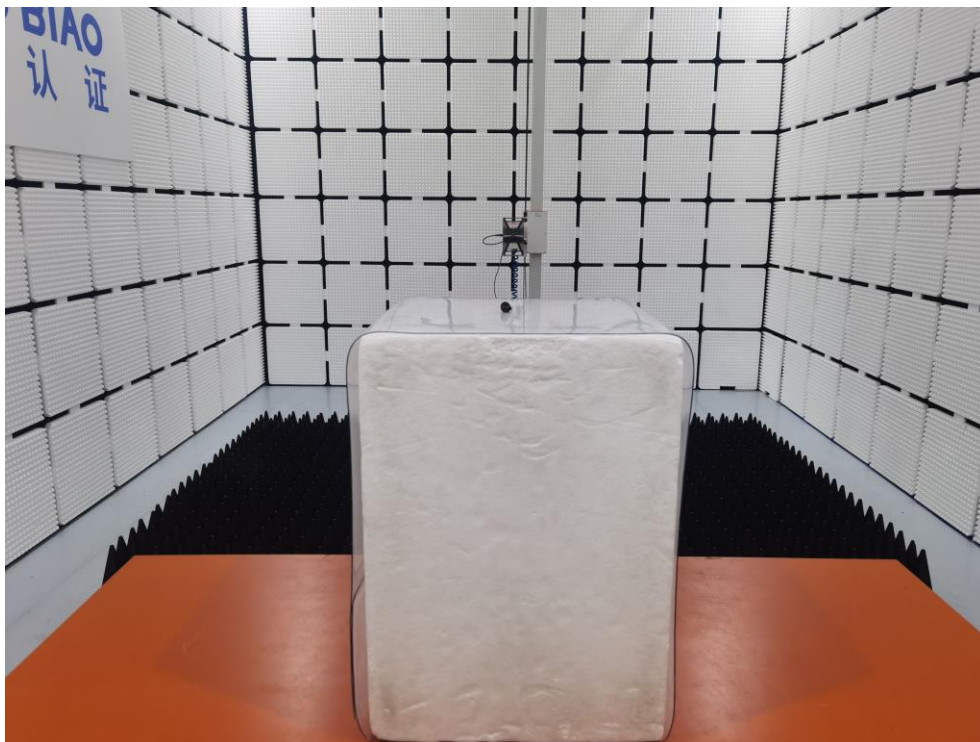
Radiated Emission Above 1GHz

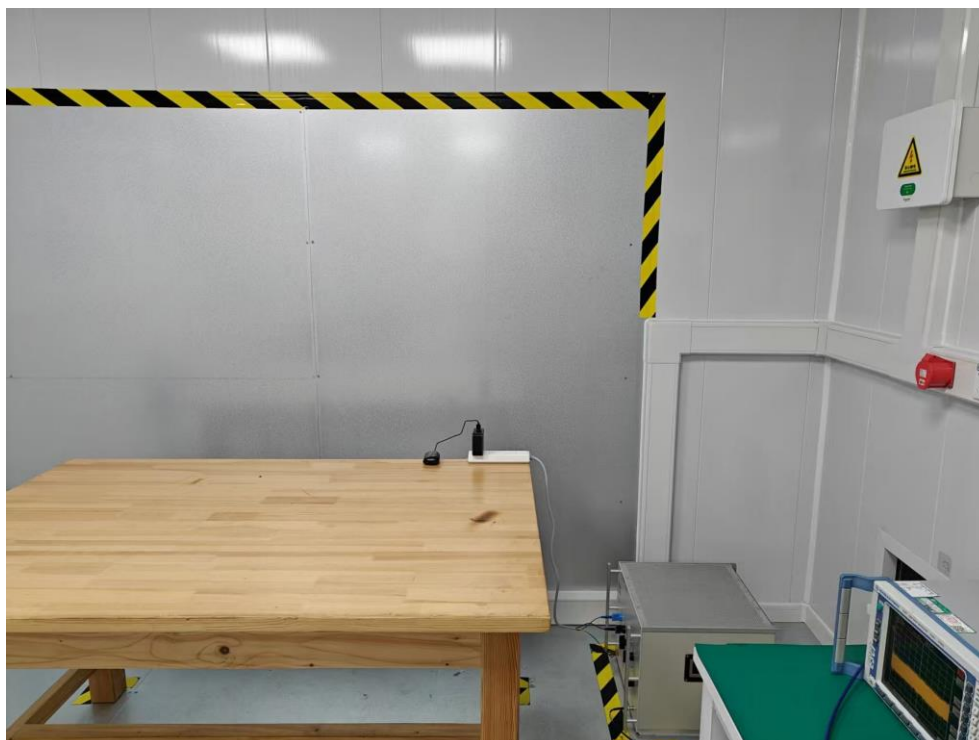
Conducted Emission
