## Appendix H: Conducted Spurious Emission Test Result

14. TEST SETUP PHOTO

15. EUT PHOTO

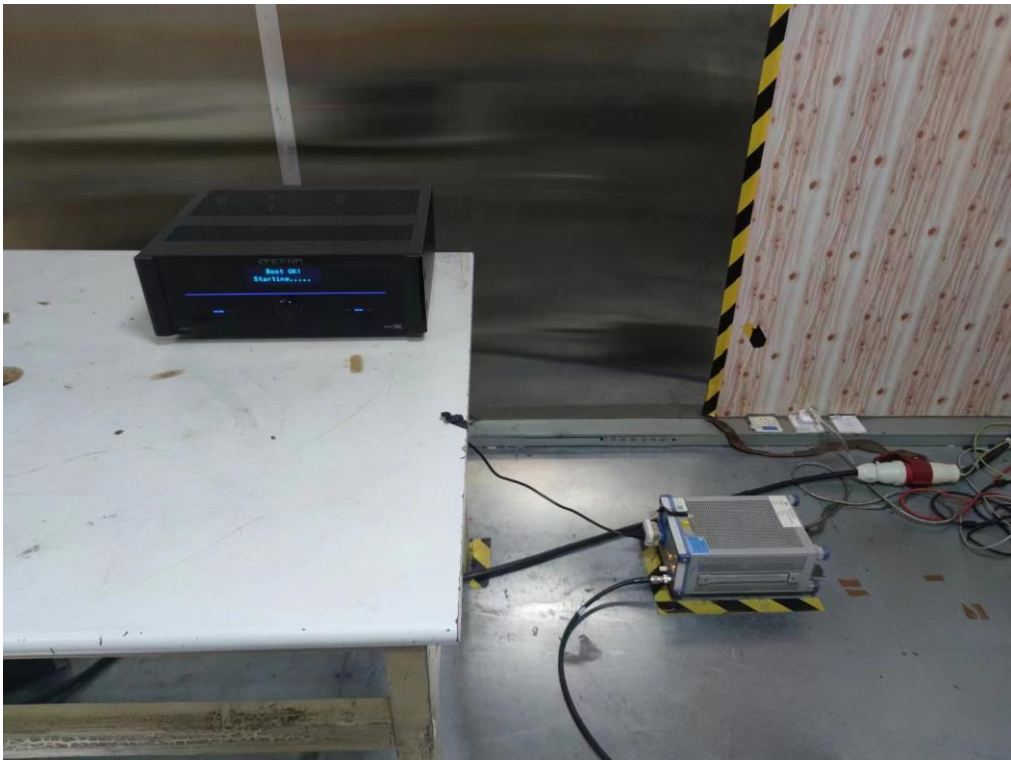
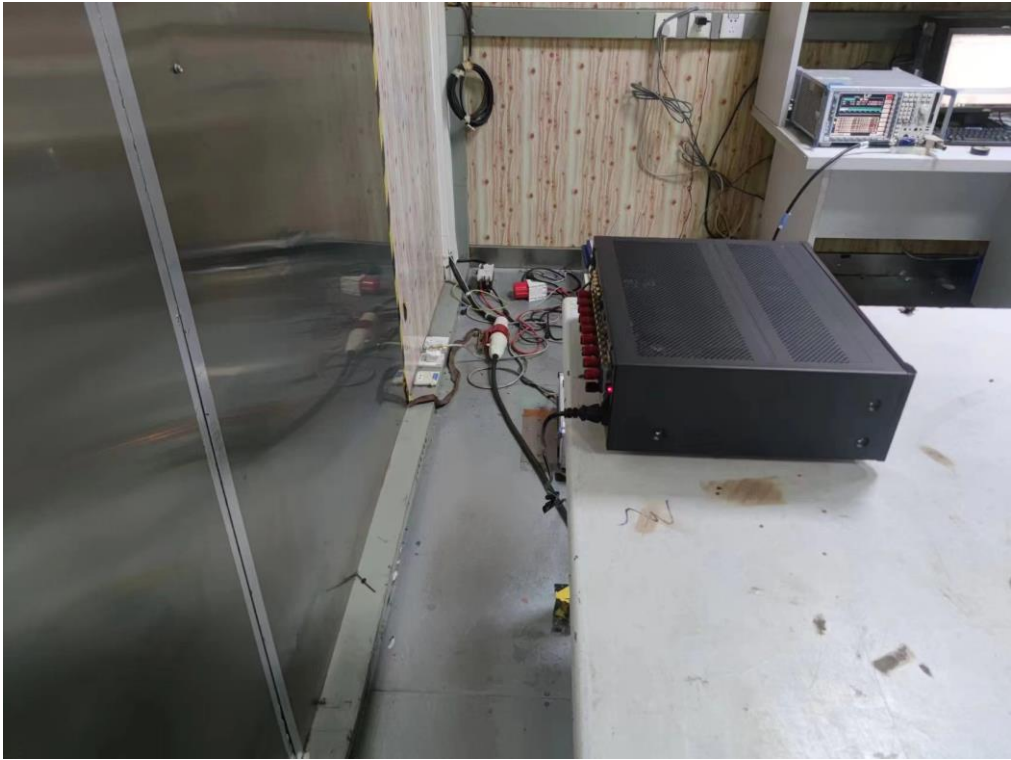
Conducted Test

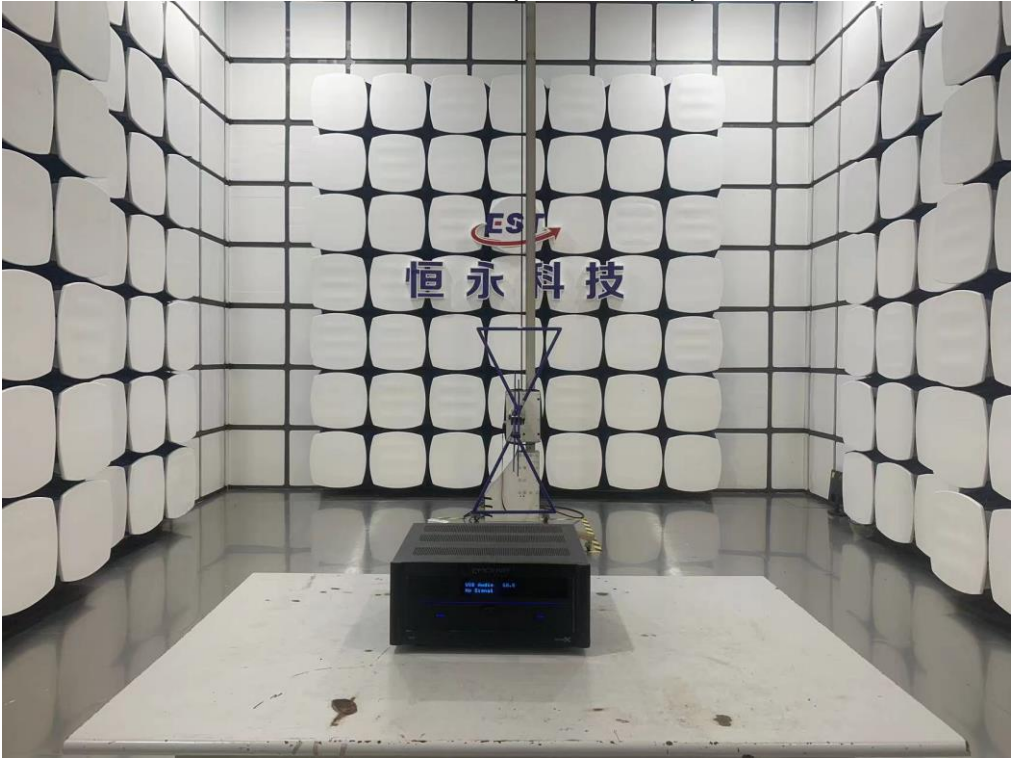
Radiated Test (Below 1GHz)

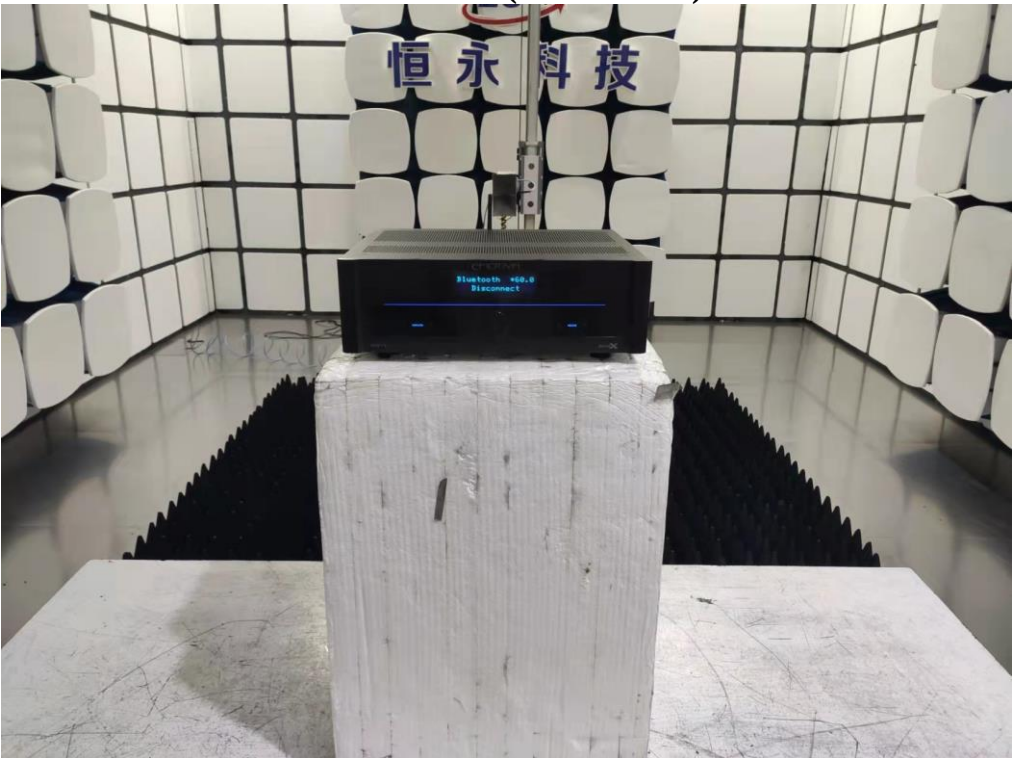
Radiated Test (Above 1GHz)

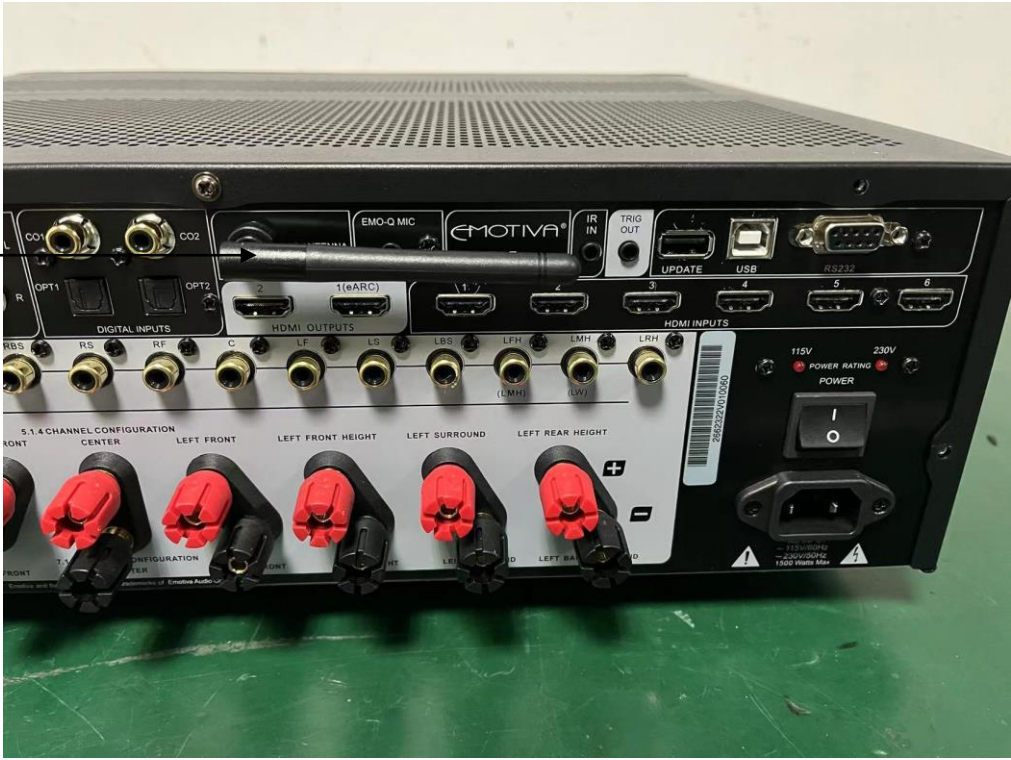
Bluetooth  
Antenna
