### **APPENDIX 3: Photographs of test setup**

#### **Radiated Emission**

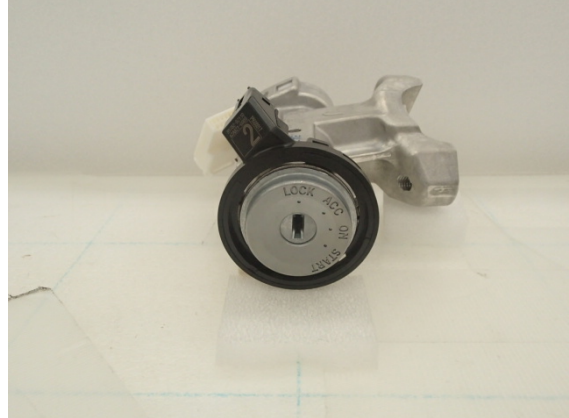
**X-axis**

**ANT**

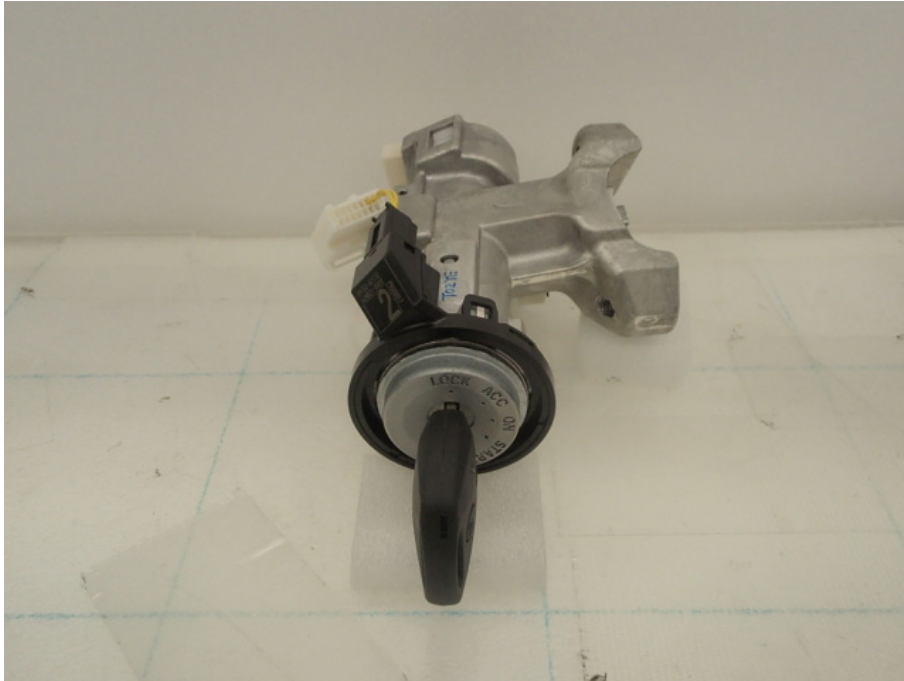
**With key (Worst)**
