### **APPENDIX 3: Photographs of test setup**

#### **Radiated Spurious Emission**

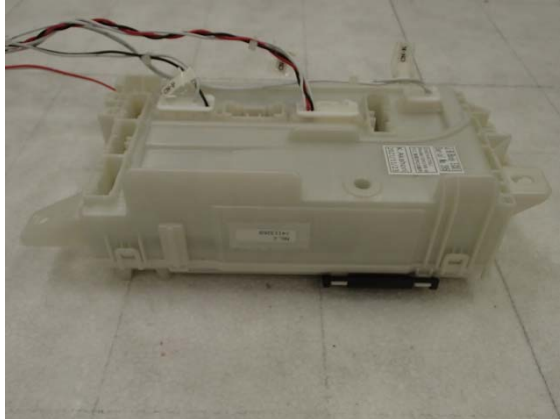
#### ECU

Below 30 MHz

X-axis

Above 30 MHz

Horizontal: X-axis / Vertical: X-axis

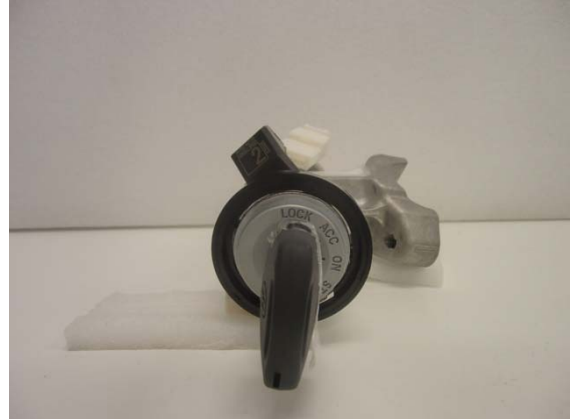
#### ANT

Below 30 MHz

X-axis

Above 30 MHz

Horizontal: X-axis / Vertical: X-axis

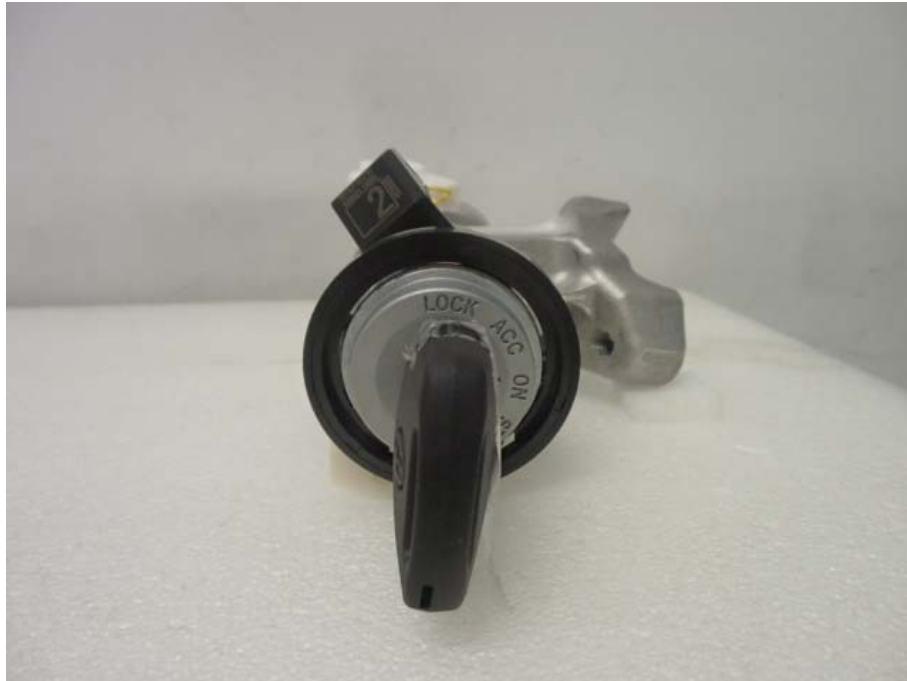
### Worst case position

With transponder key inserted (Worst)

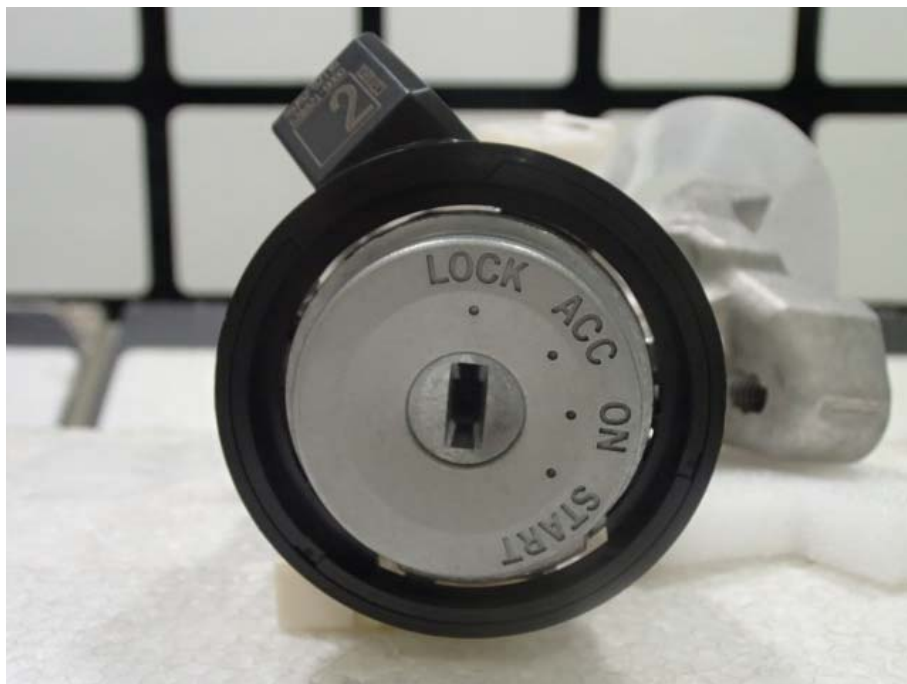
Without transponder key inserted
