### **APPENDIX 3: Photographs of test setup**

#### **Radiated Emission**

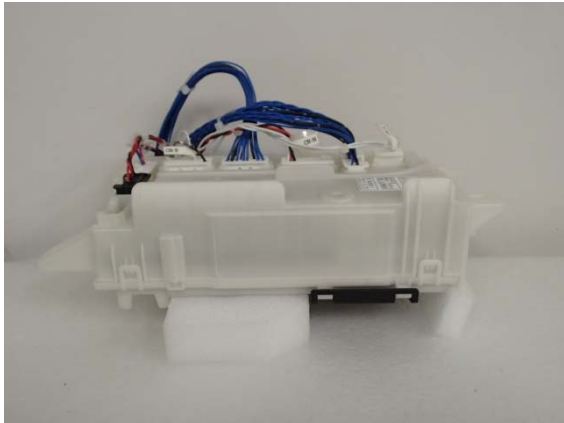
**ECU**  
Below 30 MHz  
X-axis  
Above 30 MHz  
Horizontal: X-axis / Vertical: X-axis

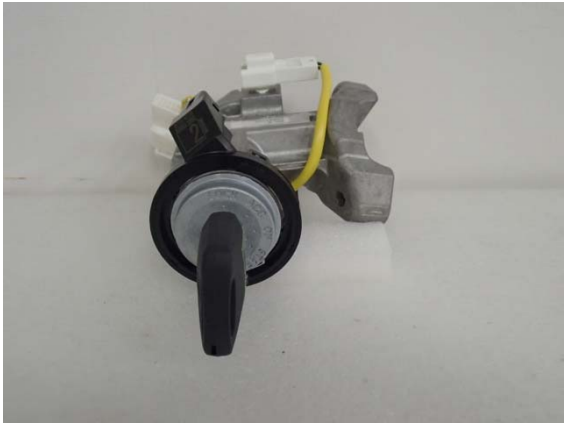
**ANT**  
Below 30 MHz  
X-axis  
Above 30 MHz  
Horizontal: X-axis / Vertical: X-axis

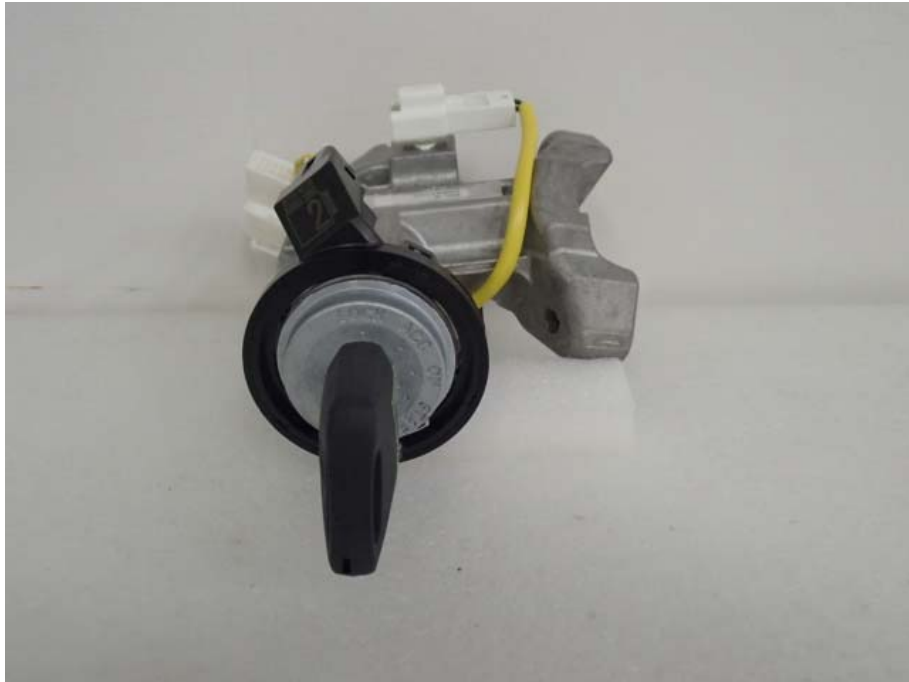
**Worst case position**

With transponder key inserted (Worst)

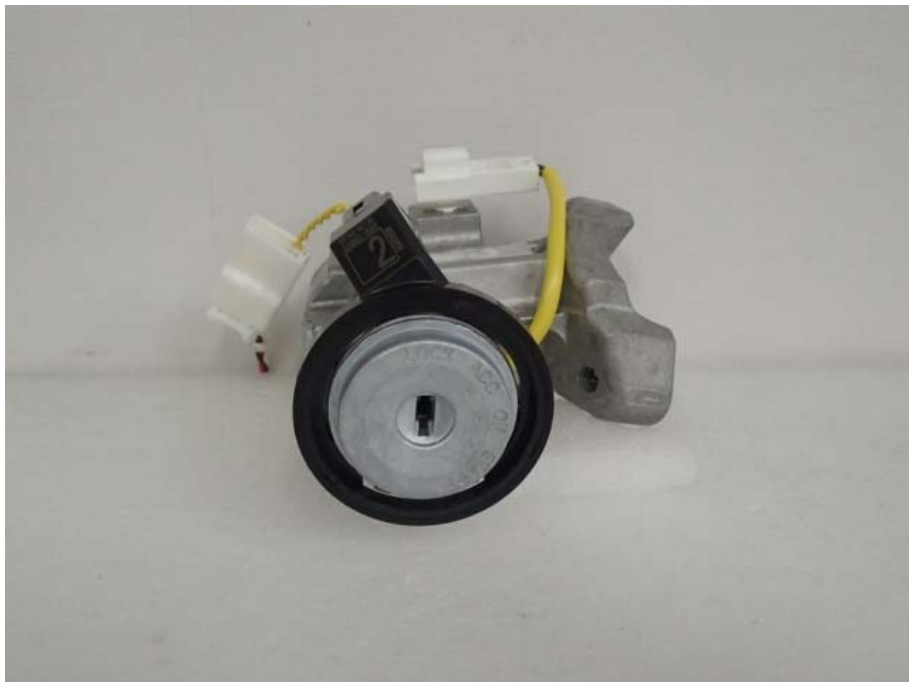
Without transponder key inserted
