## Appendix B: photographs of test setup

Reference to the test report no. BLA-EMC-202601-A1001.

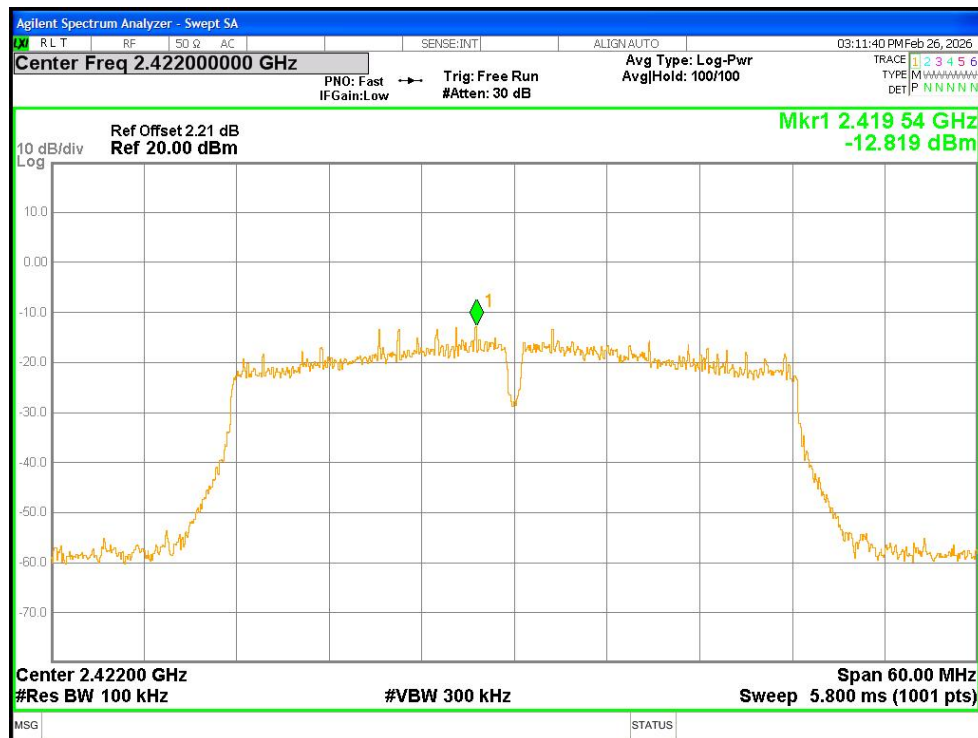
Tx. Spurious NVNT n40 2422MHz Ant1 Emission

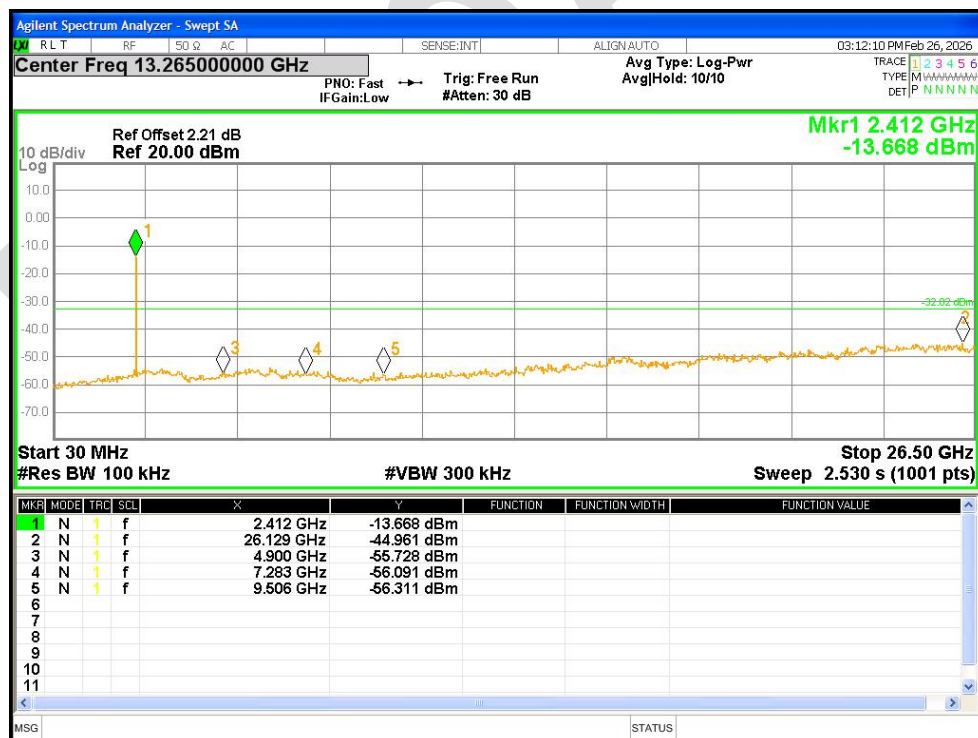
Tx. Spurious NVNT n40 2437MHz Ant1 Ref

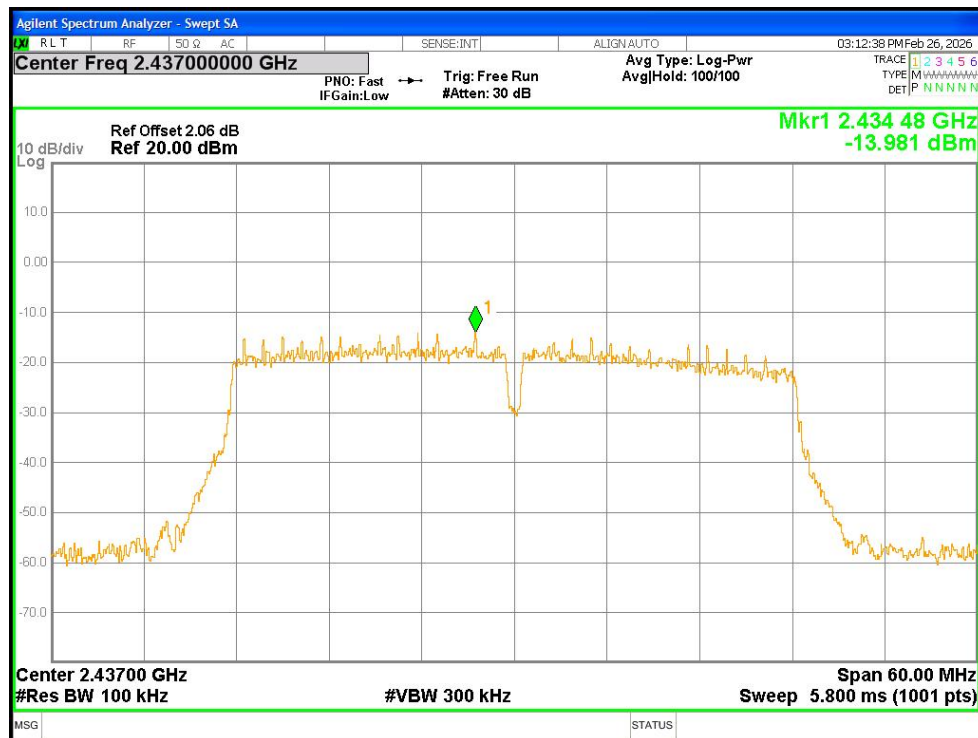
Tx. Spurious NVNT n40 2437MHz Ant1 Emission

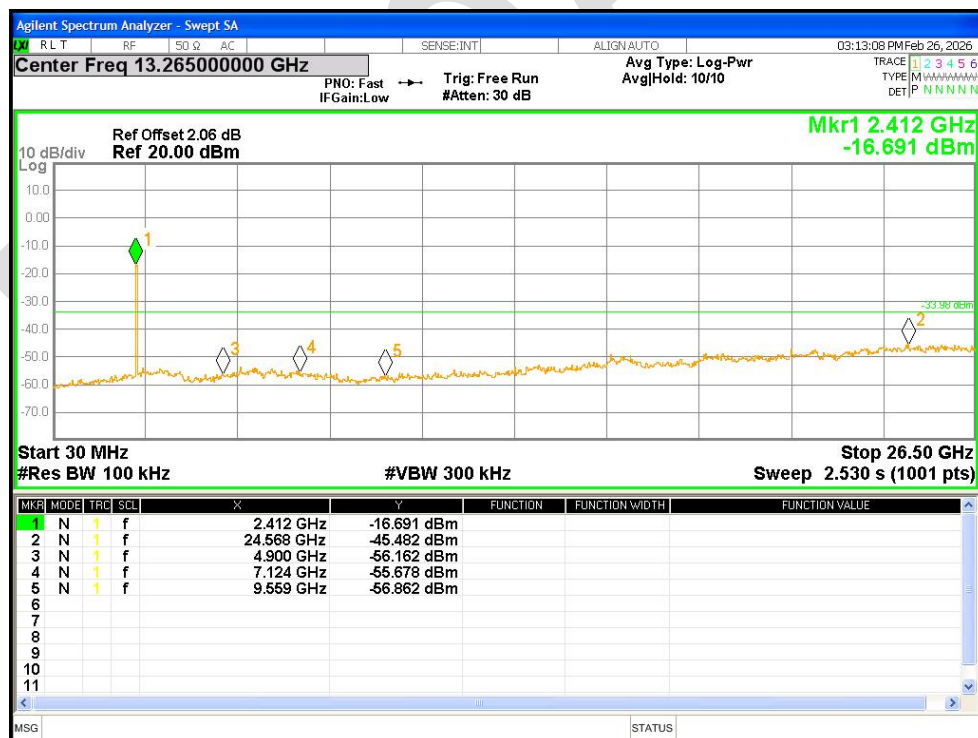
Tx. Spurious NVNT n40 2452MHz Ant1 Ref

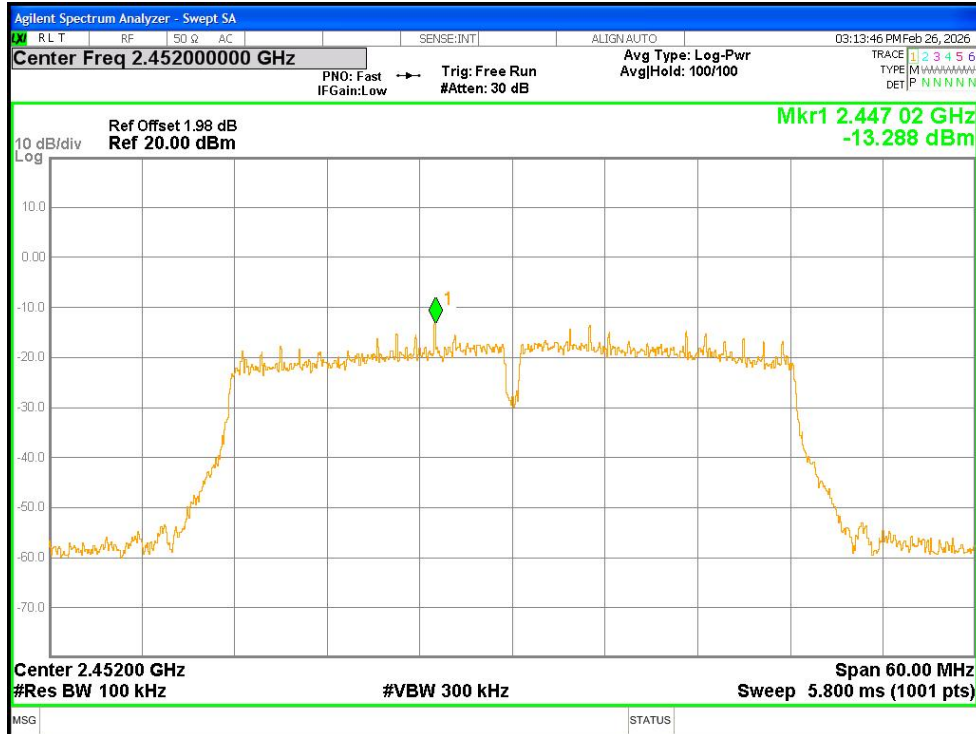
Tx. Spurious NVNT n40 2452MHz Ant1 Emission

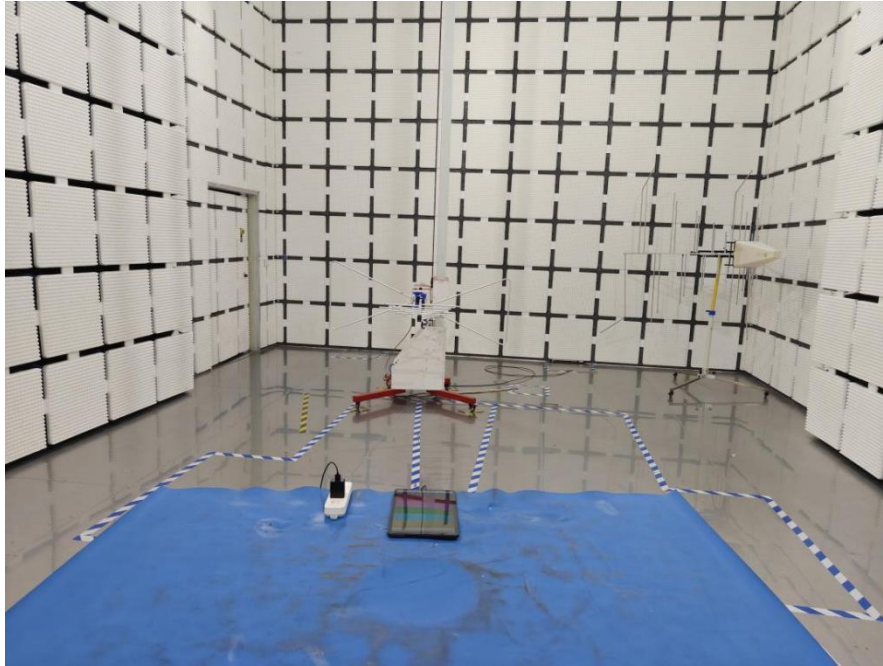
Radiated Emissions (30MHz-1GHz)

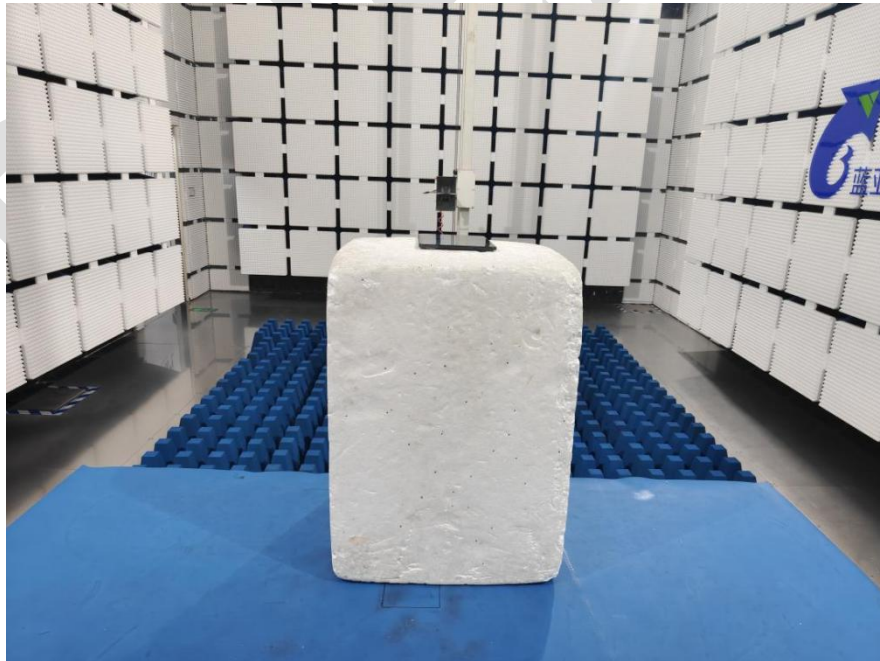
Radiated Emissions (above 1GHz)

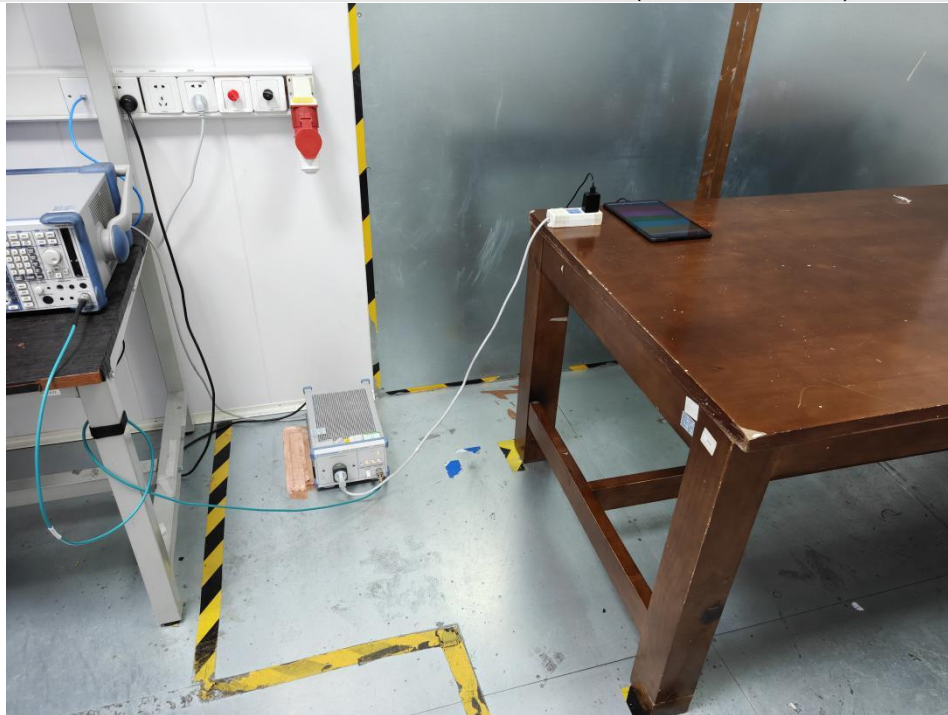
Conducted Emissions at Mains Terminals (150 kHz-30MHz)
