## Appendix B: photographs of test setup

## Appendix C: photographs of EUT

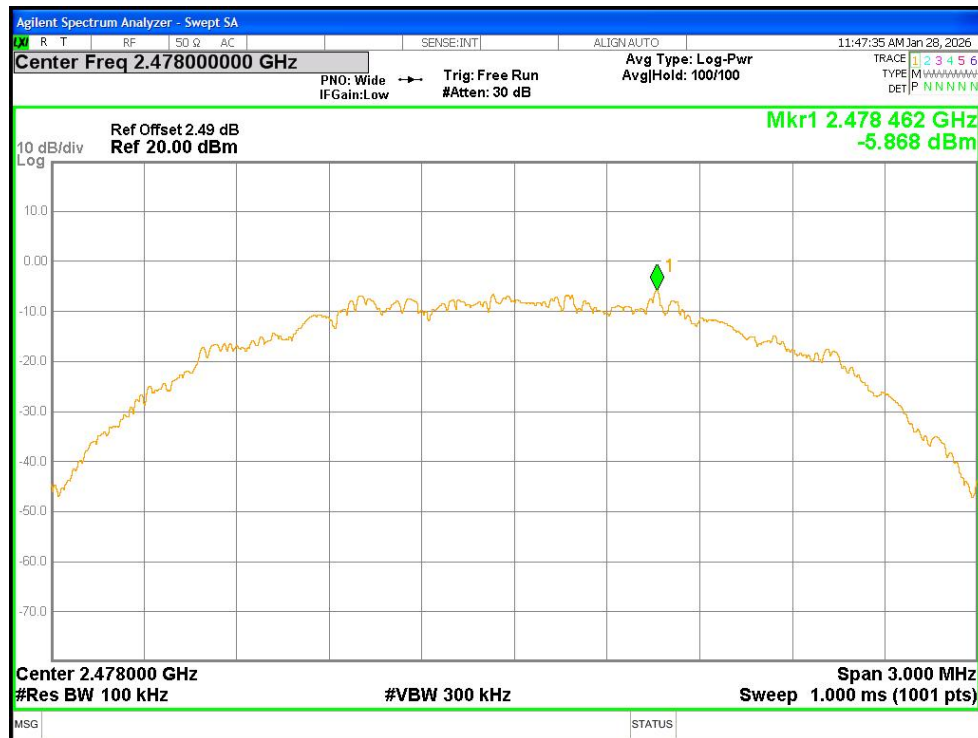
Tx. Spurious NVNT BLE 2M 2478MHz Ant1 Ref

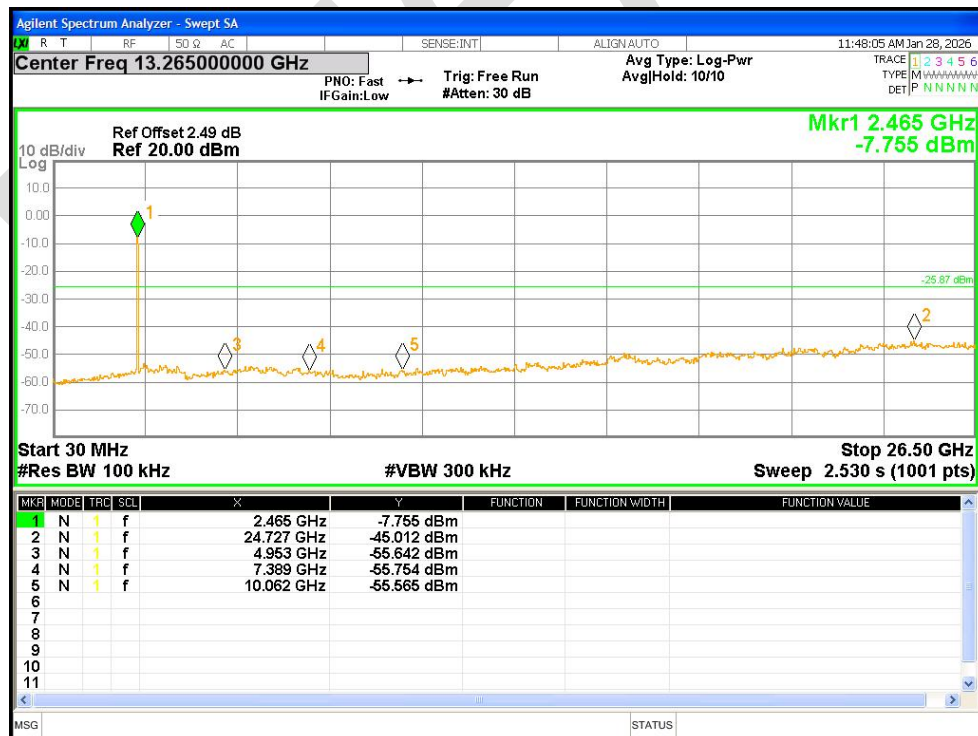
Tx. Spurious NVNT BLE 2M 2478MHz Ant1 Emission

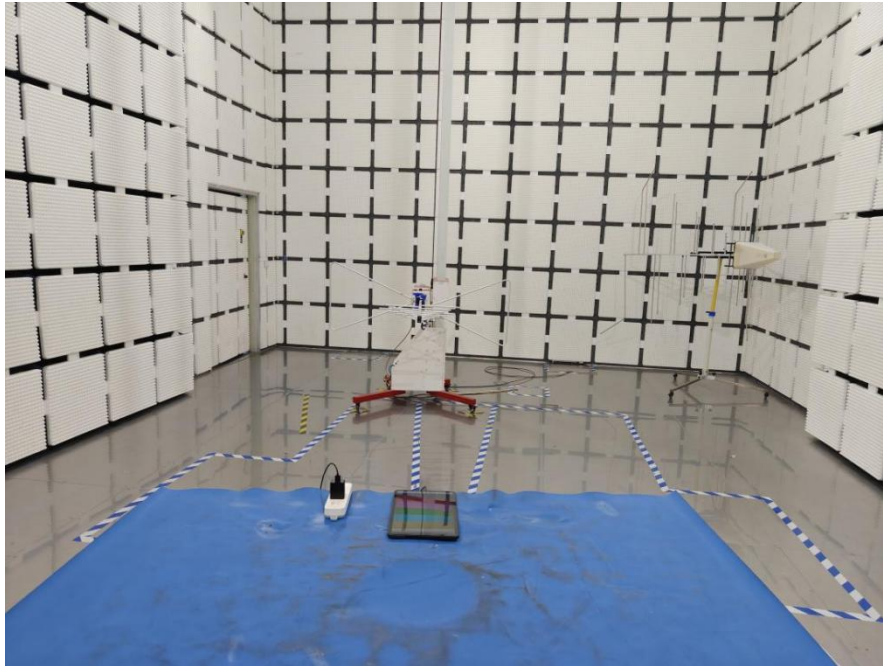
Radiated Emissions (30MHz-1GHz)

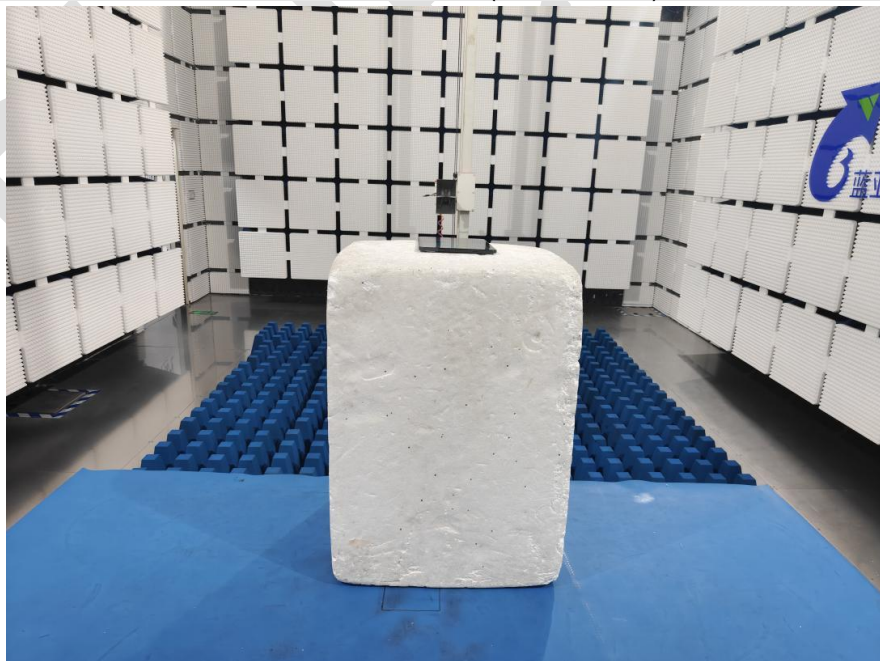
Radiated Emissions (above 1GHz)

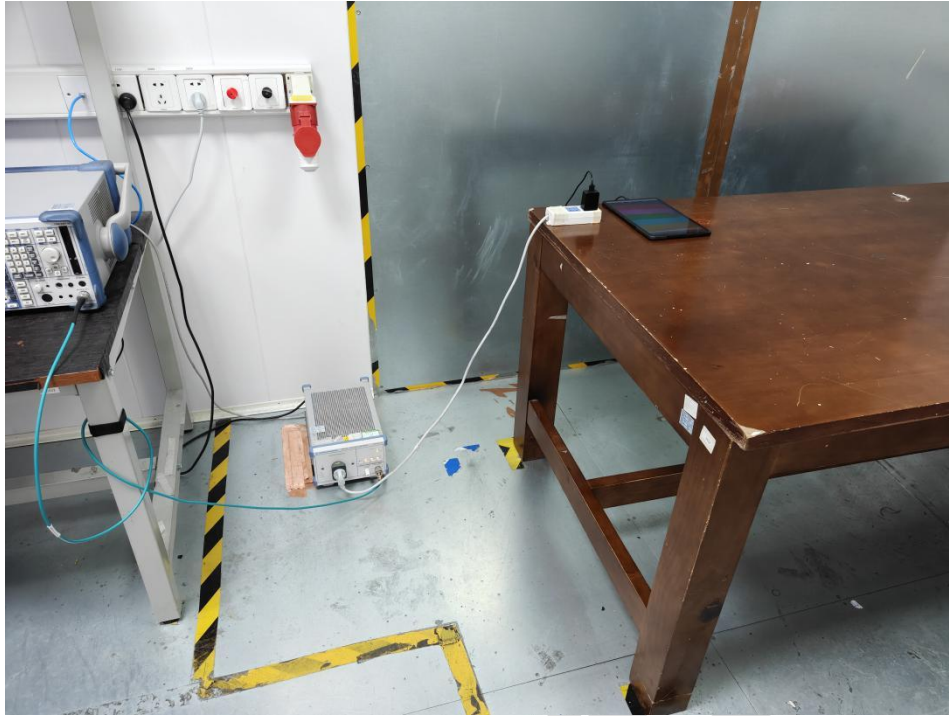
Conducted Emissions at Mains Terminals (150kHz-30MHz)
