Reference to the test report no. BLA-EMC-202509-A4201

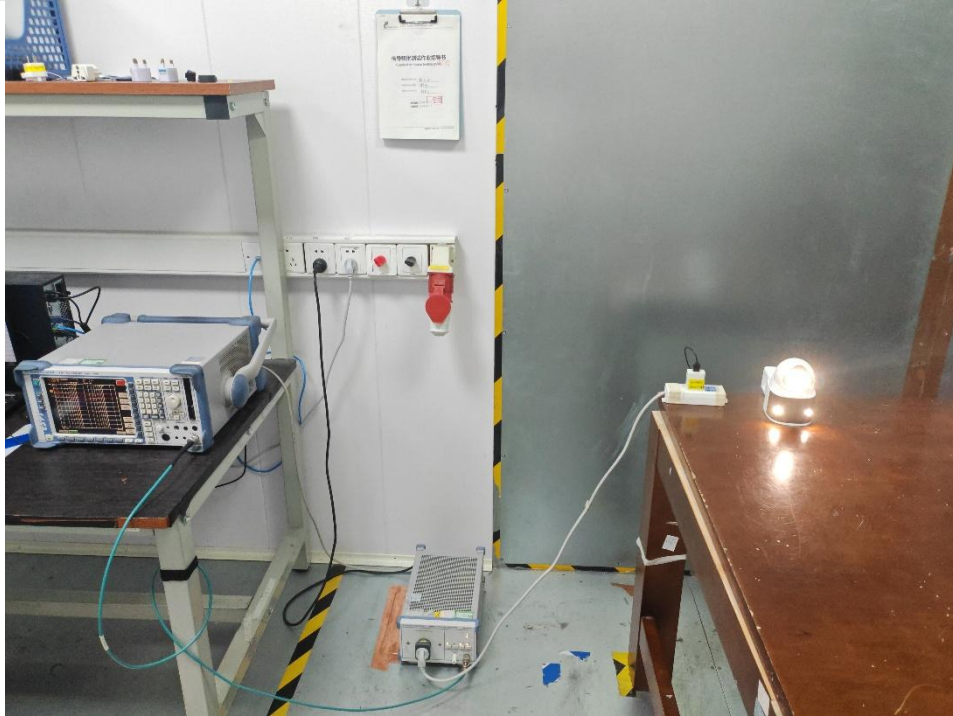
Conducted emissions at AC power line (150kHz-30MHz)

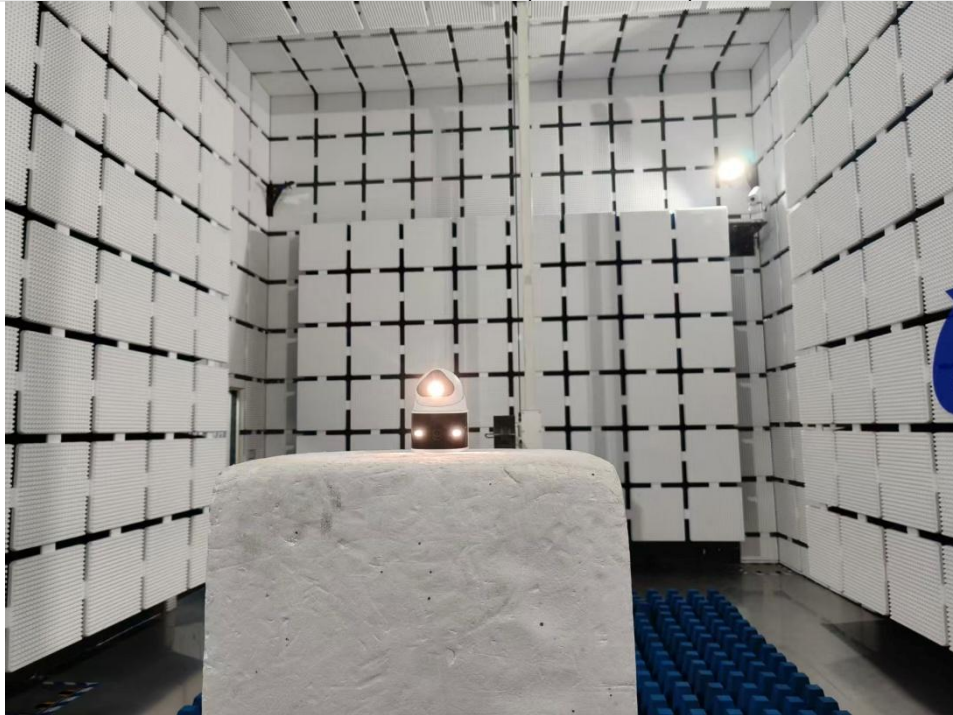
Radiated Emissions (above 1GHz)
