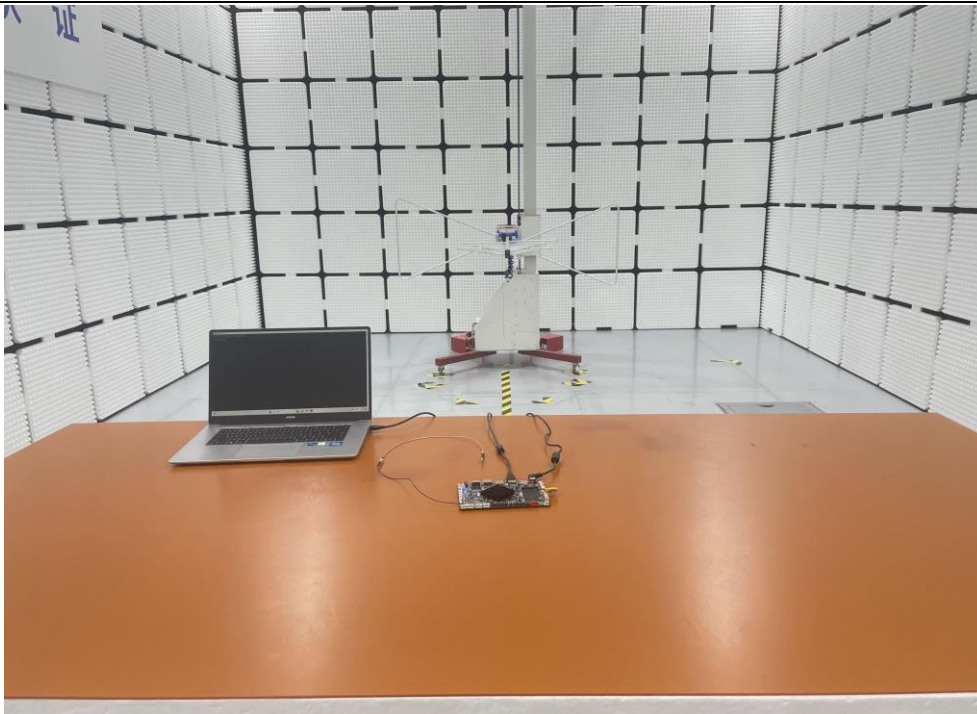
Radiated Emission Below 1GHz

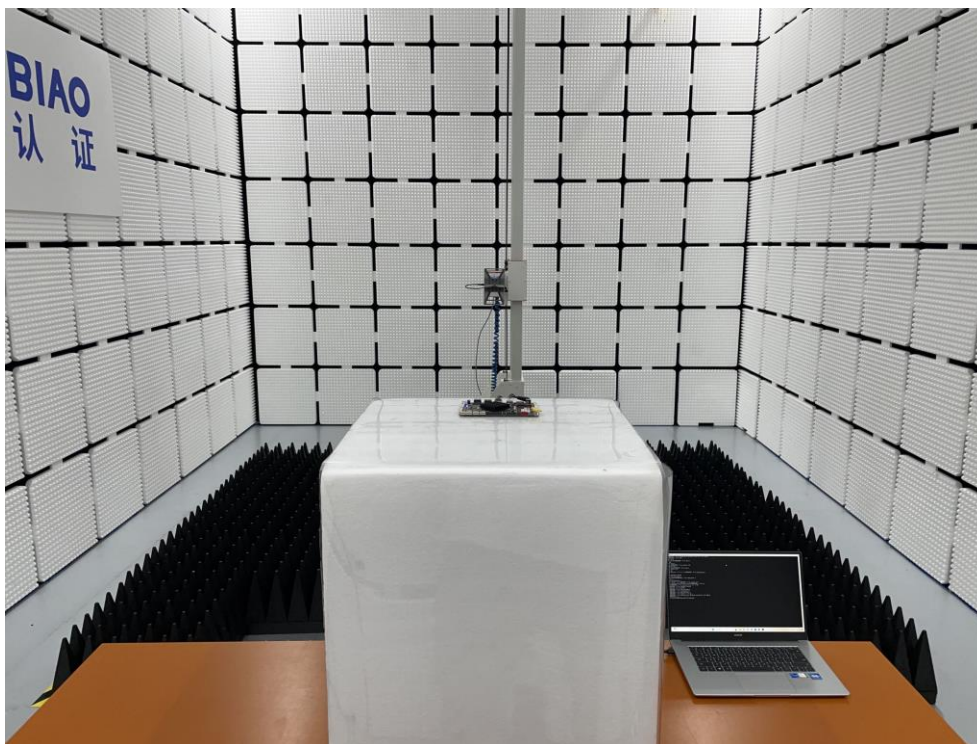
Radiated Emission Above 1GHz

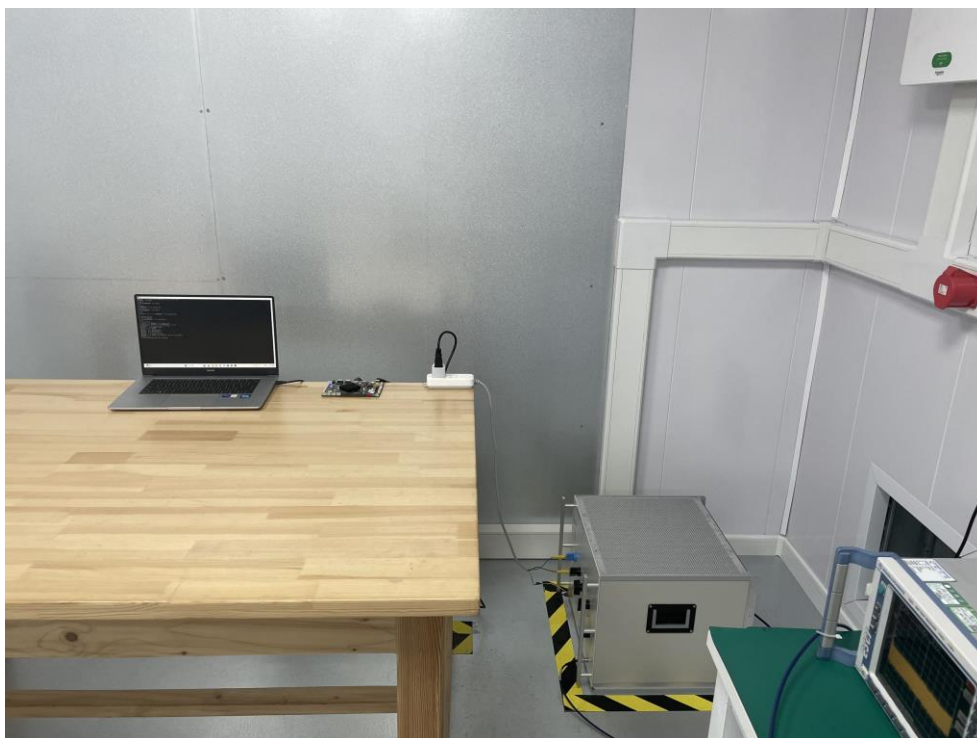
Conducted emission
