## Appendix F: Reference level measurement

## Appendix G: Band edge measurements

## Appendix H: Conducted Spurious Emission Test Result

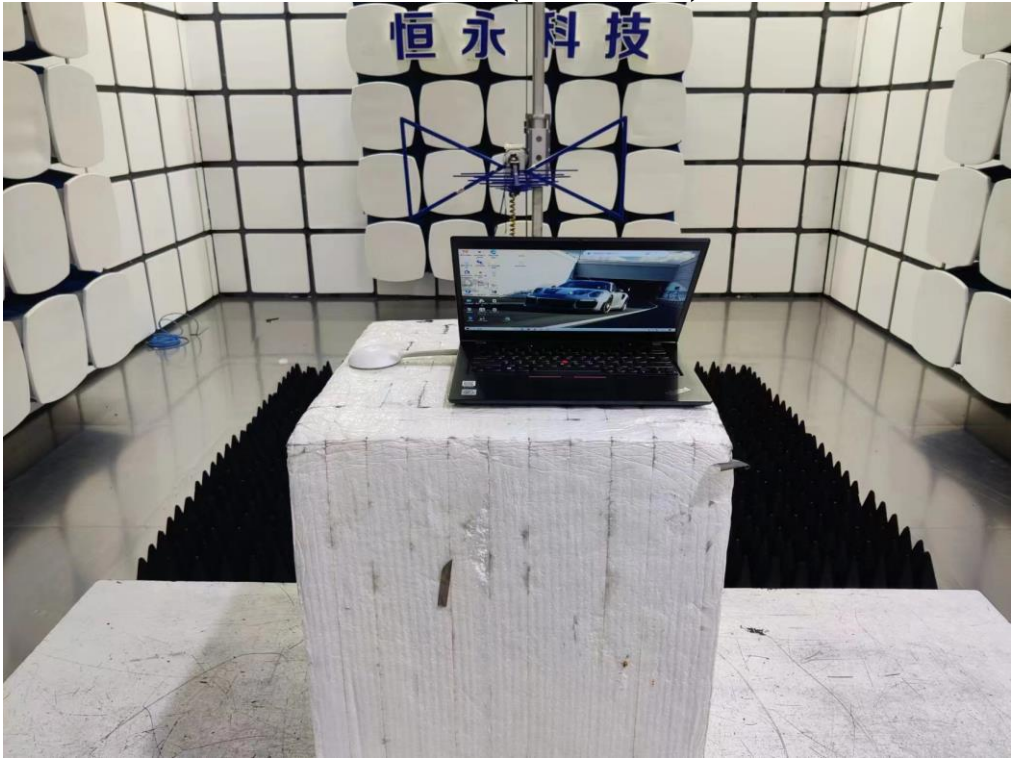
Radiated Test (Below 1GHz)

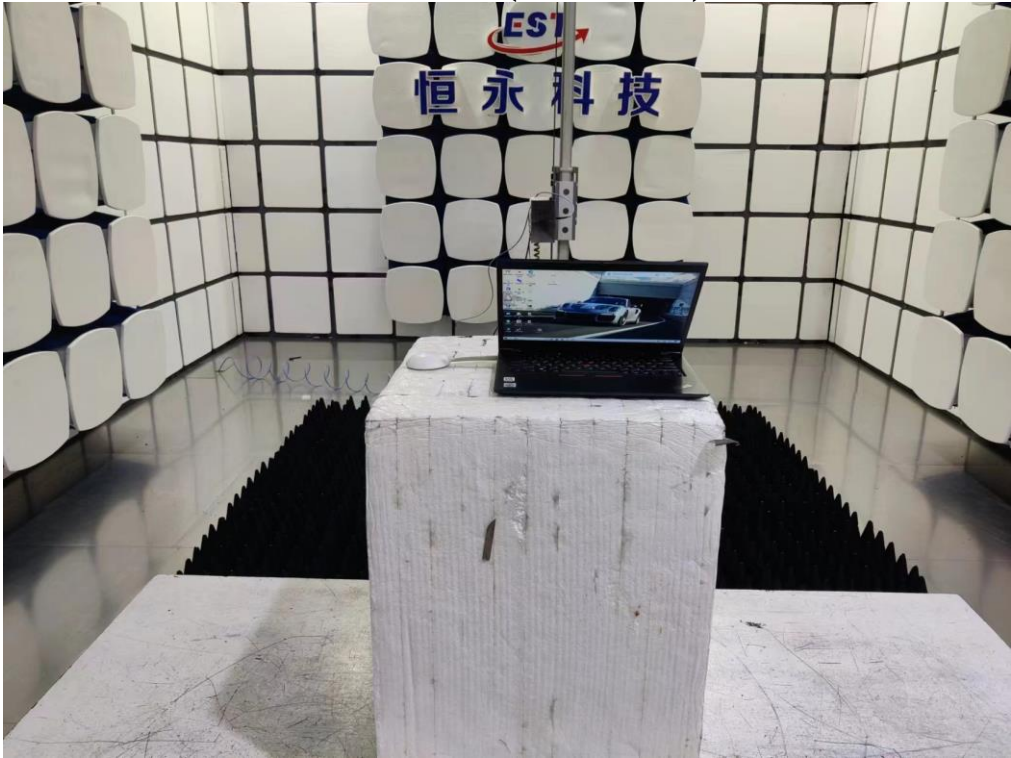
Radiated Test (Above 1GHz)

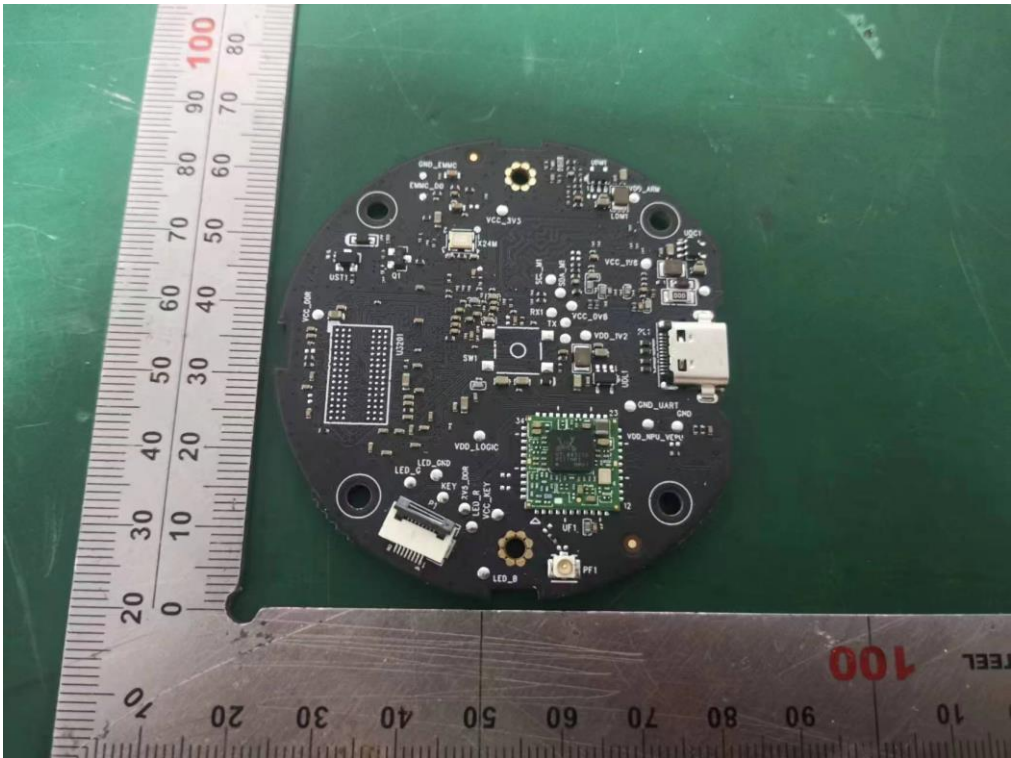
Internal Photos  
M/N: TA01A

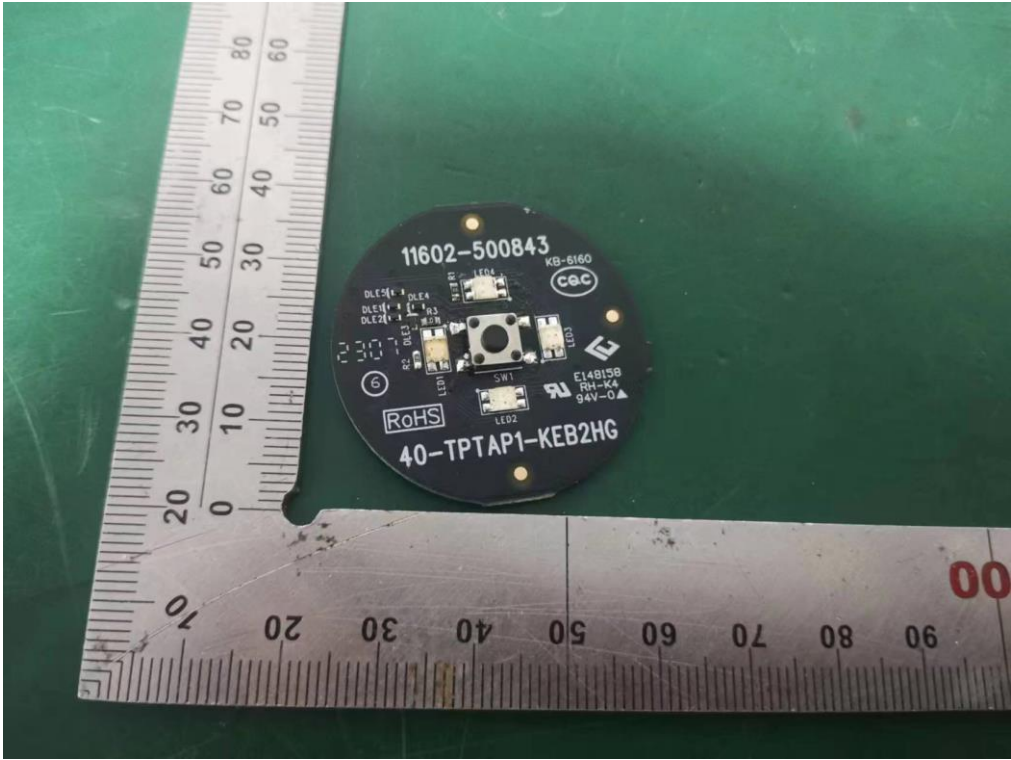
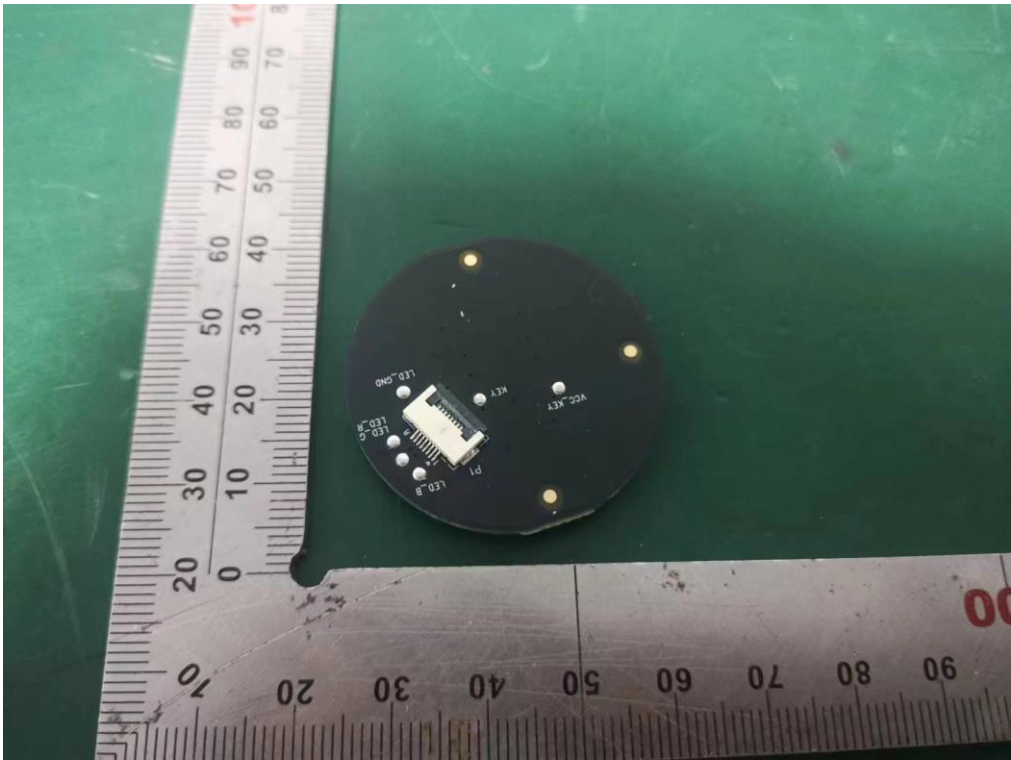
Internal Photos  
M/N: TA01A
