## Appendix B: photographs of test setup

Reference to the test report no. BLA-EMC-202404-A6801

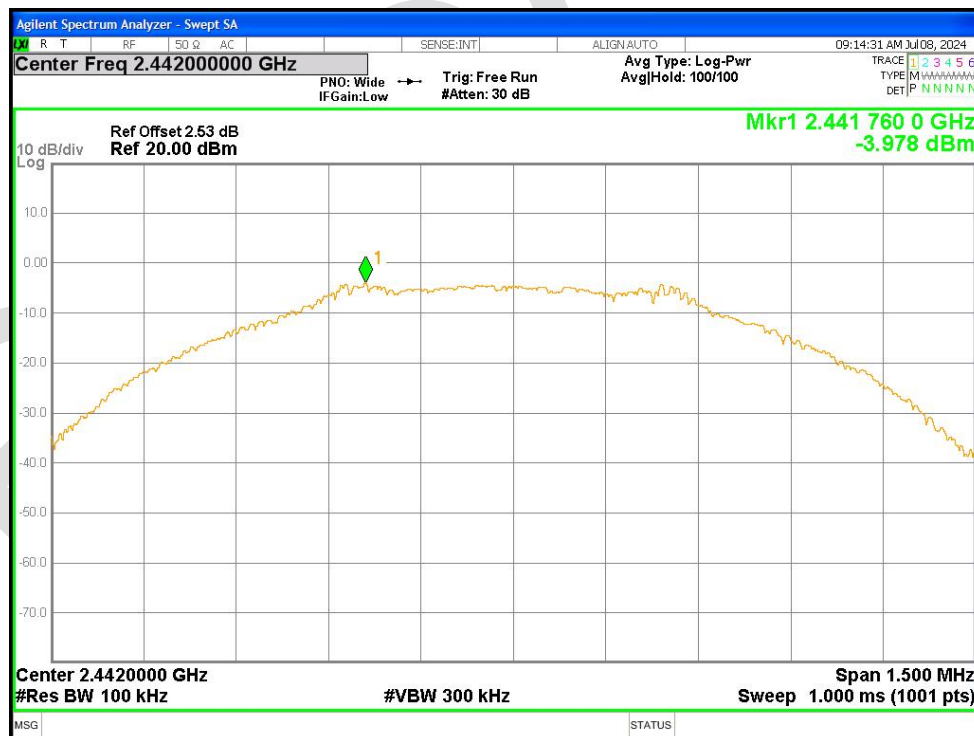
Tx. Spurious NVNT BLE 1M 2442MHz Ant1 Emission

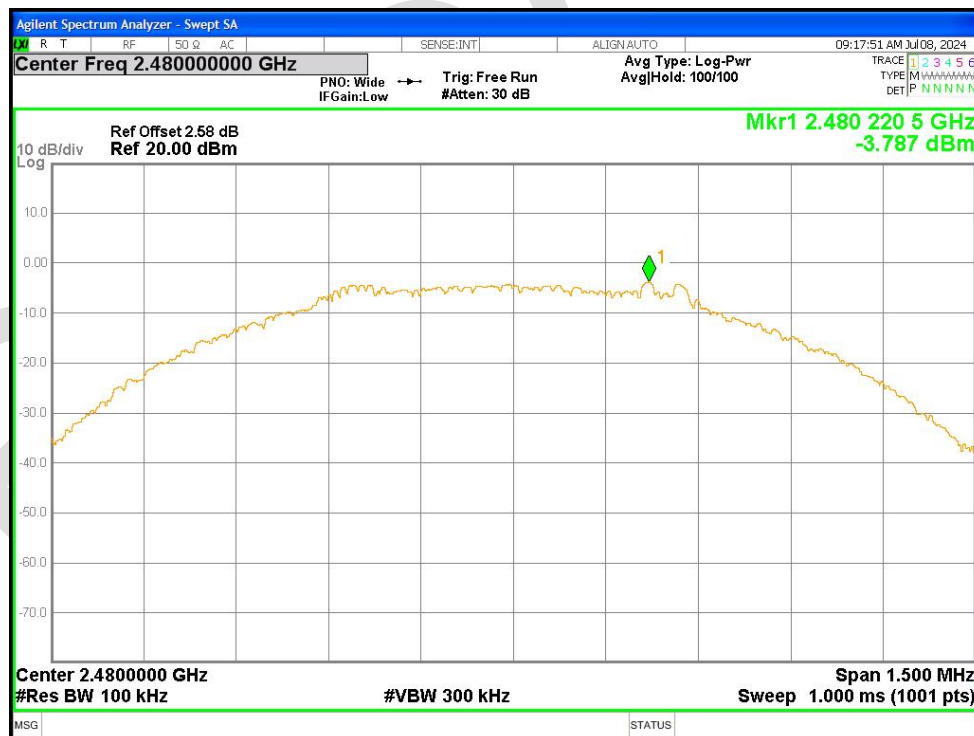
Tx. Spurious NVNT BLE 1M 2480MHz Ant1 Emission

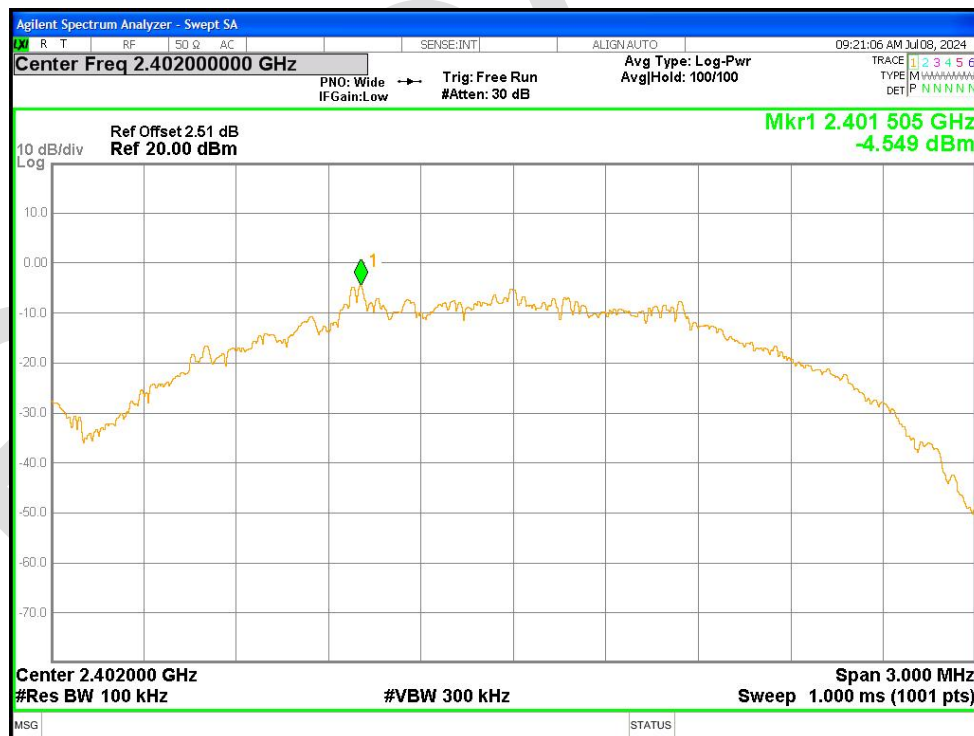
Tx. Spurious NVNT BLE 2M 2402MHz Ant1 Emission

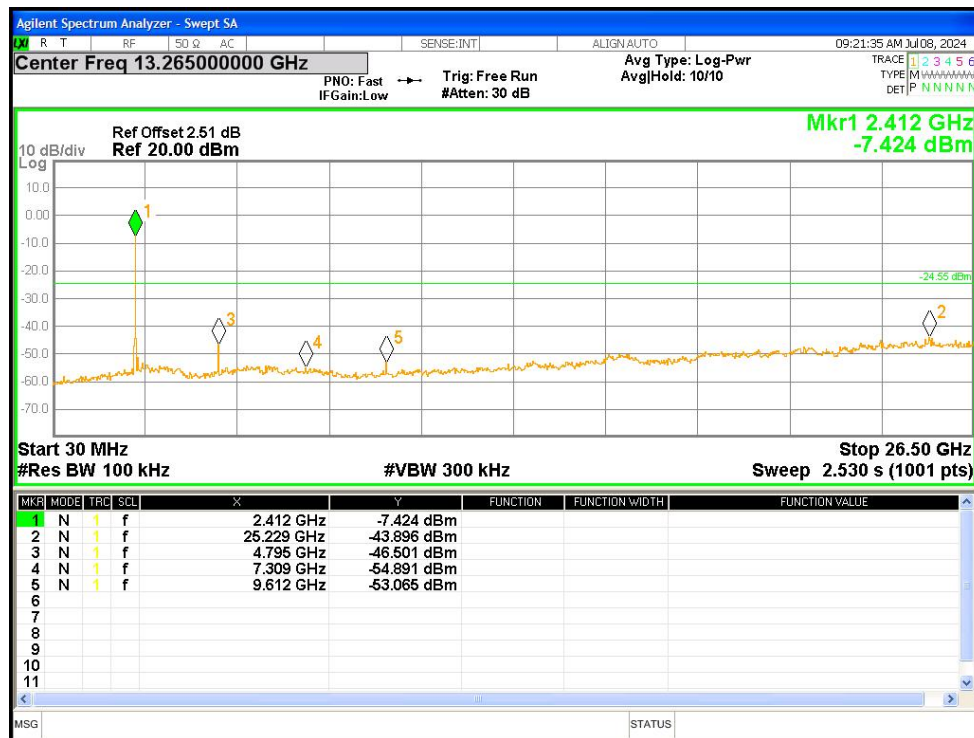
Tx. Spurious NVNT BLE 2M 2442MHz Ant1 Ref

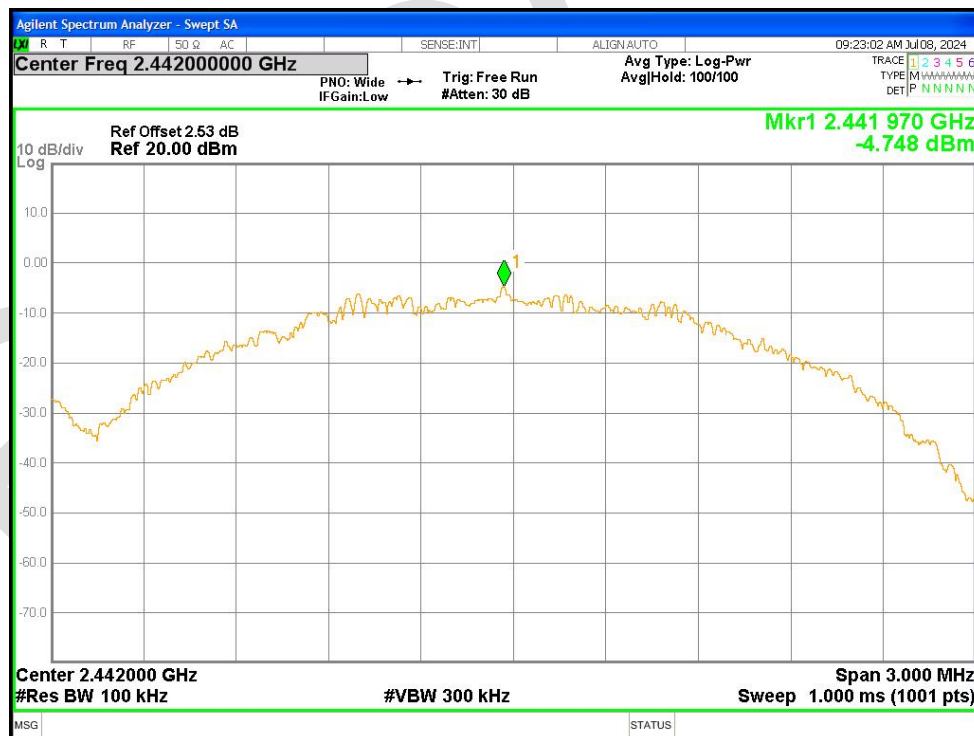
Tx. Spurious NVNT BLE 2M 2442MHz Ant1 Emission

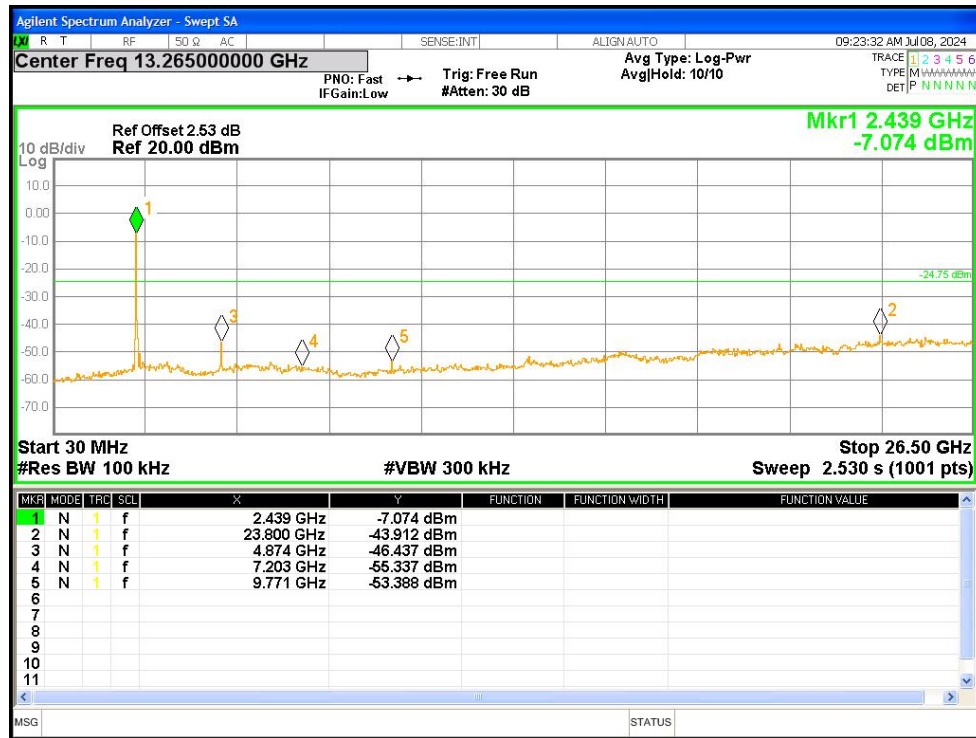
Tx. Spurious NVNT BLE 2M 2480MHz Ant1 Ref

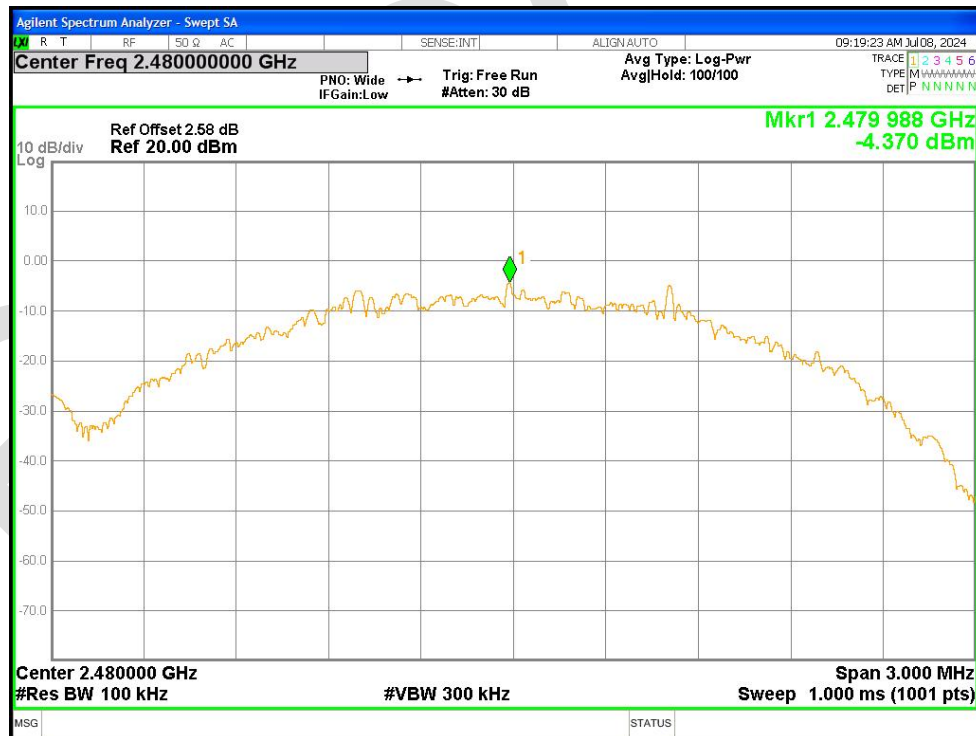
Tx. Spurious NVNT BLE 2M 2480MHz Ant1 Emission

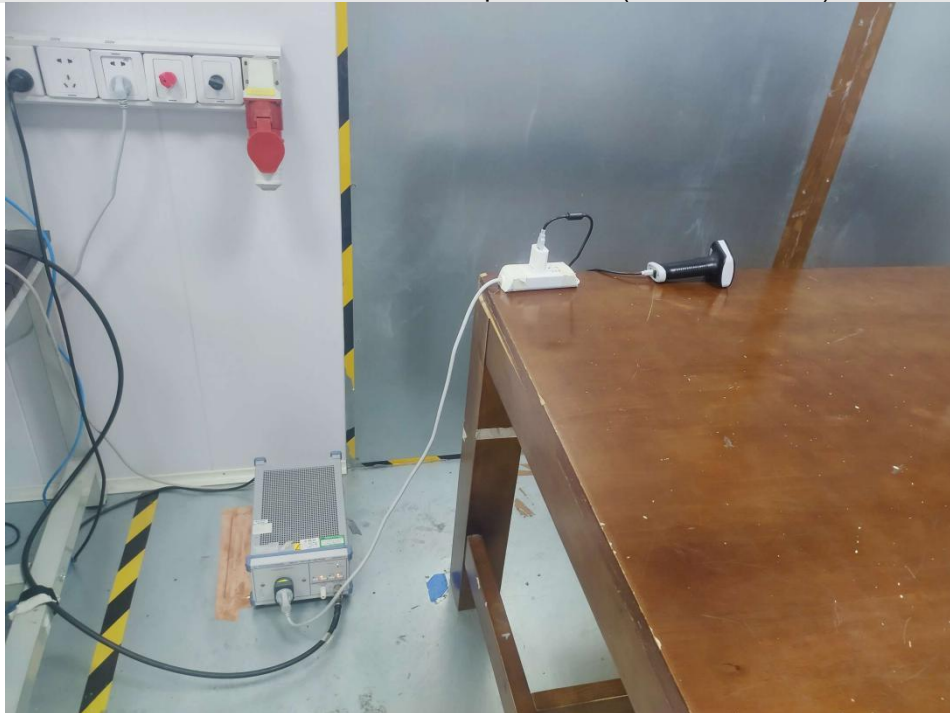
### Conducted emissions at AC power line (150kHz-30MHz)

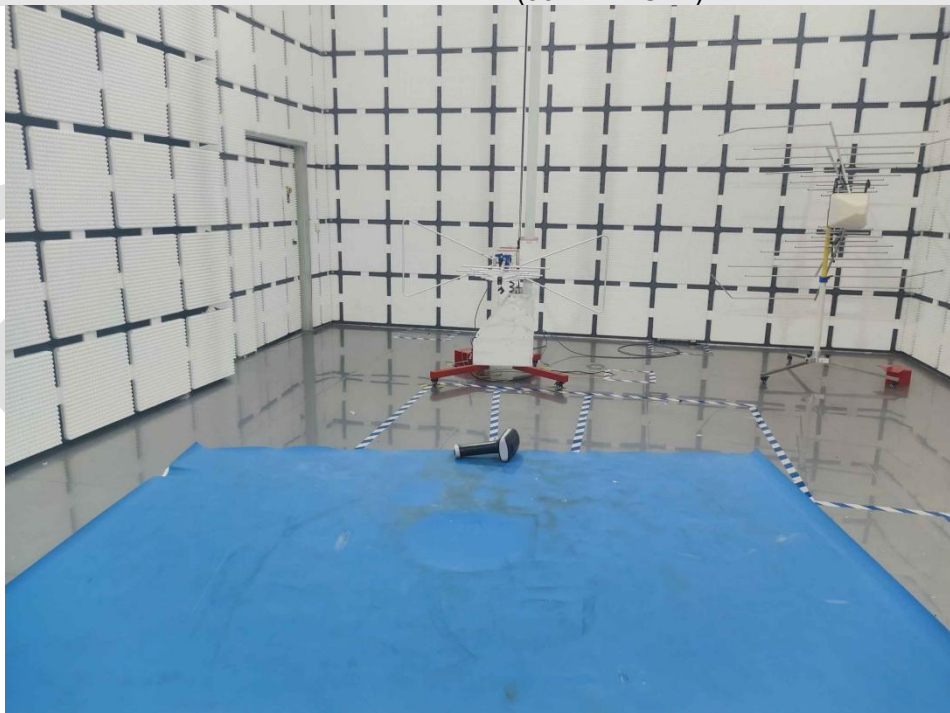
## Radiated Emissions (30MHz-1GHz)

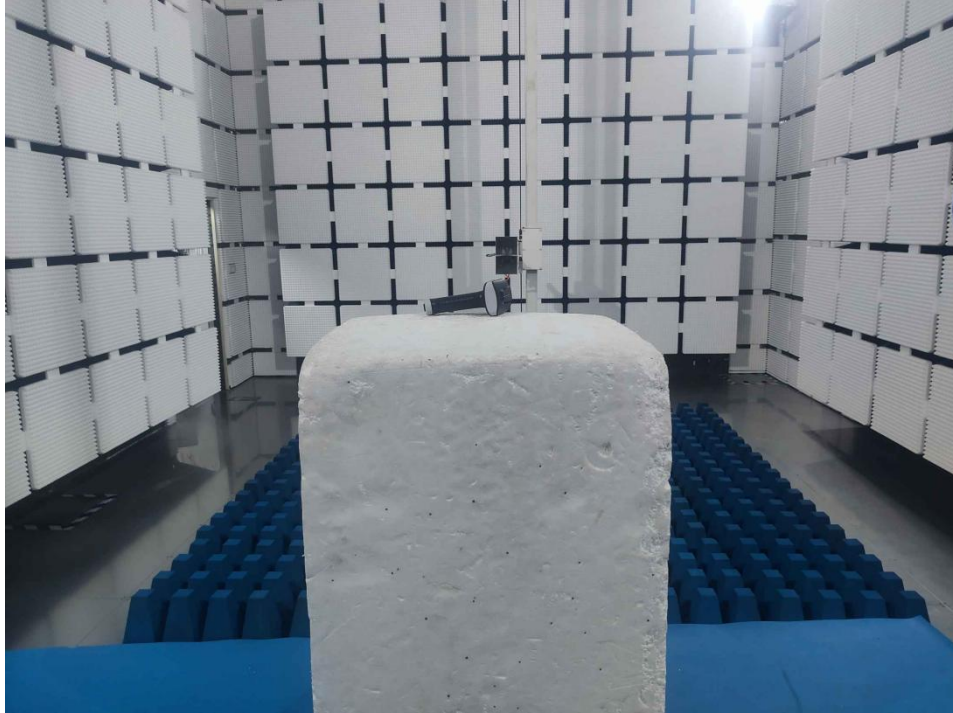
Radiated Emissions (above 1GHz)
