## APPENDIX A: PHOTOGRAPHS OF TEST SETUP

Reference to the test report No. BLA-EMC-202306-A2401

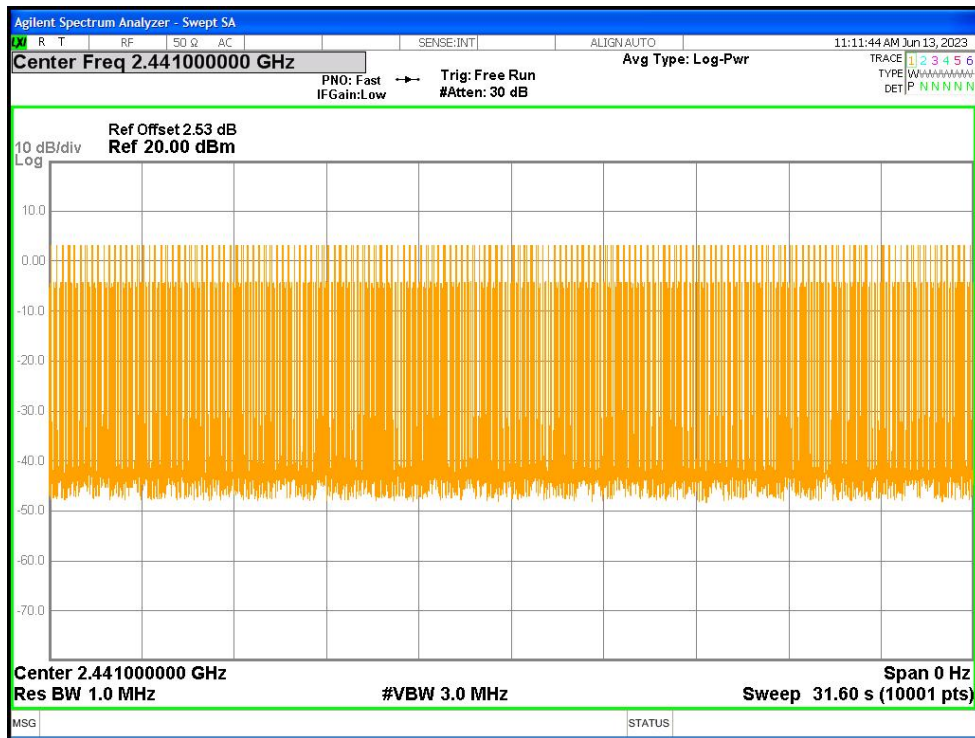
Dwell NVNT 1-DH3 2441MHz Ant1 One Burst

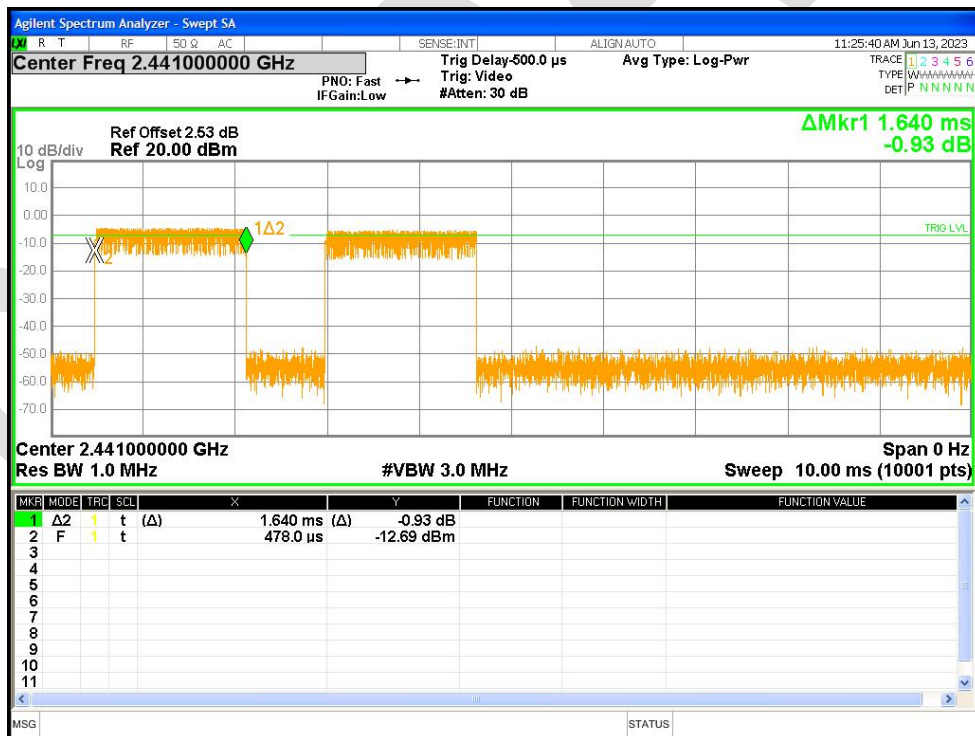
Dwell NVNT 1-DH3 2441MHz Ant1 Accumulated

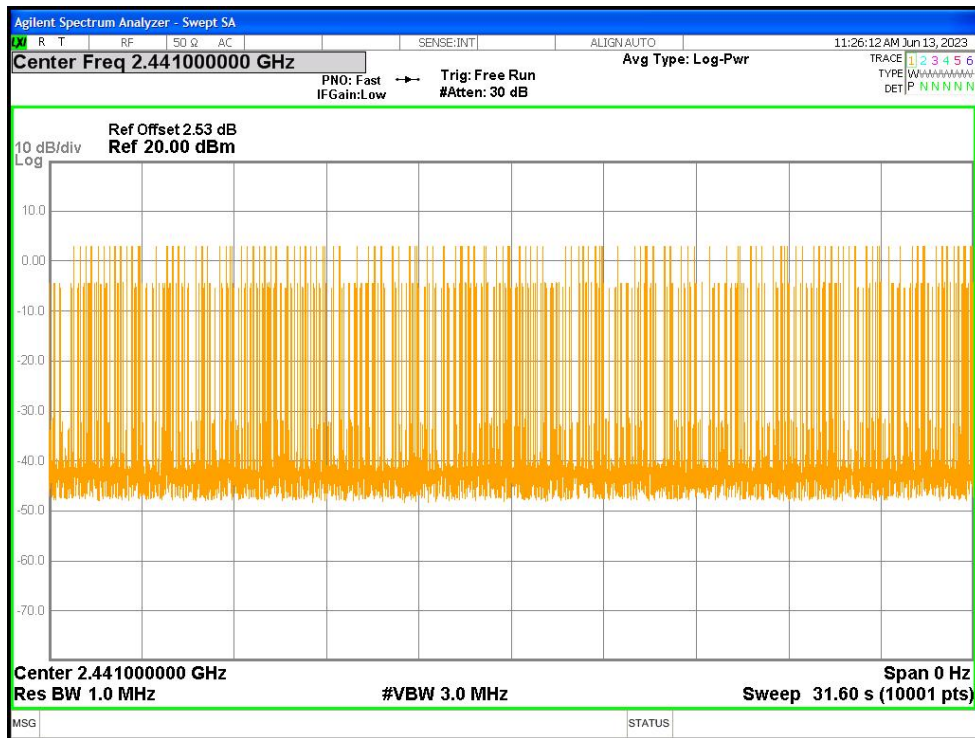
Dwell NVNT 1-DH5 2441MHz Ant1 One Burst

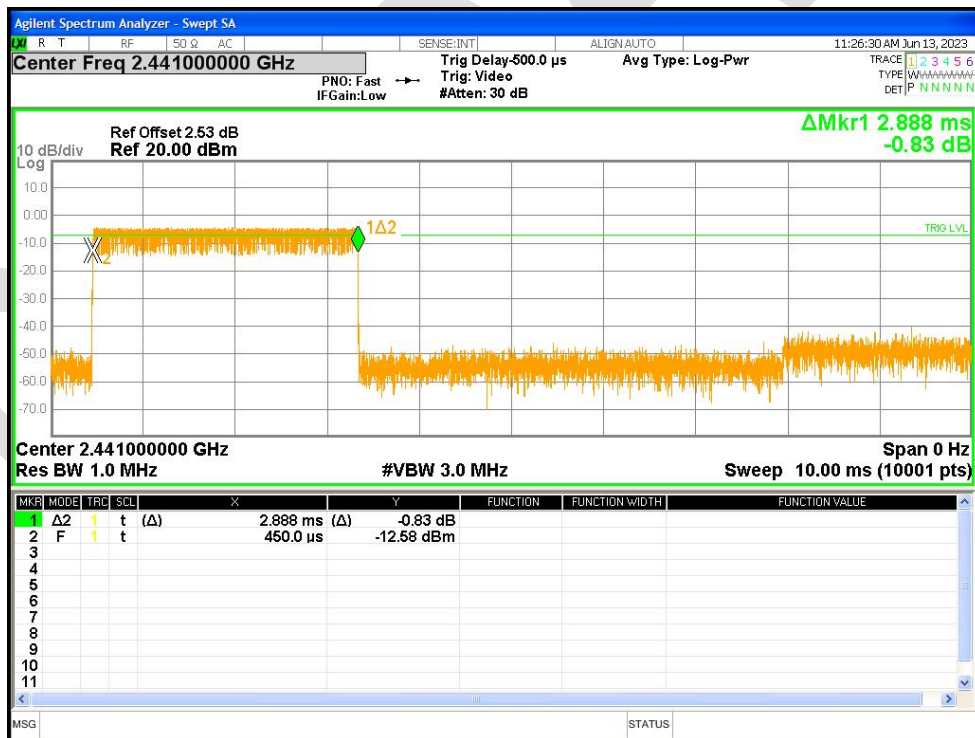
Dwell NVNT 1-DH5 2441MHz Ant1 Accumulated

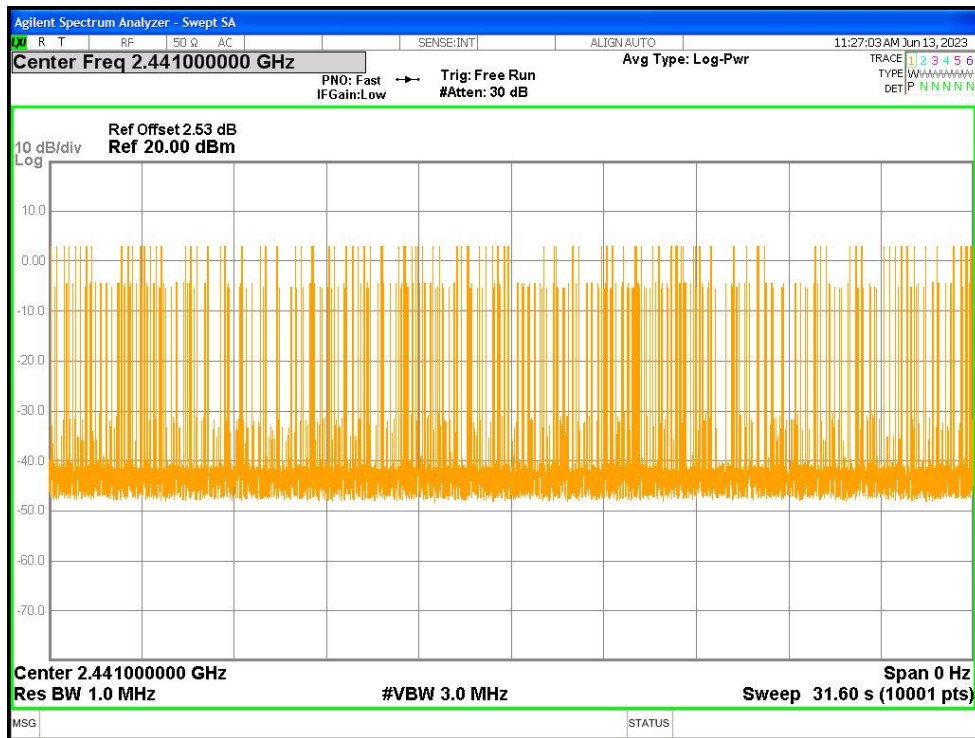
Dwell NVNT 2-DH1 2441MHz Ant1 One Burst

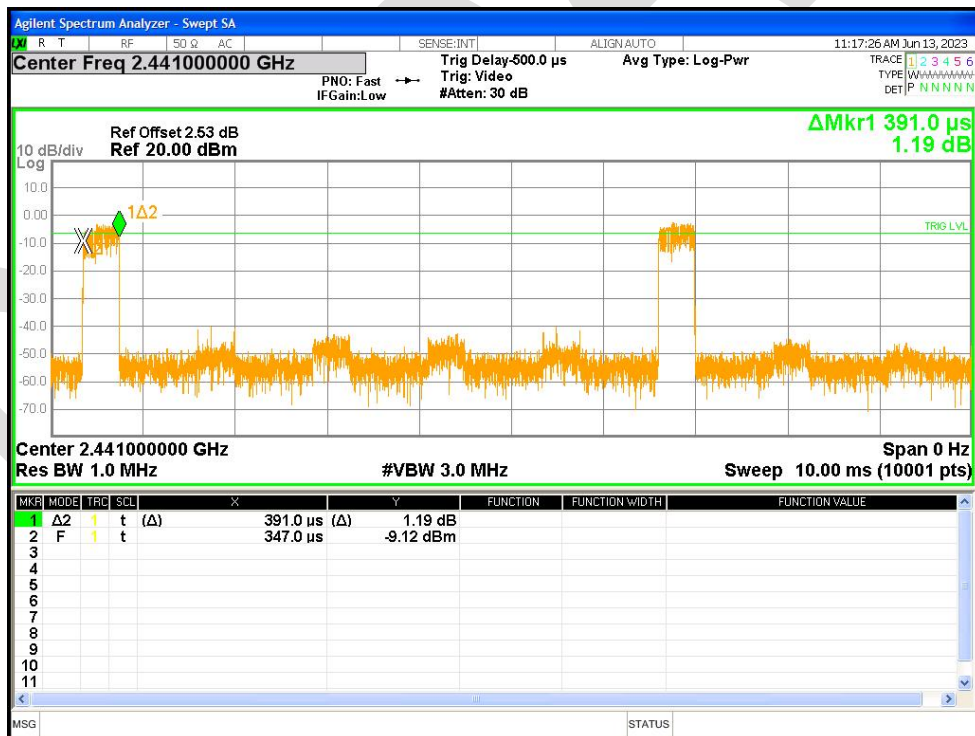
Dwell NVNT 2-DH1 2441MHz Ant1 Accumulated

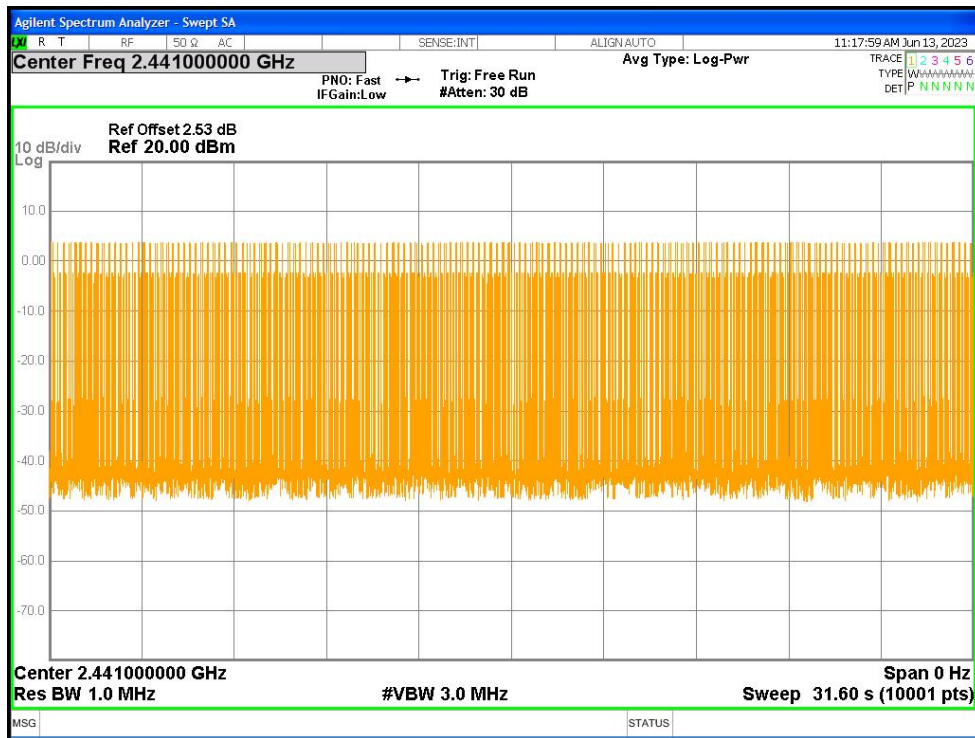
Dwell NVNT 2-DH5 2441MHz Ant1 One Burst

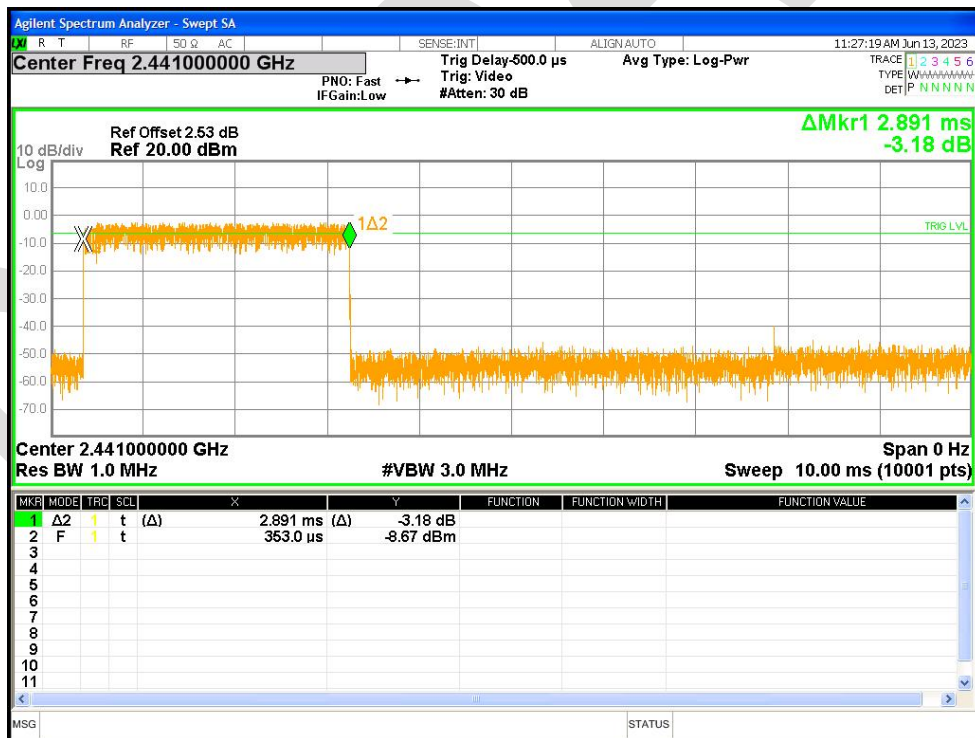
Dwell NVNT 2-DH5 2441MHz Ant1 Accumulated

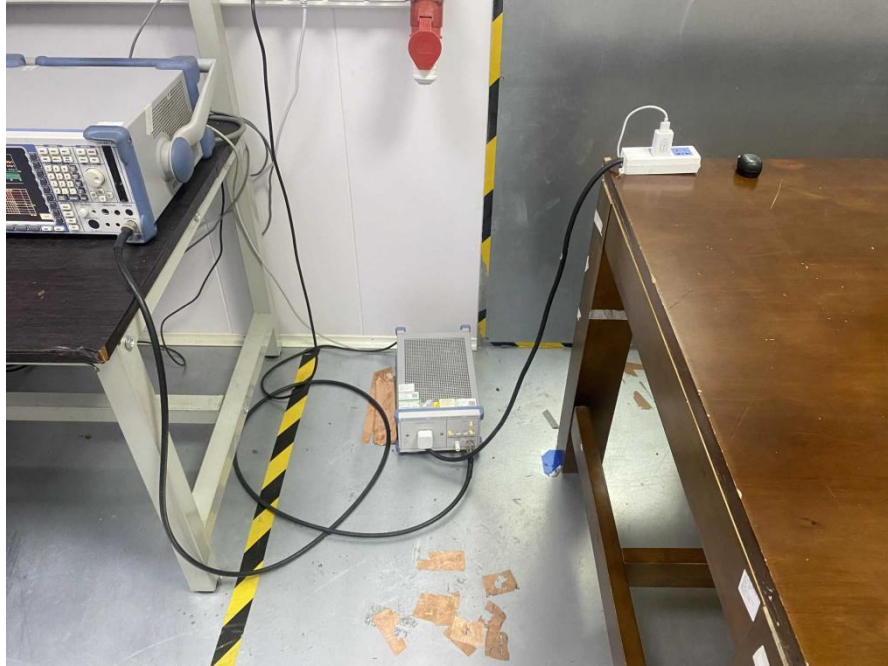
### Conducted Emissions at AC Power Line (150kHz-30MHz)

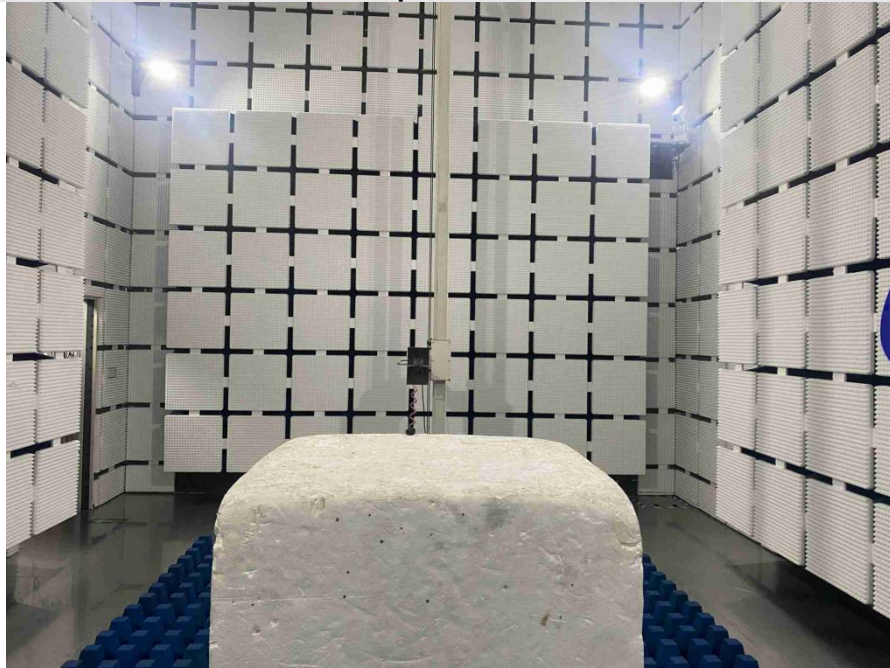
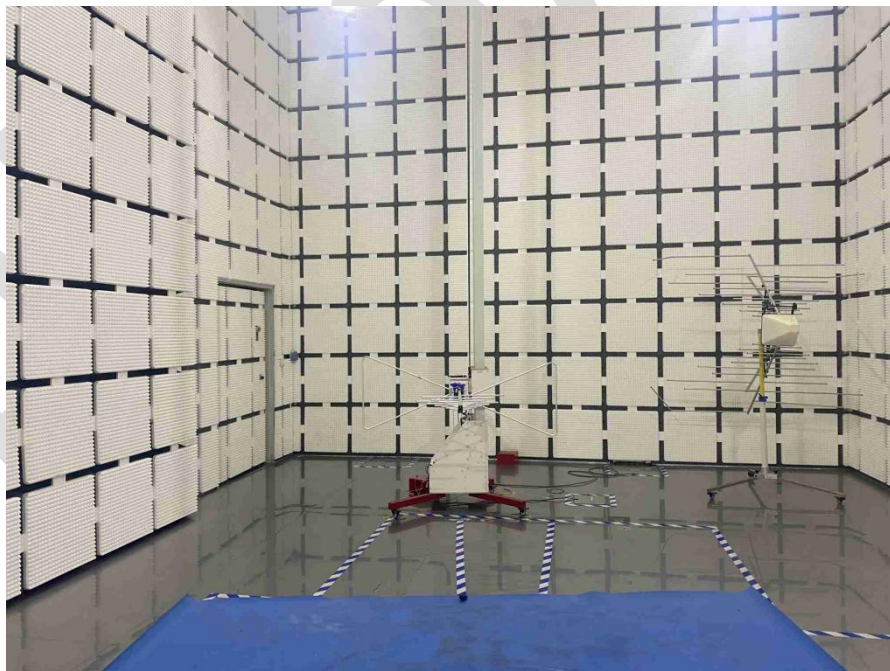
### Radiated Spurious Emissions
