# Appendix F: Reference level measurement Test Result

## Appendix G: Band edge measurements

## Appendix H: Conducted Spurious Emission Test Result

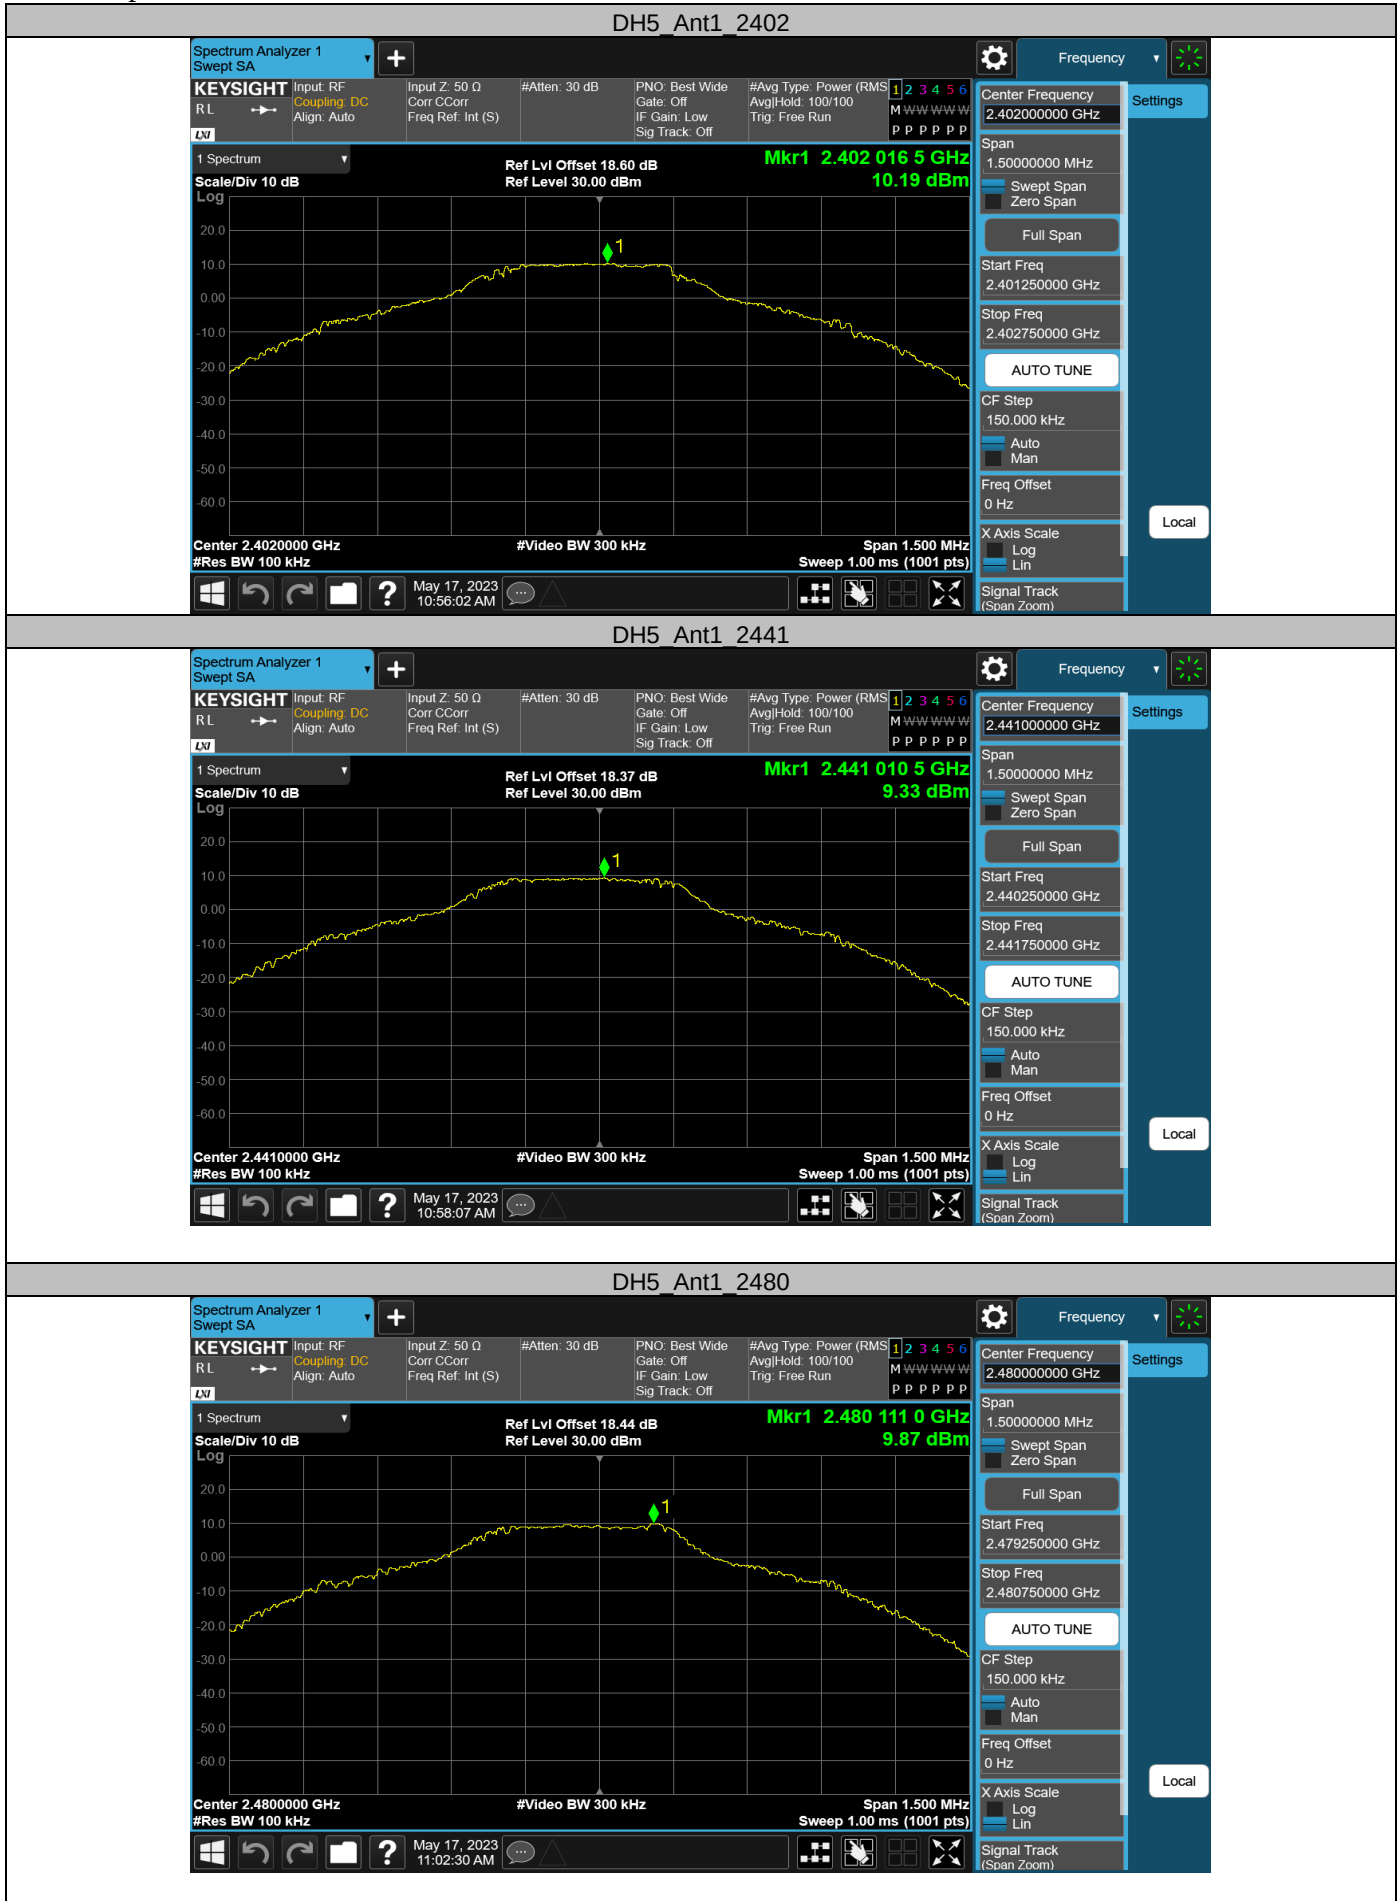
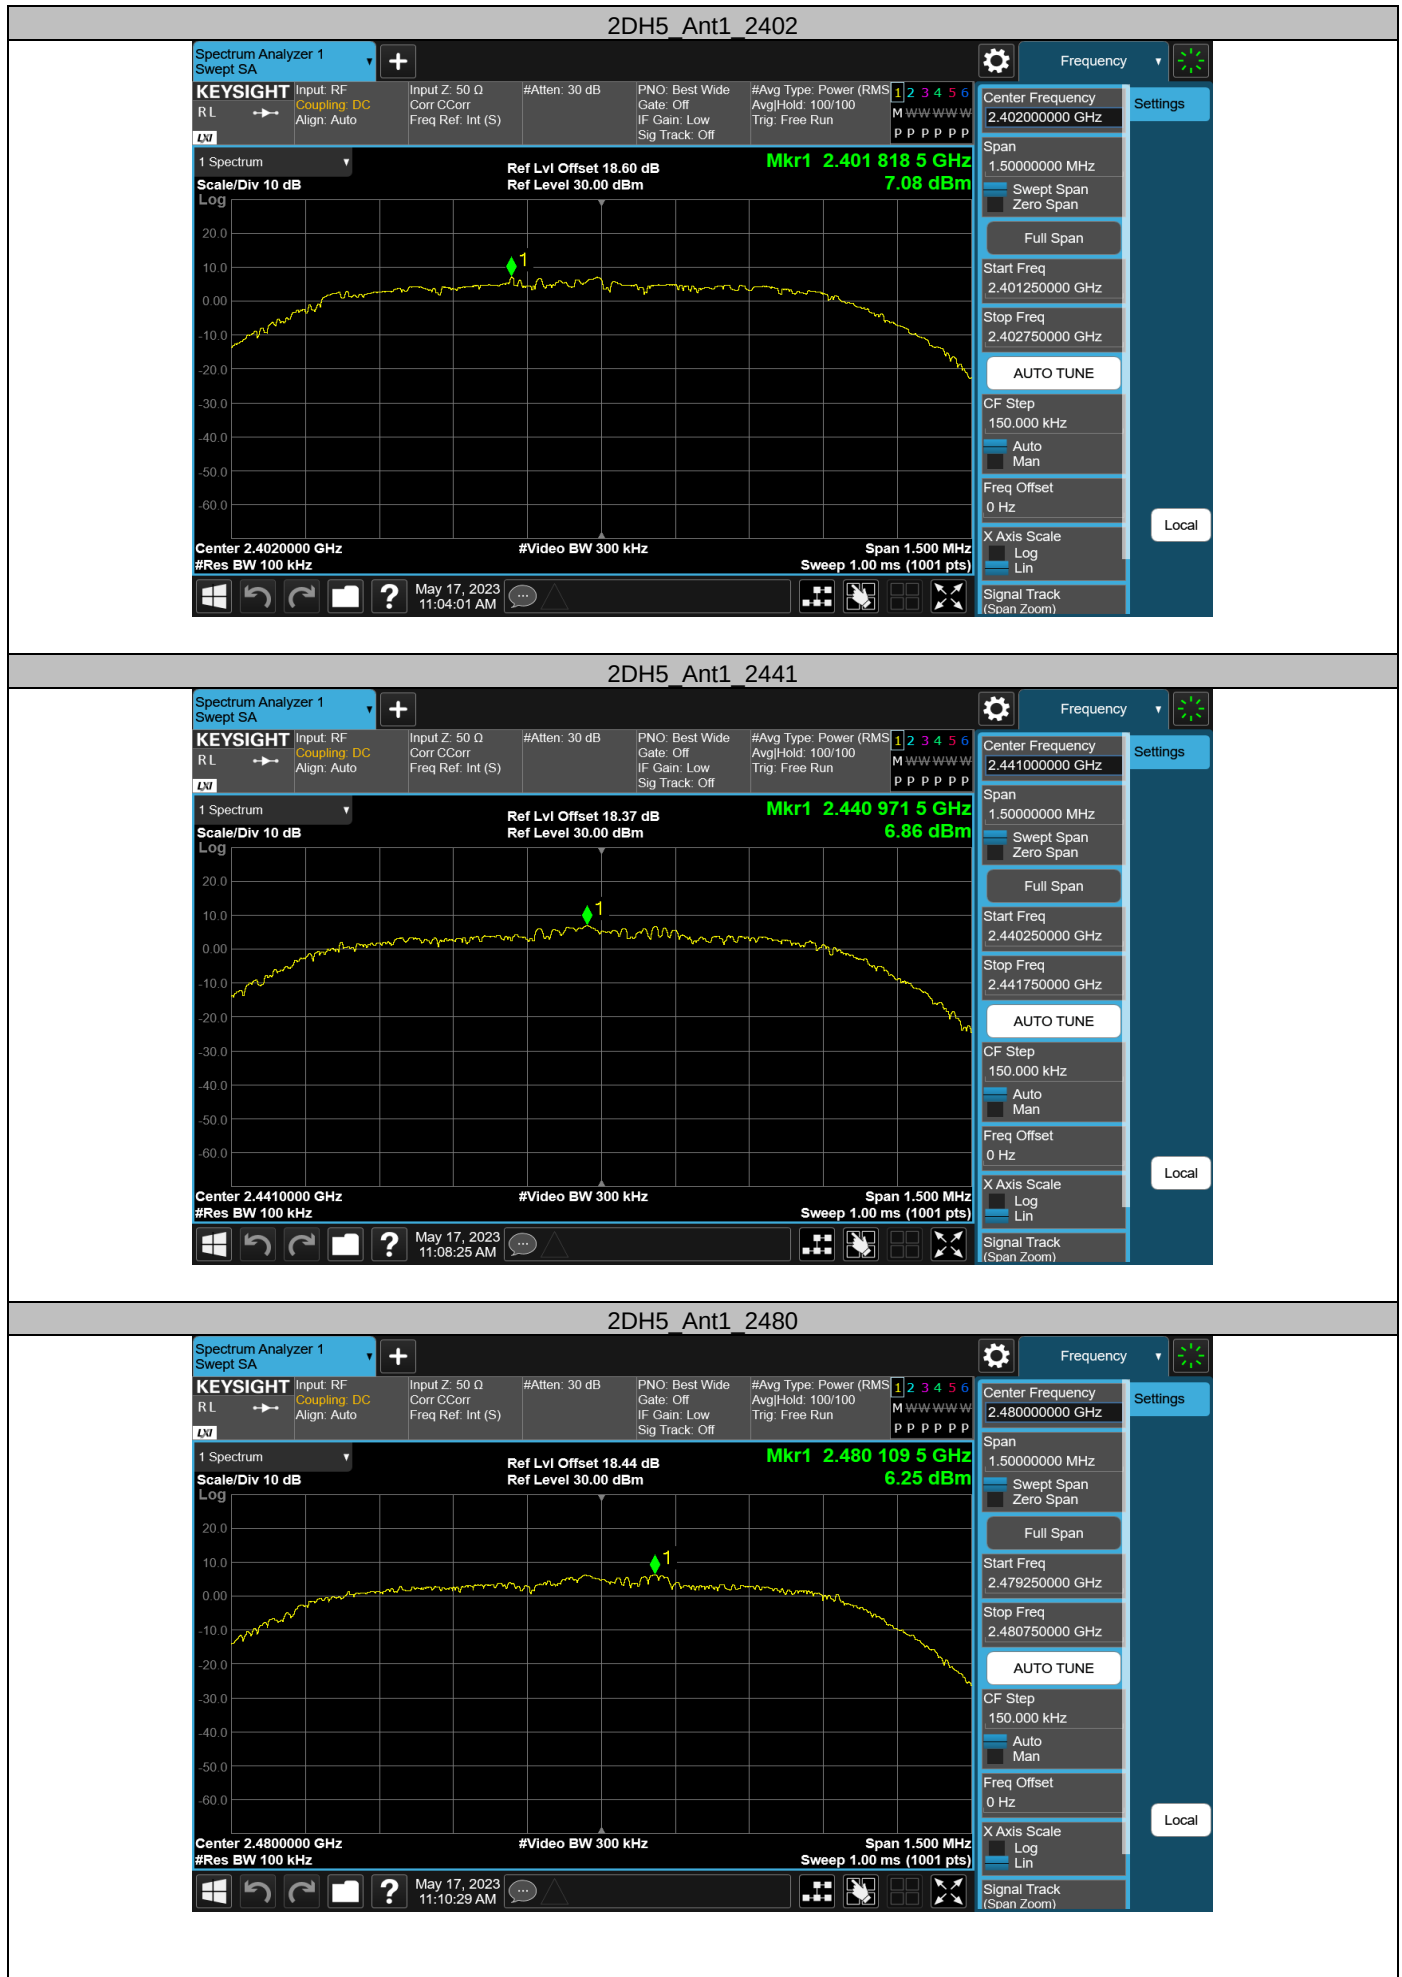
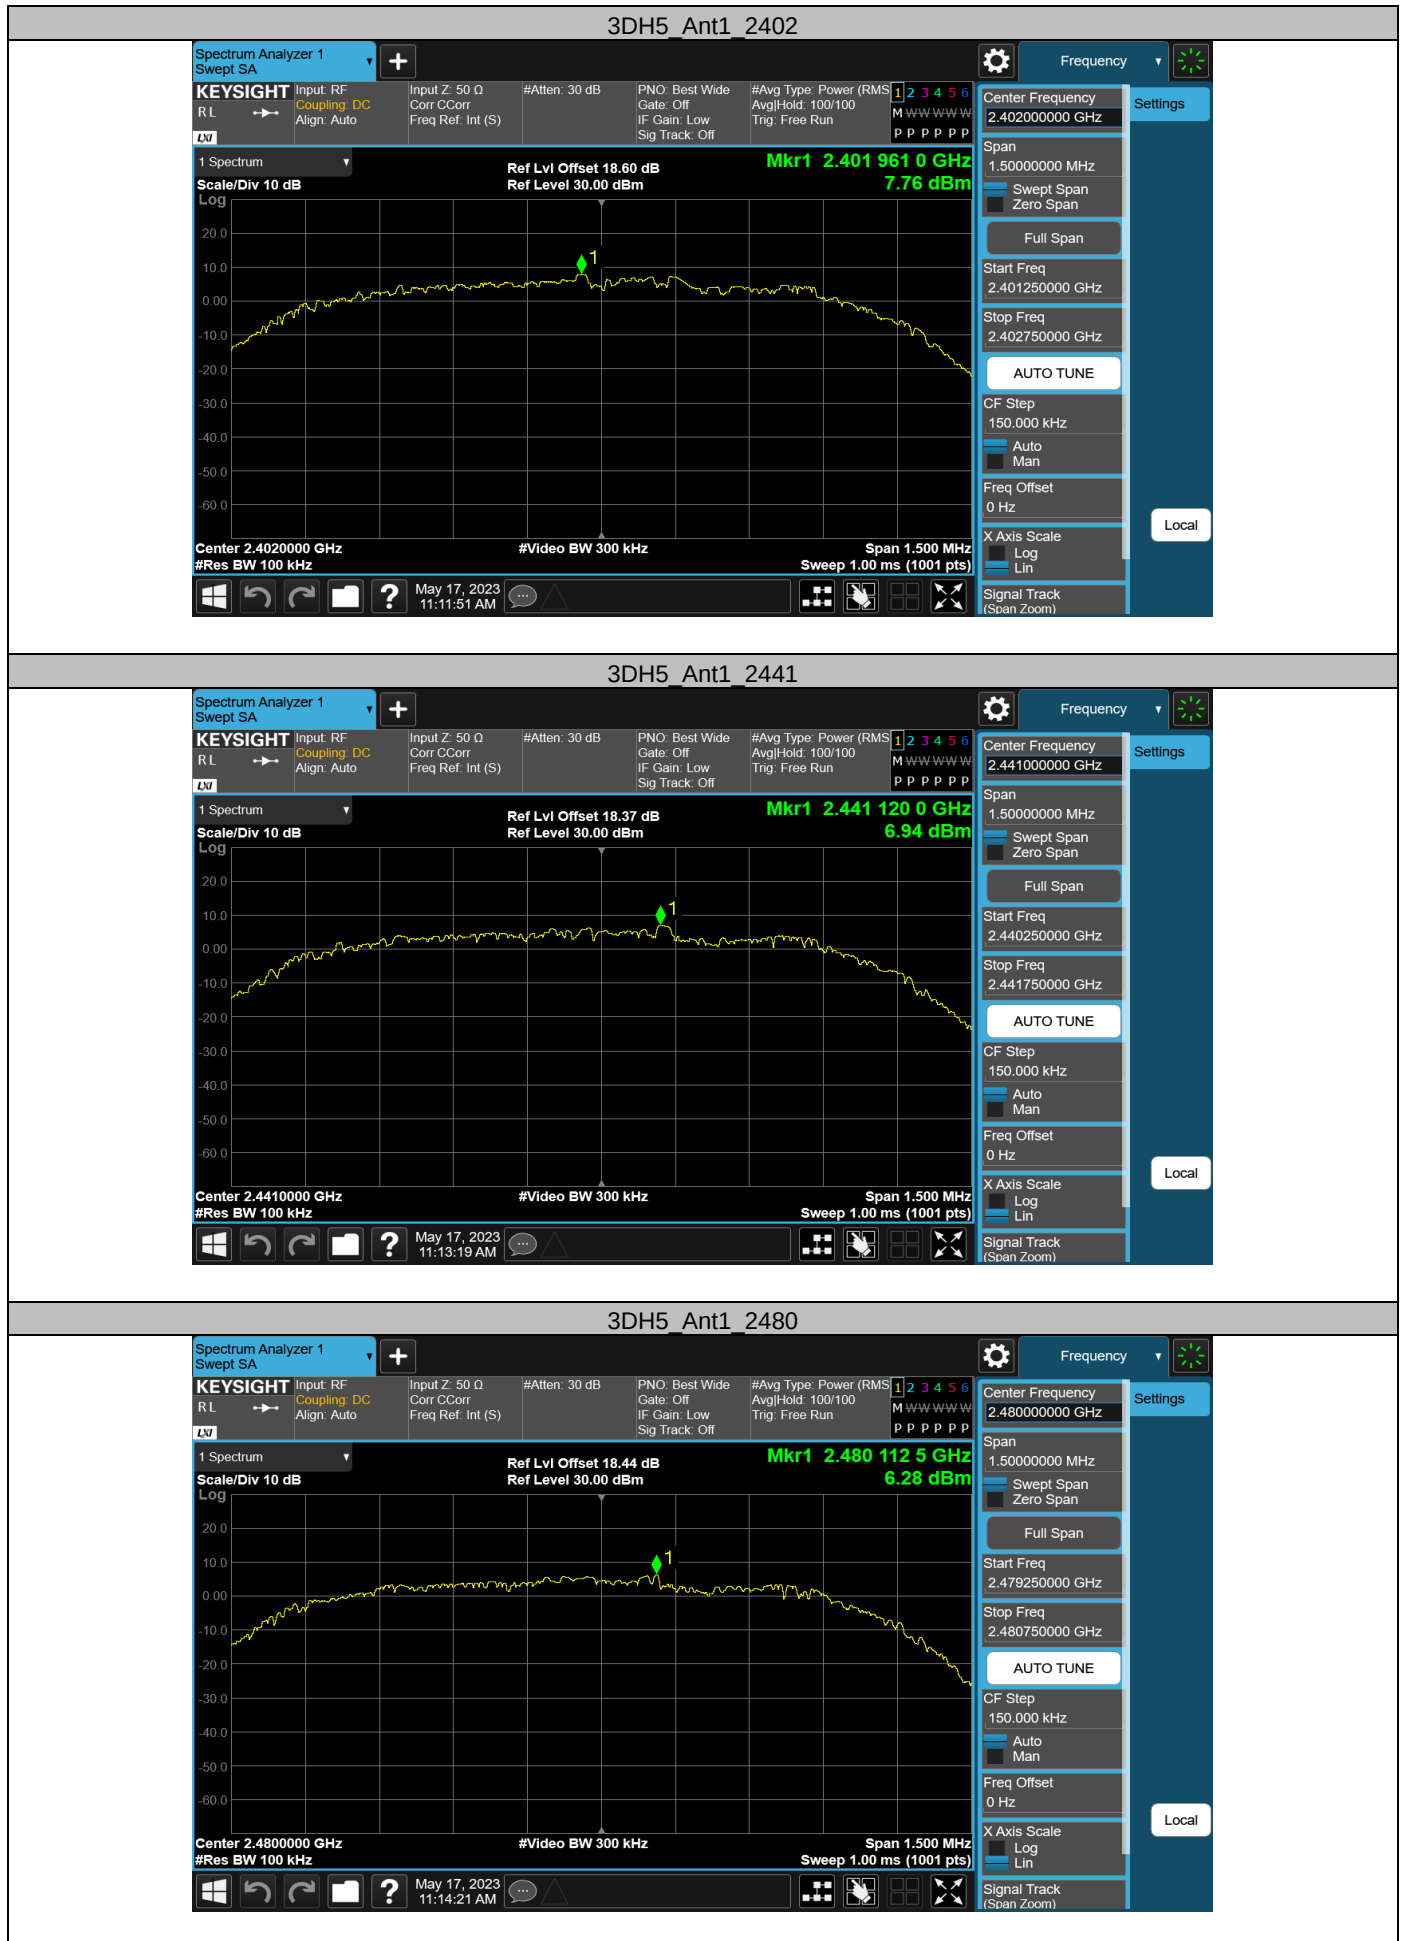
## Test Graphs

| Test Mode | Antenna | Freq(MHz) | Max.Point[MHz] | Result[dBm] |
| DH5 | Ant1 | 2402 | 2402.02 | 10.19 |
| | | 2441 | 2441.01 | 9.33 |
| | | 2480 | 2480.11 | 9.87 |
| 2DH5 | Ant1 | 2402 | 2401.82 | 7.08 |
| | | 2441 | 2440.97 | 6.86 |
| | | 2480 | 2480.11 | 6.25 |
| 3DH5 | Ant1 | 2402 | 2401.96 | 7.76 |
| | | 2441 | 2441.12 | 6.94 |
| | | 2480 | 2480.11 | 6.28 |

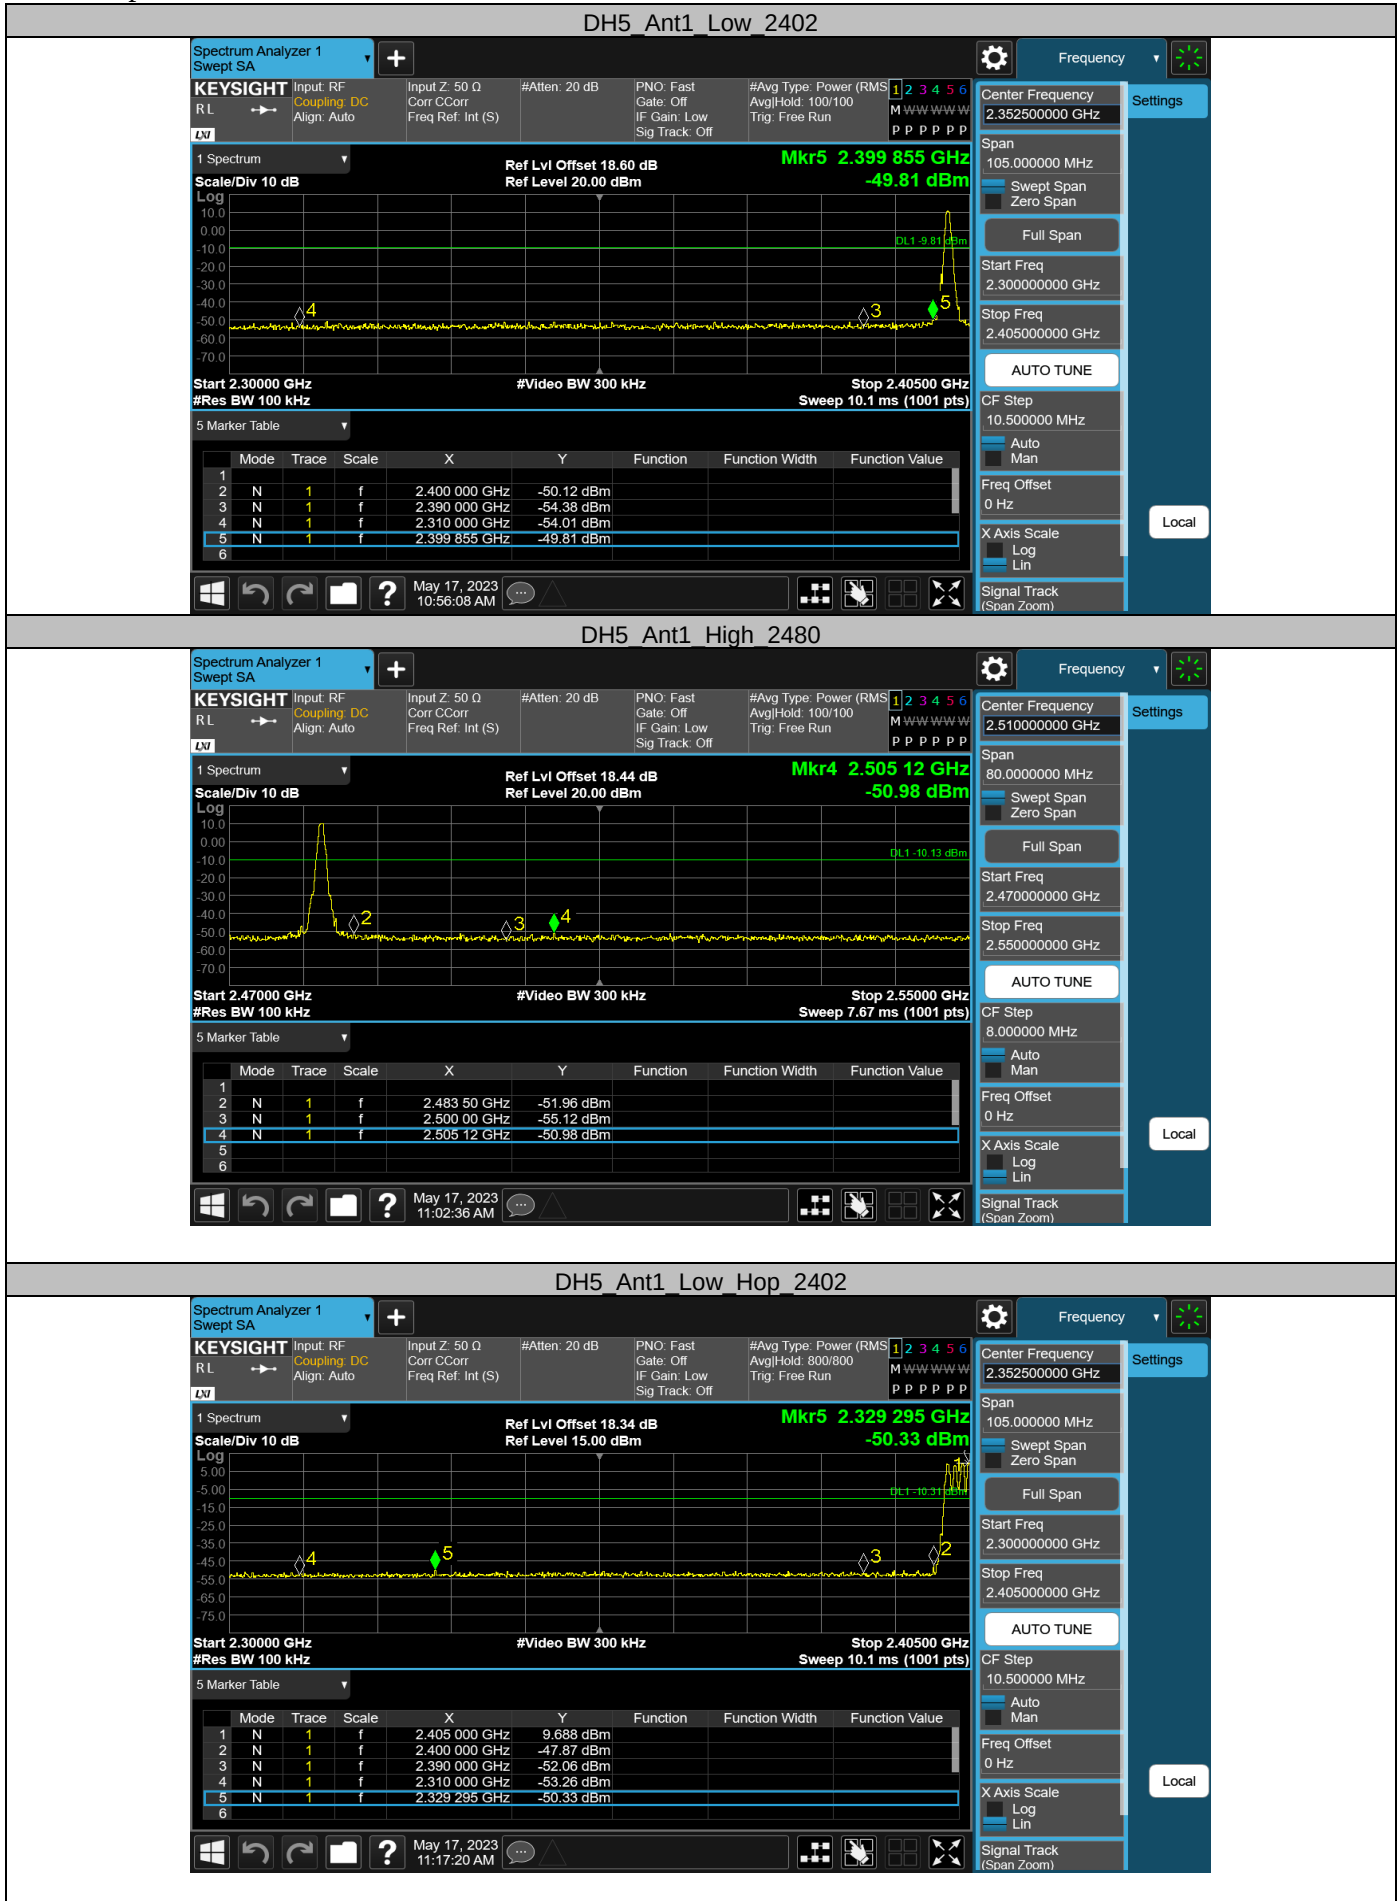
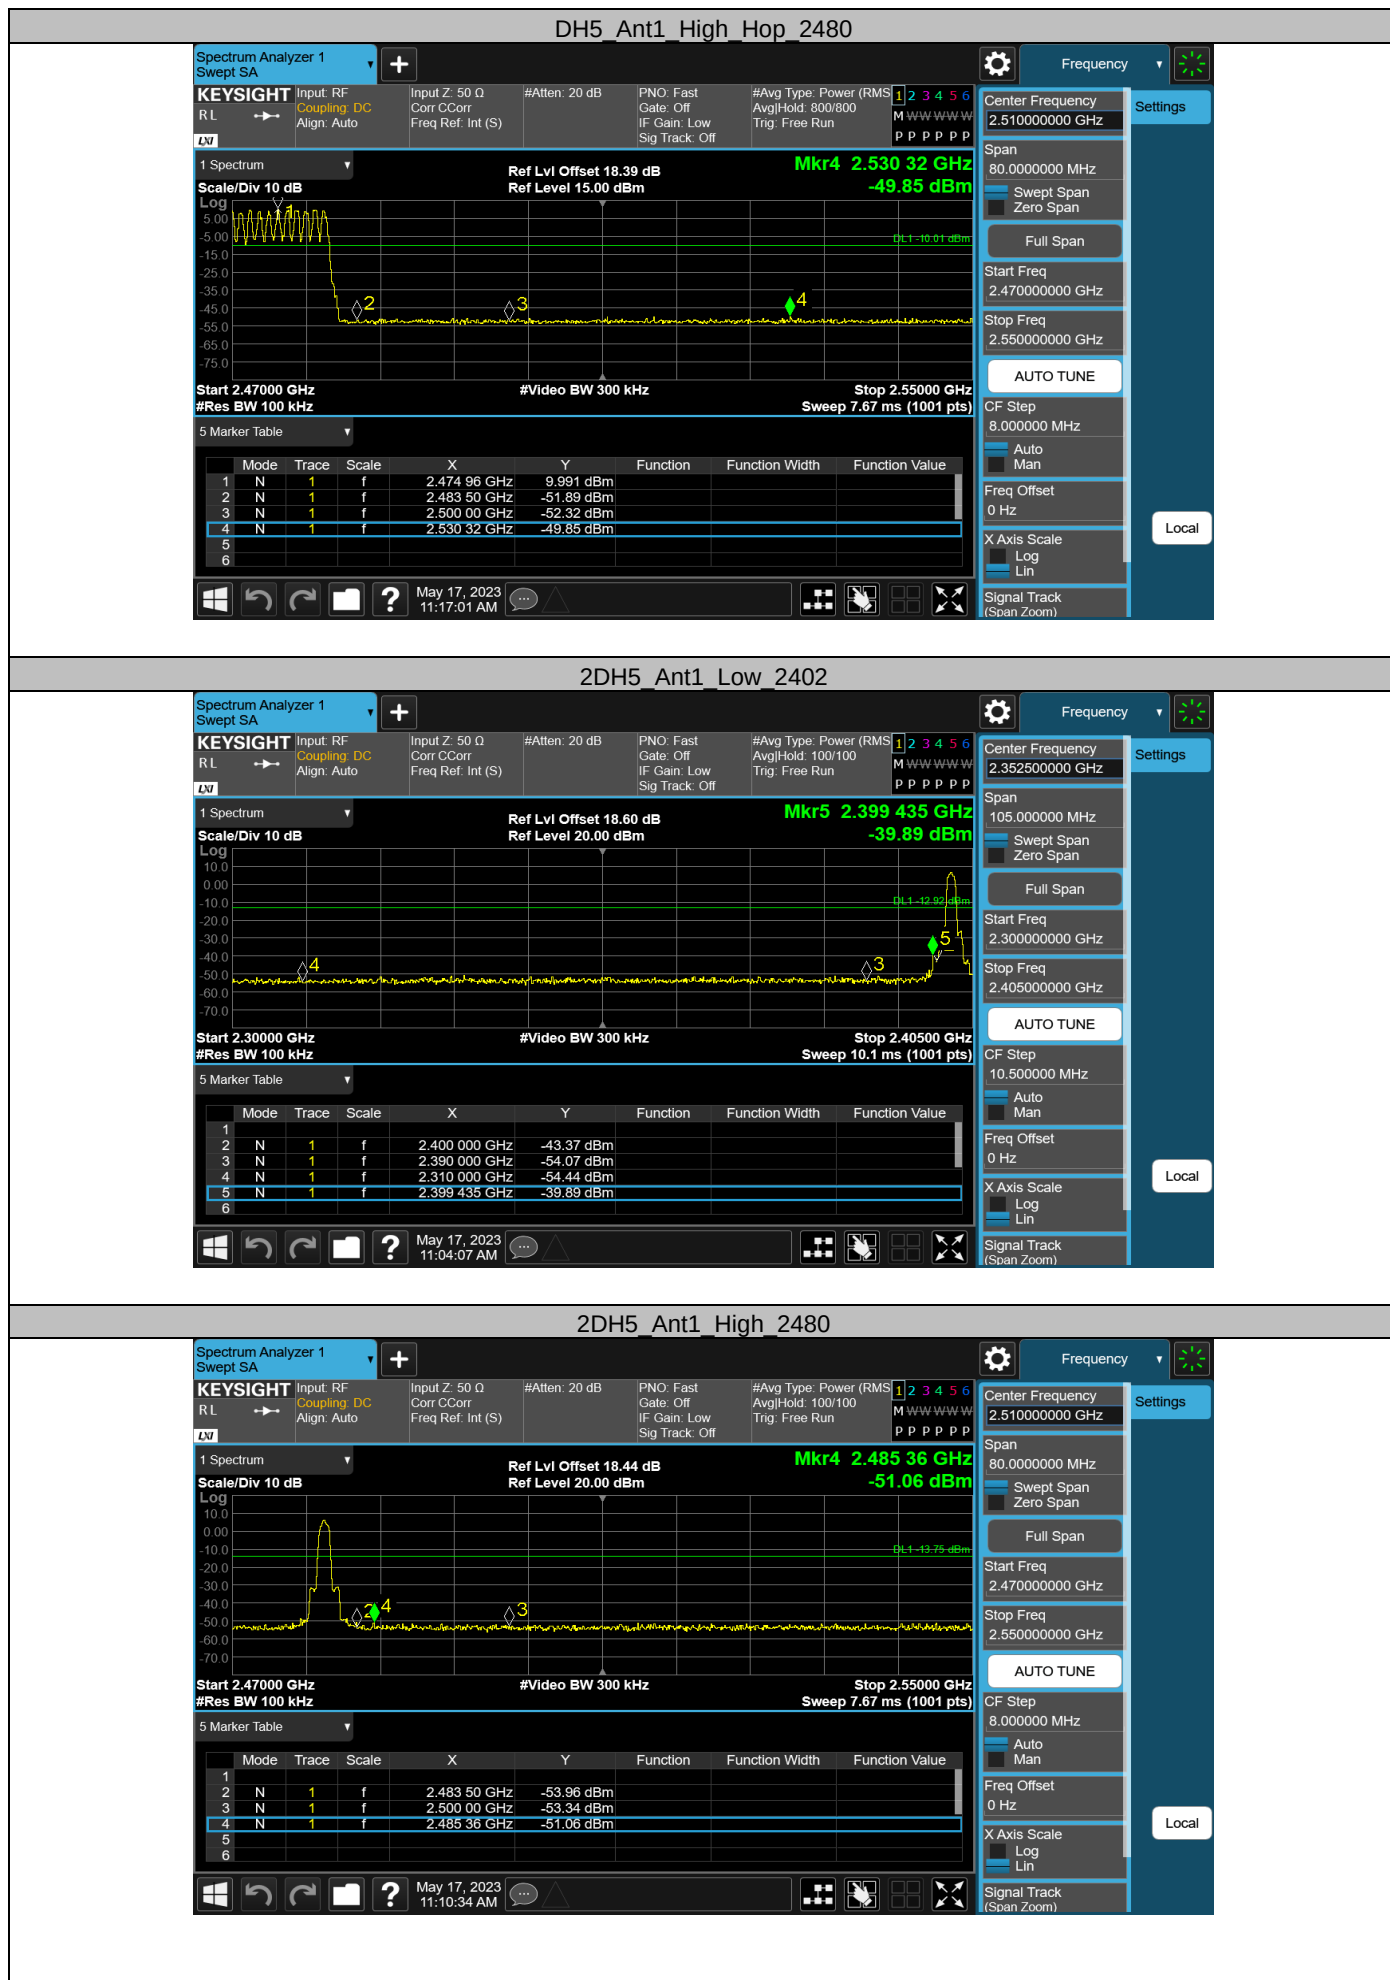
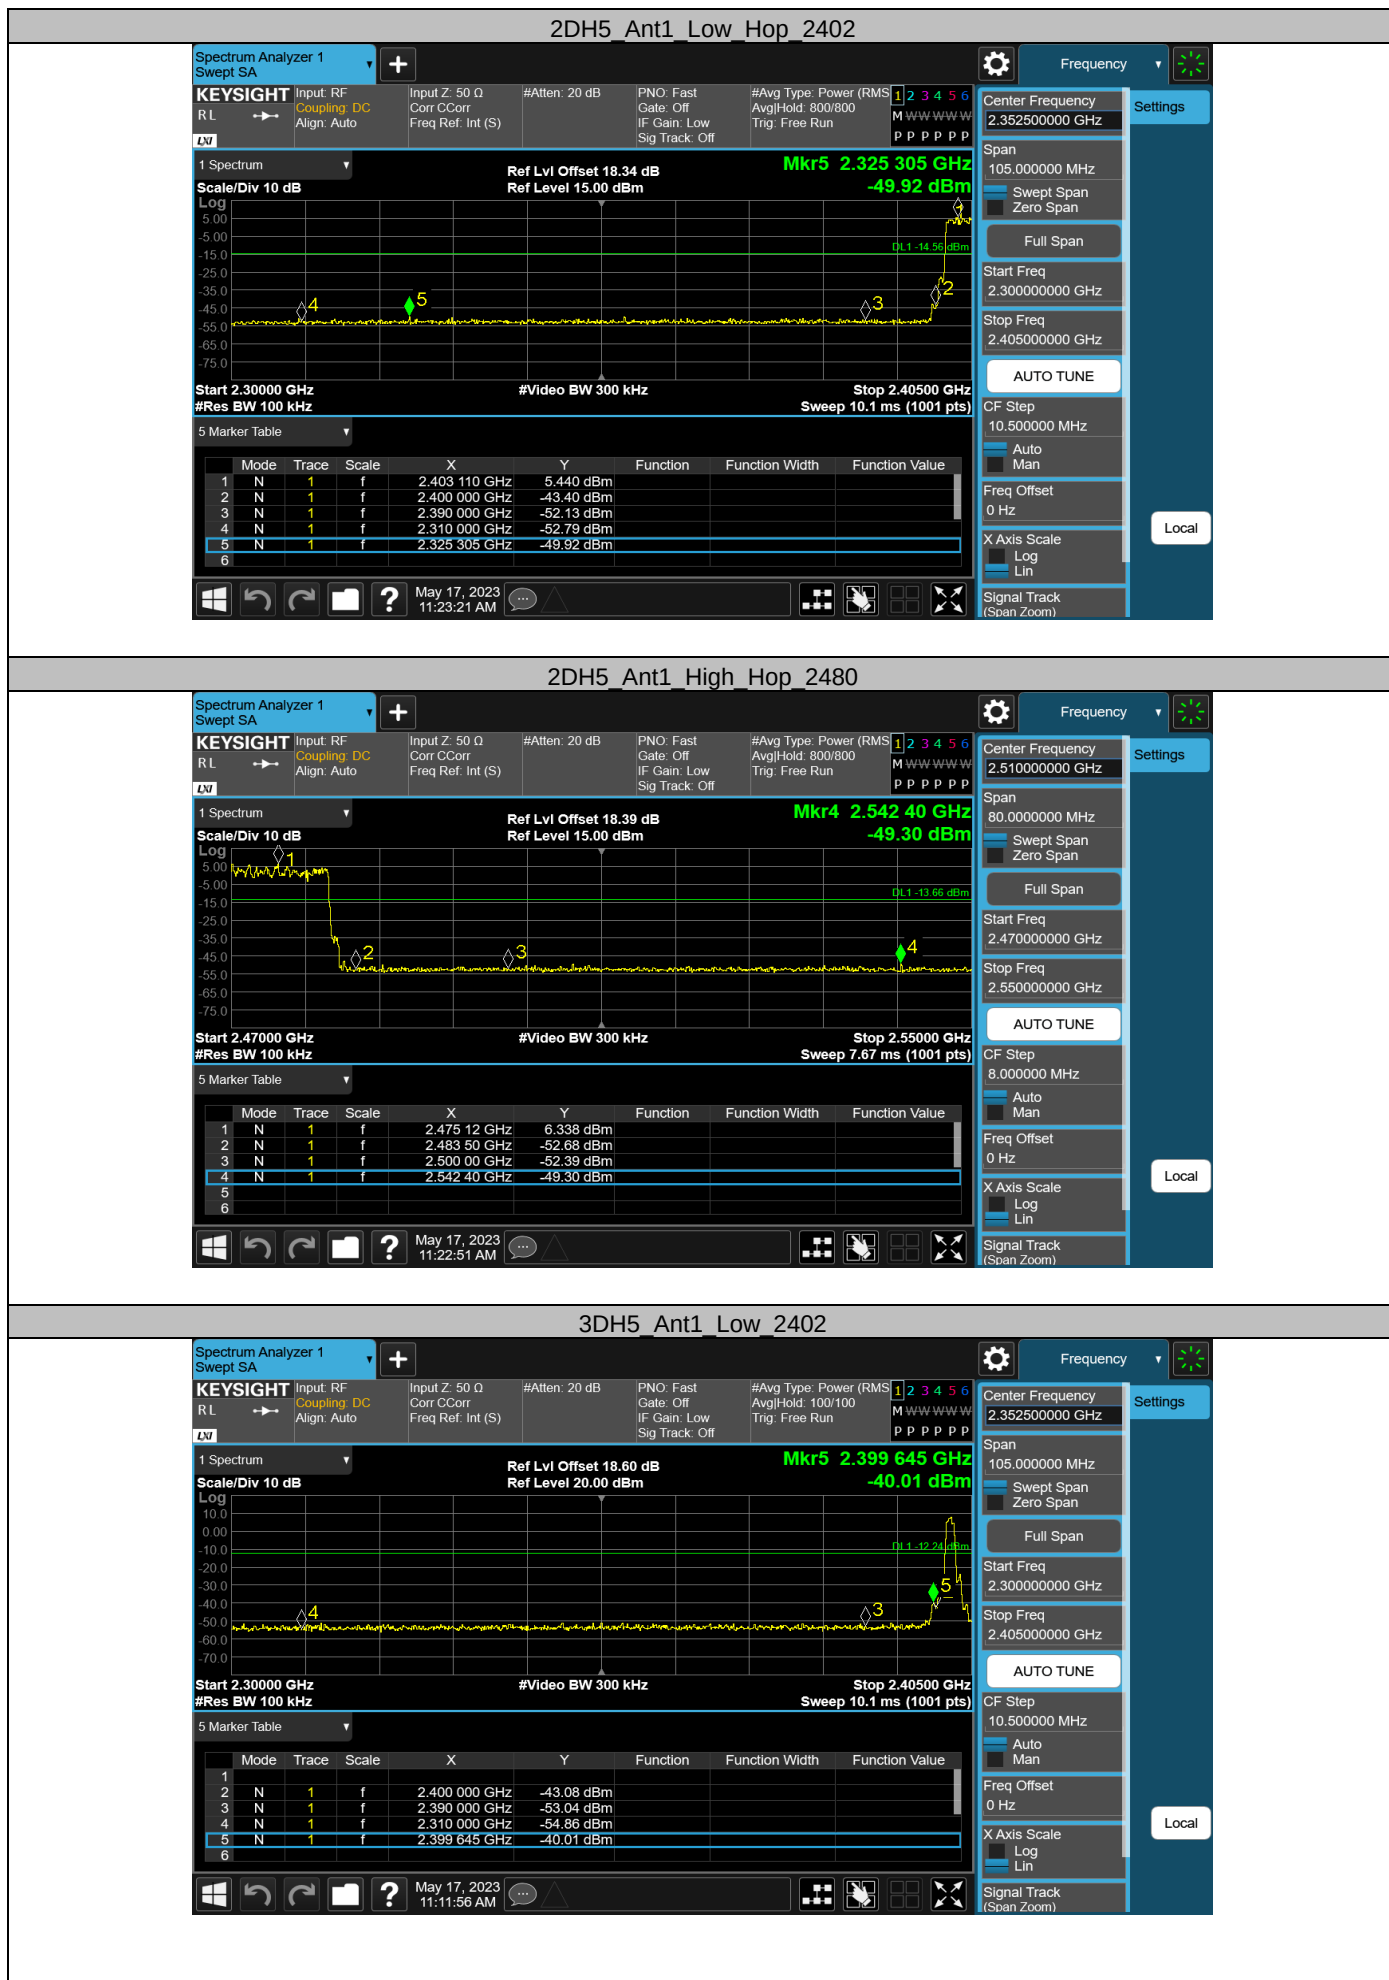
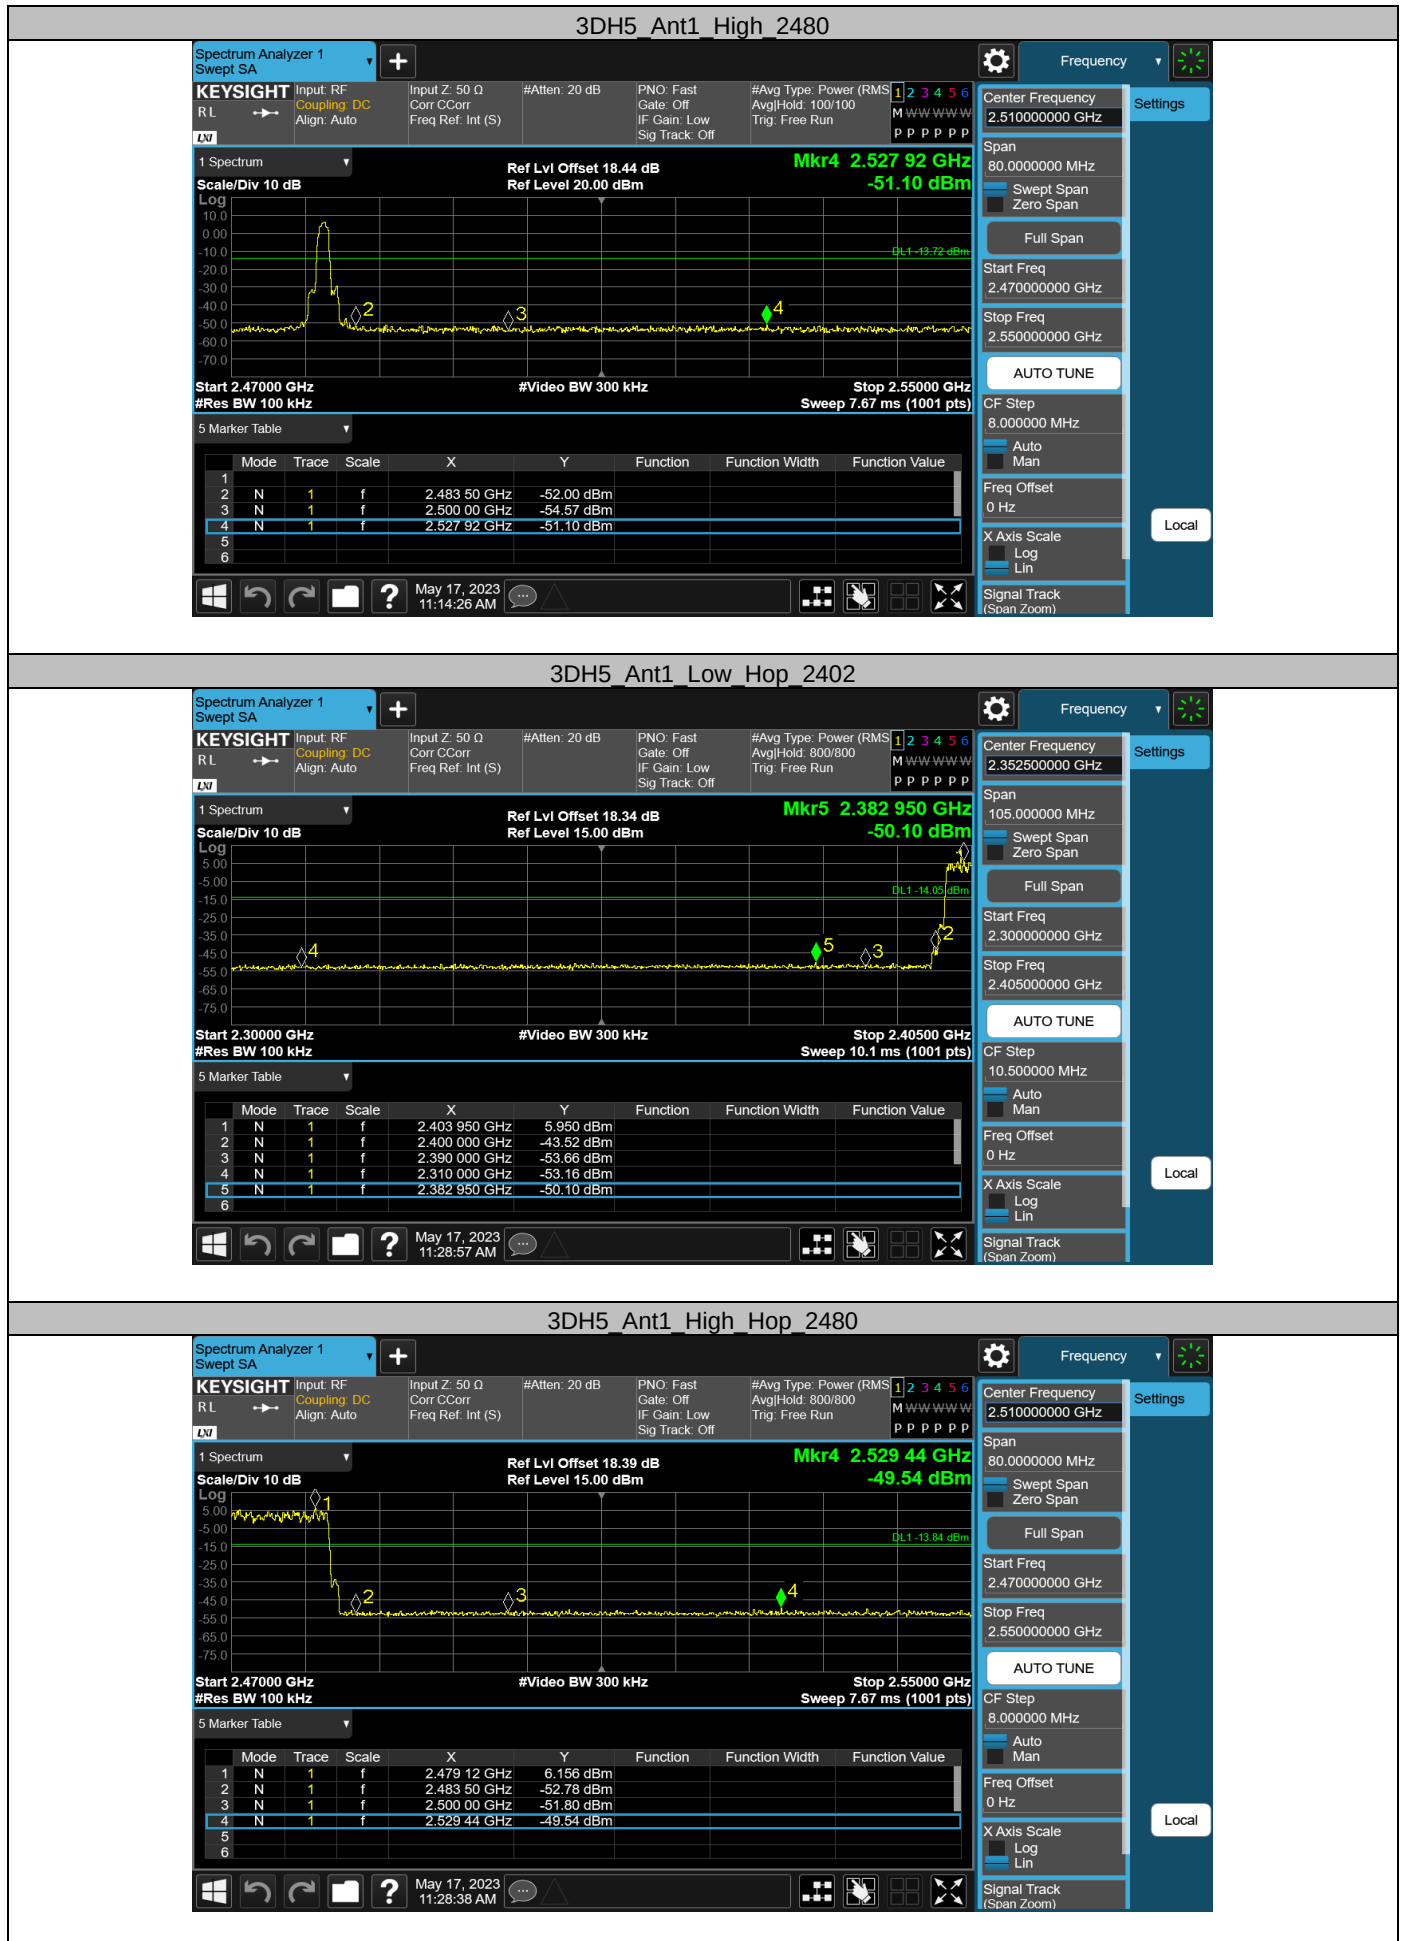
## Test Graphs

| Test Mode | Antenna | Ch Name | Freq(MHz) | Ref Level [dBm] | Result [dBm] | Limit [dBm] | Verdict |
| DH5 | Ant1 | Low | 2402 | 10.19 | -49.81 | $\leq -9.81$ | PASS |
| | | High | 2480 | 9.87 | -50.98 | $\leq -10.13$ | PASS |
| | | Low | Hop_2402 | 9.69 | -50.33 | $\leq -10.31$ | PASS |
| | | High | Hop_2480 | 9.99 | -49.85 | $\leq -10.01$ | PASS |
| 2DH5 | Ant1 | Low | 2402 | 7.08 | -39.89 | $\leq -12.92$ | PASS |
| | | High | 2480 | 6.25 | -51.06 | $\leq -13.75$ | PASS |
| | | Low | Hop_2402 | 5.44 | -49.92 | $\leq -14.56$ | PASS |
| | | High | Hop_2480 | 6.34 | -49.3 | $\leq -13.66$ | PASS |
| 3DH5 | Ant1 | Low | 2402 | 7.76 | -40.01 | $\leq -12.24$ | PASS |
| | | High | 2480 | 6.28 | -51.1 | $\leq -13.72$ | PASS |
| | | Low | Hop_2402 | 5.95 | -50.1 | $\leq -14.05$ | PASS |
| | | High | Hop_2480 | 6.16 | -49.54 | $\leq -13.84$ | PASS |
