# Appendix F: Reference level measurement Test Result

## Appendix G: Band edge measurements

## Appendix H: Conducted Spurious Emission Test Result

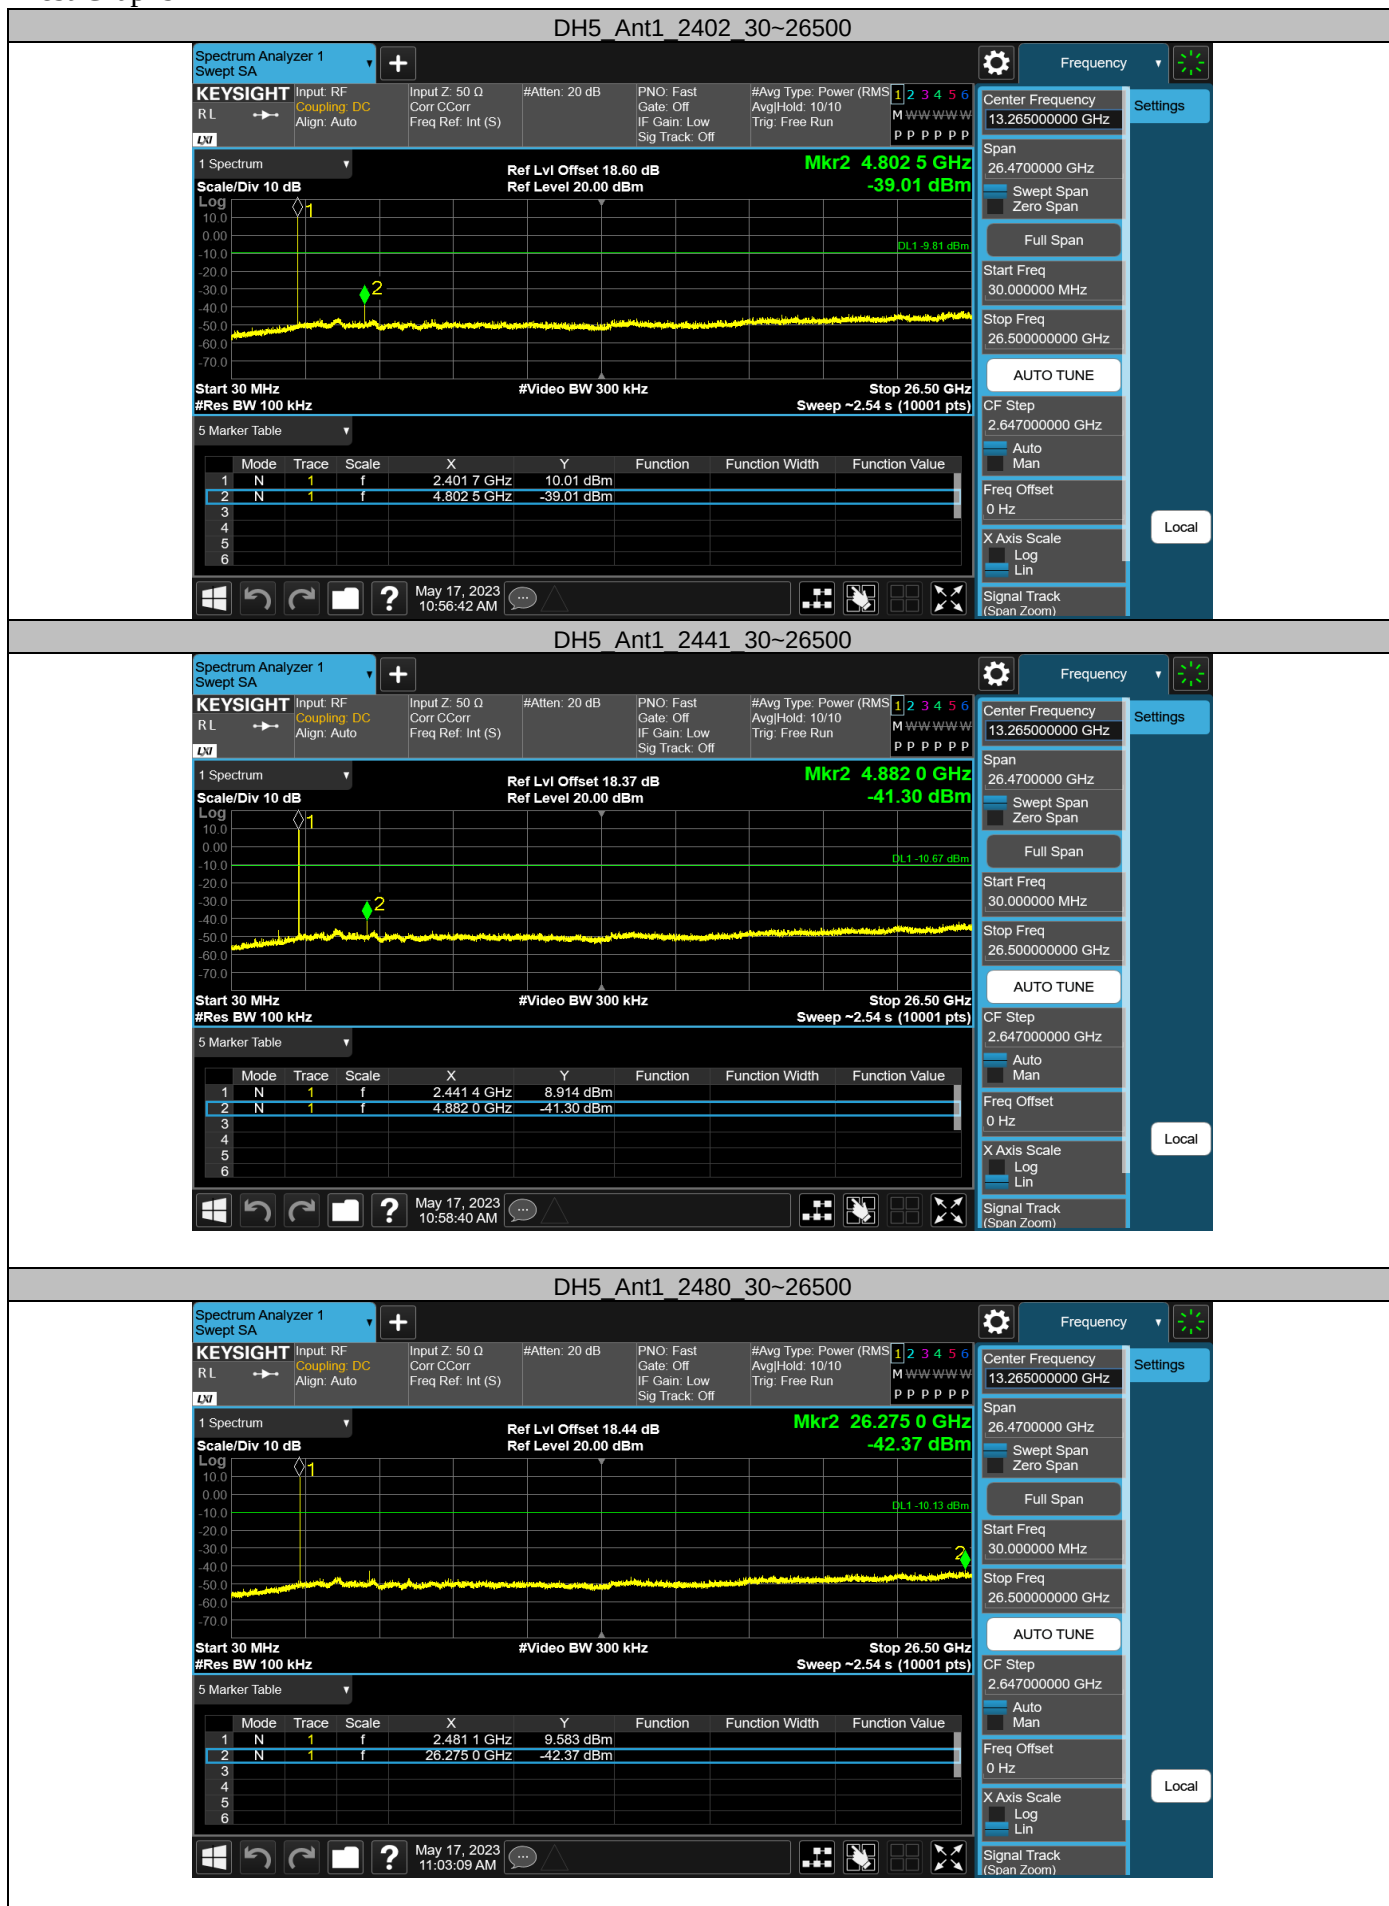
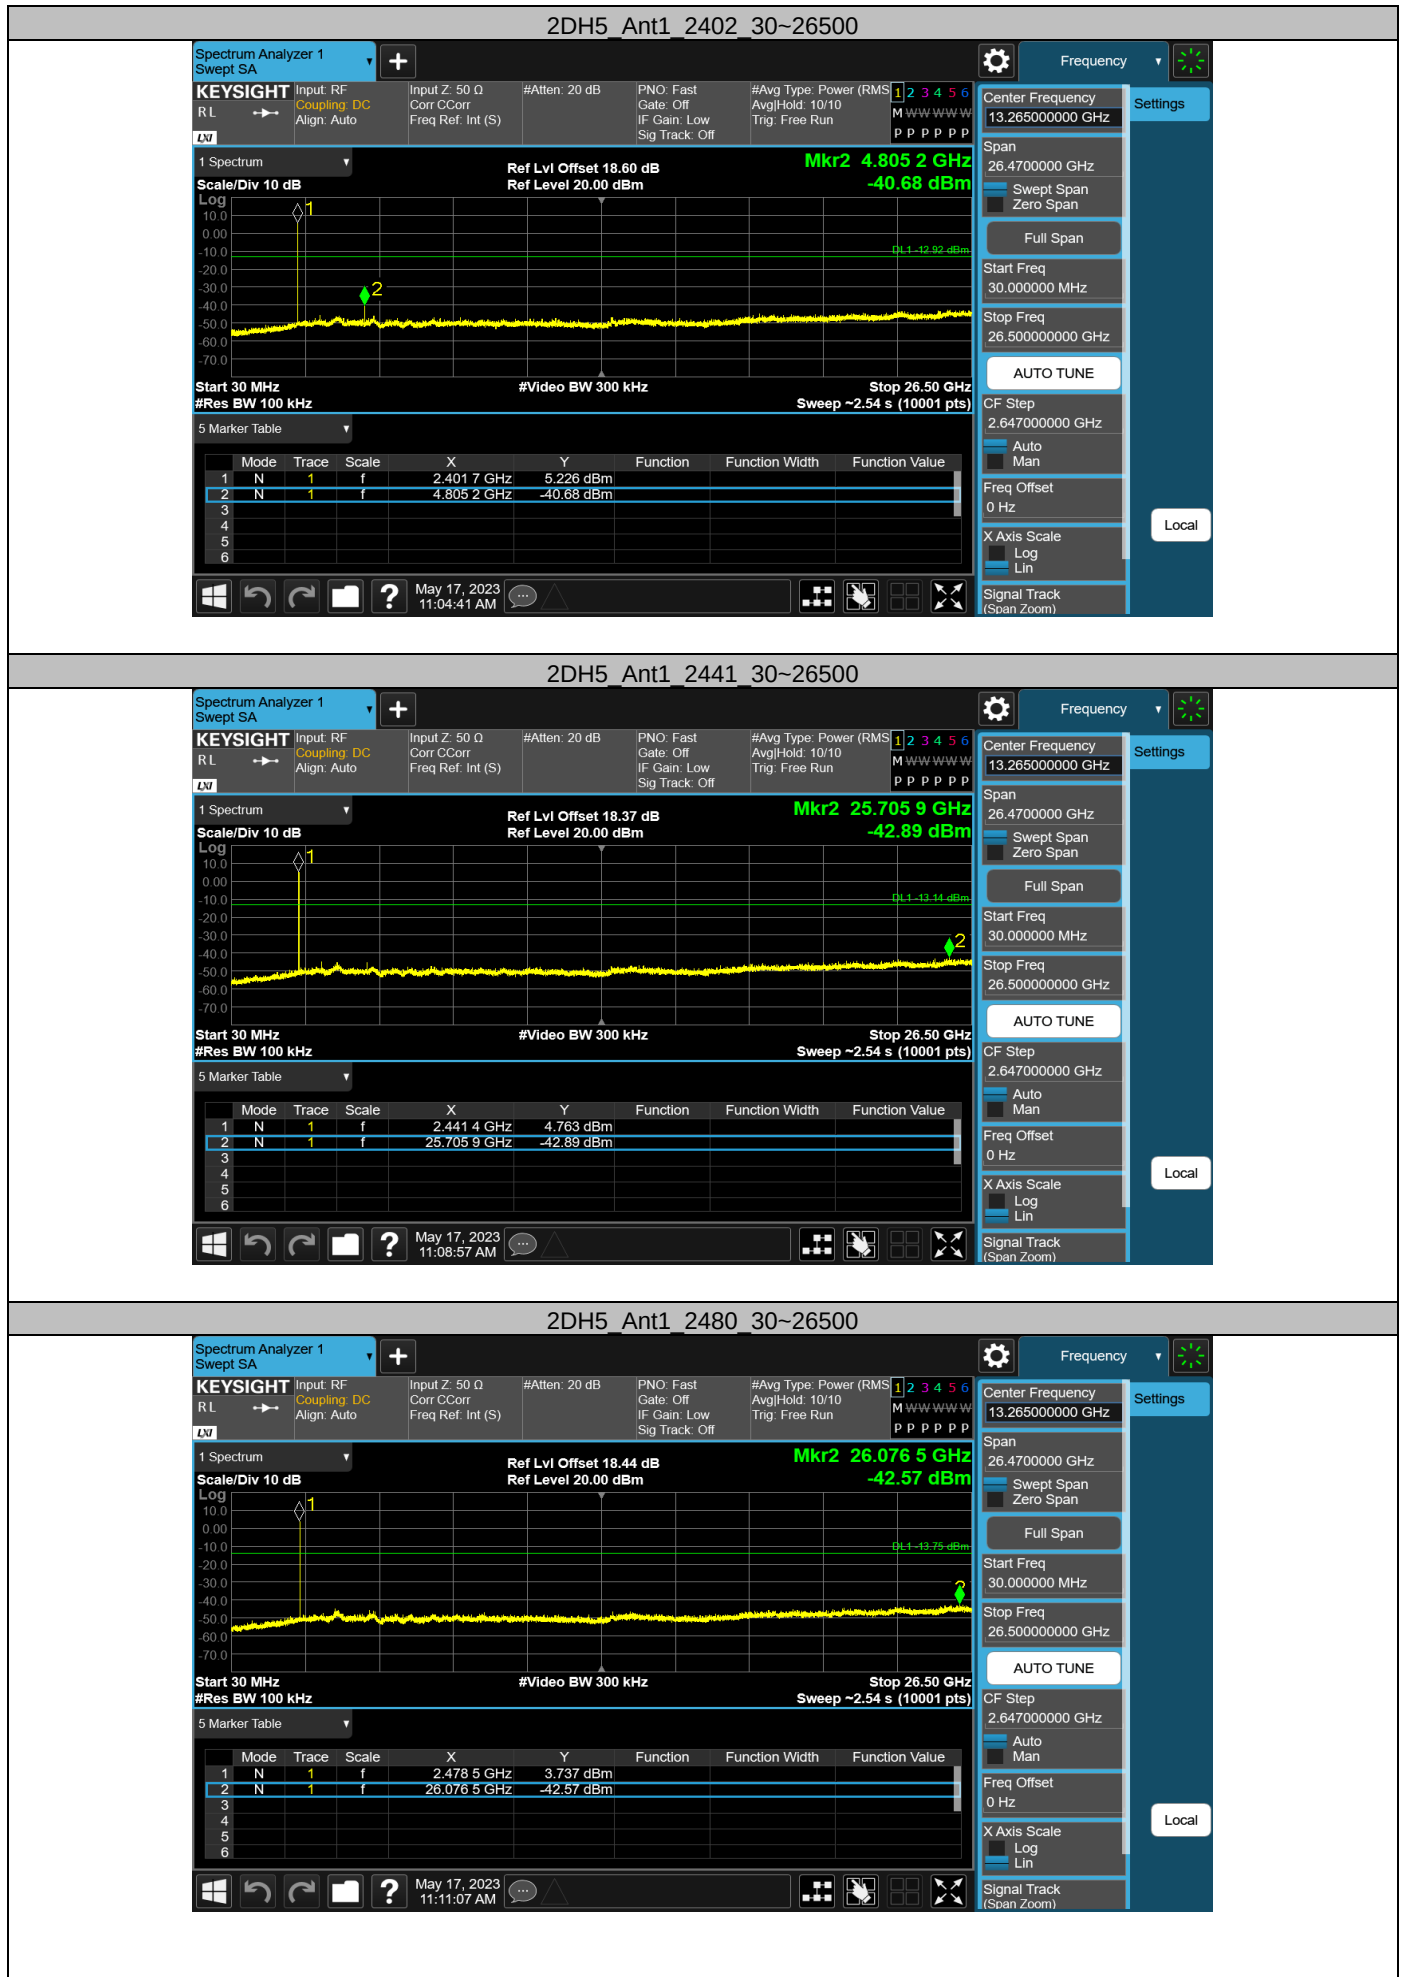
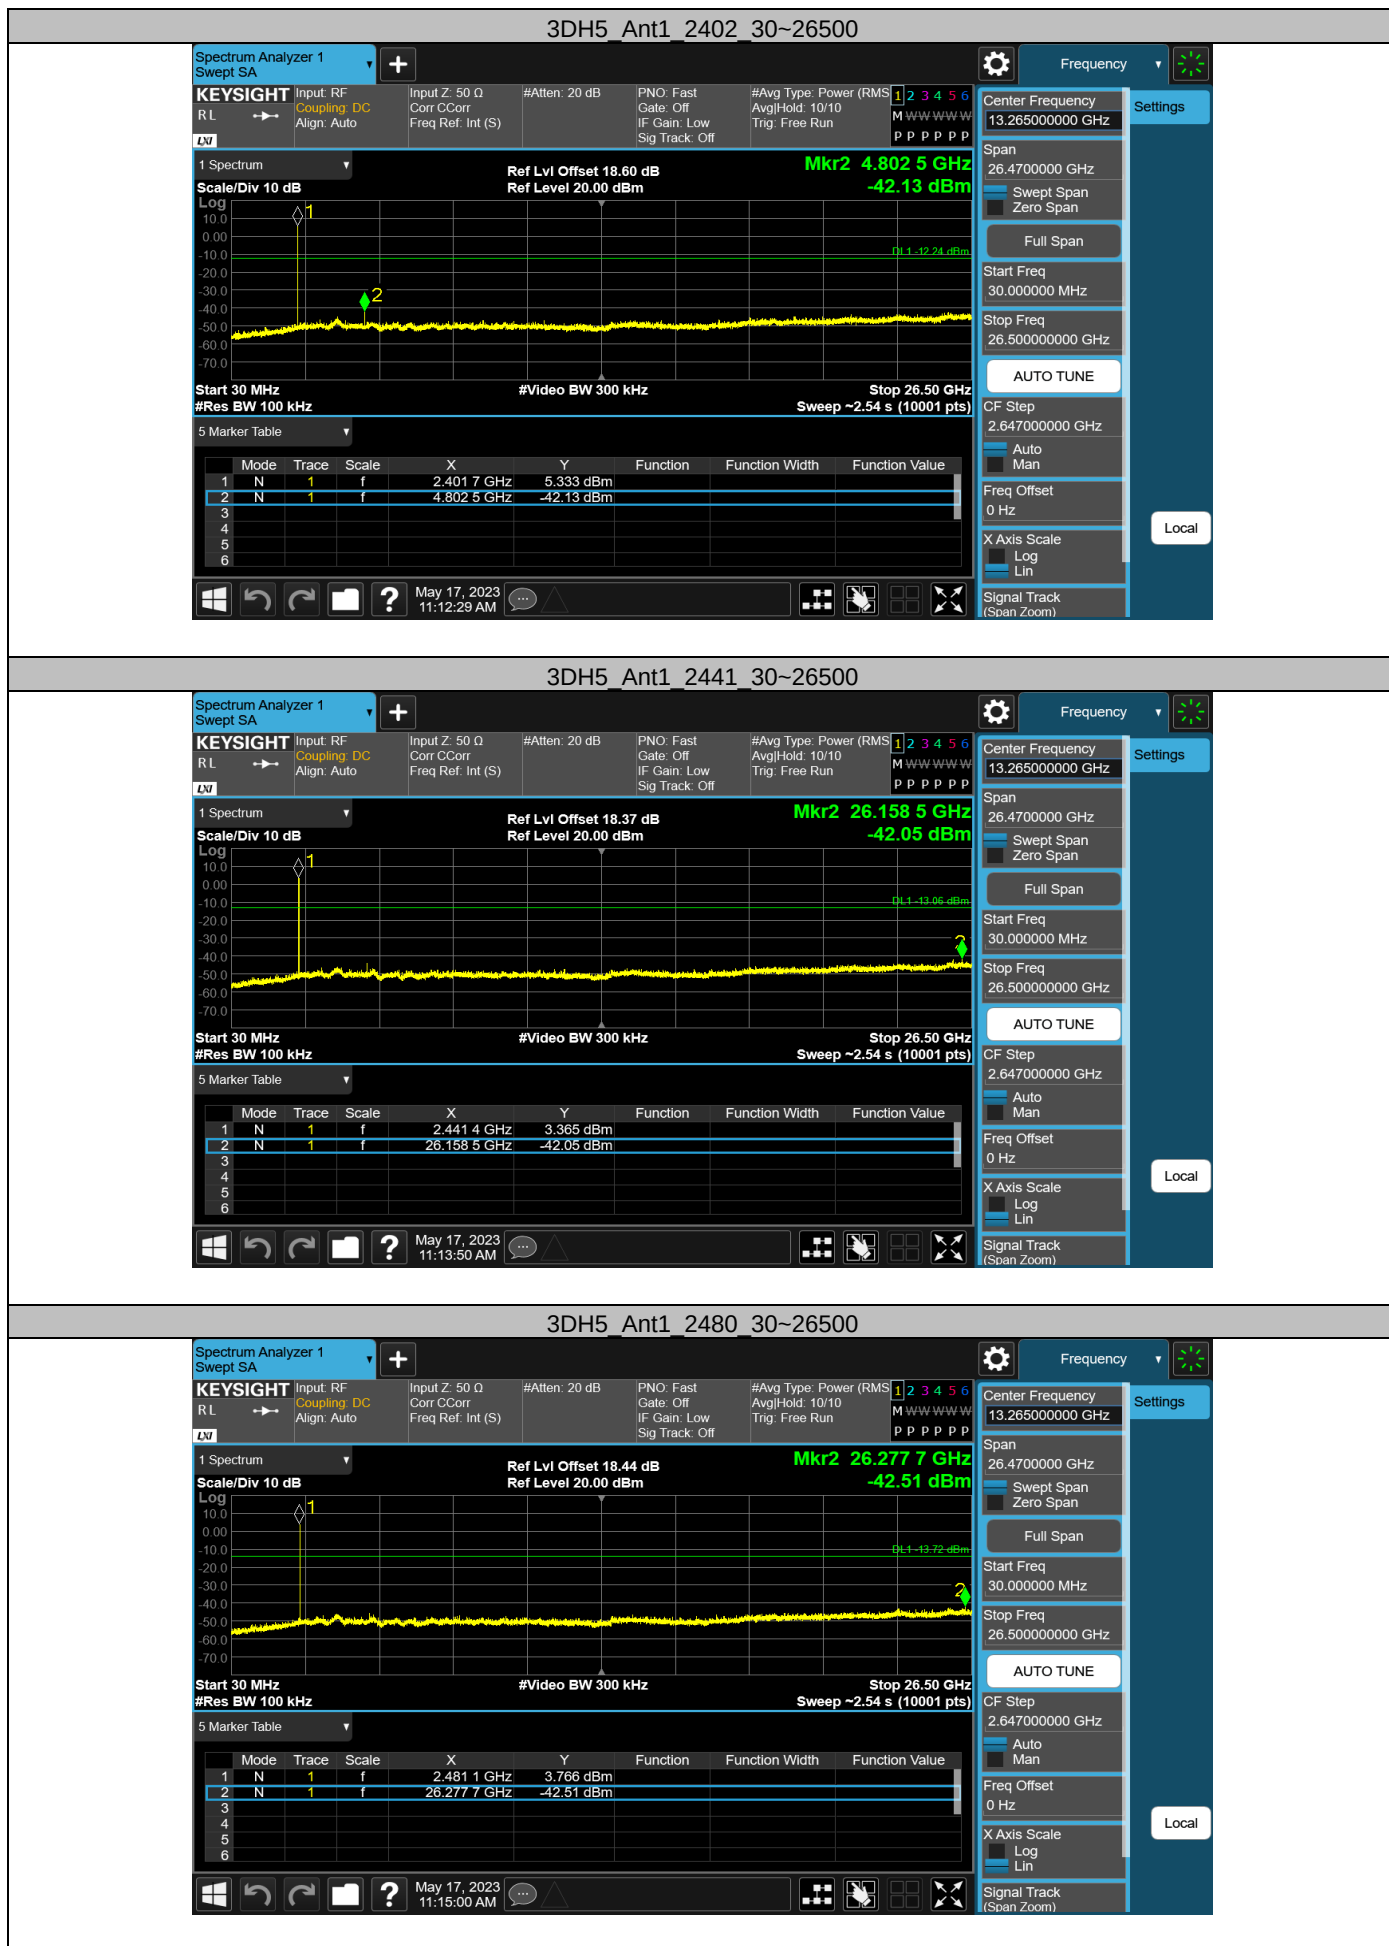
## Test Graphs

| Test Mode | Antenna | Freq(MHz) | Freq Range [MHz] | Ref Level [dBm] | Result [dBm] | Limit [dBm] | Verdict |
| DH5 | Ant1 | 2402 | 30~26500 | 10.19 | -39.01 | $\leq -9.81$ | PASS |
| | | 2441 | 30~26500 | 9.33 | -41.3 | $\leq -10.67$ | PASS |
| | | 2480 | 30~26500 | 9.87 | -42.37 | $\leq -10.13$ | PASS |
| 2DH5 | Ant1 | 2402 | 30~26500 | 7.08 | -40.68 | $\leq -12.92$ | PASS |
| | | 2441 | 30~26500 | 6.86 | -42.89 | $\leq -13.14$ | PASS |
| | | 2480 | 30~26500 | 6.25 | -42.57 | $\leq -13.75$ | PASS |
| 3DH5 | Ant1 | 2402 | 30~26500 | 7.76 | -42.14 | $\leq -12.24$ | PASS |
| | | 2441 | 30~26500 | 6.94 | -42.05 | $\leq -13.06$ | PASS |
| | | 2480 | 30~26500 | 6.28 | -42.51 | $\leq -13.72$ | PASS |

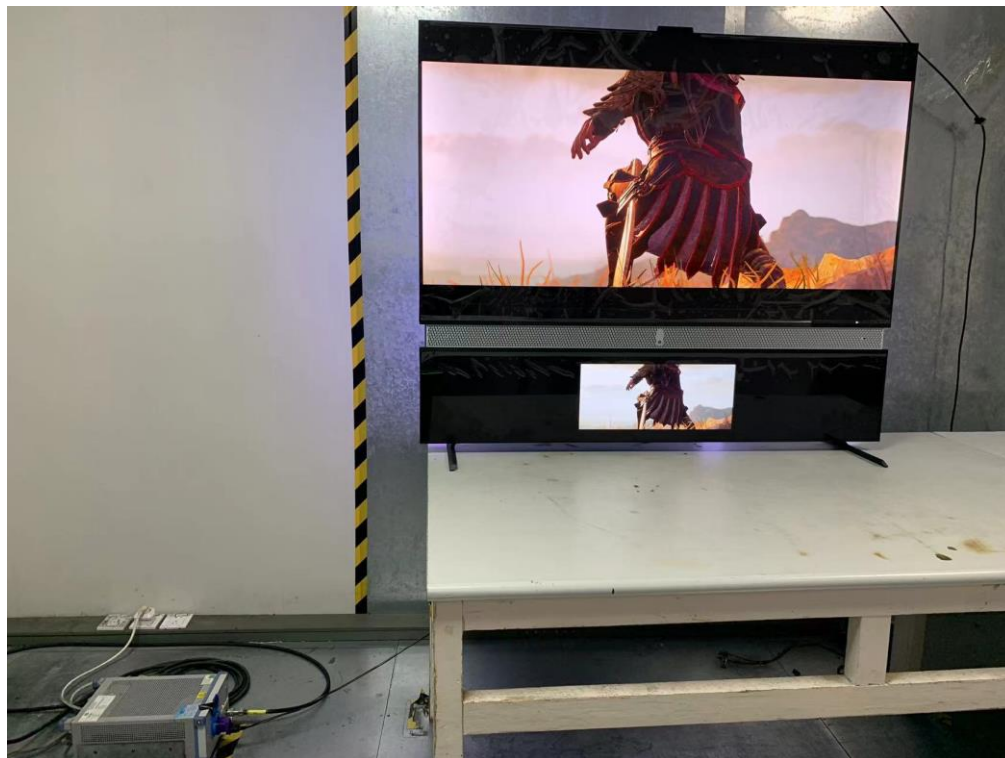
Conducted Test

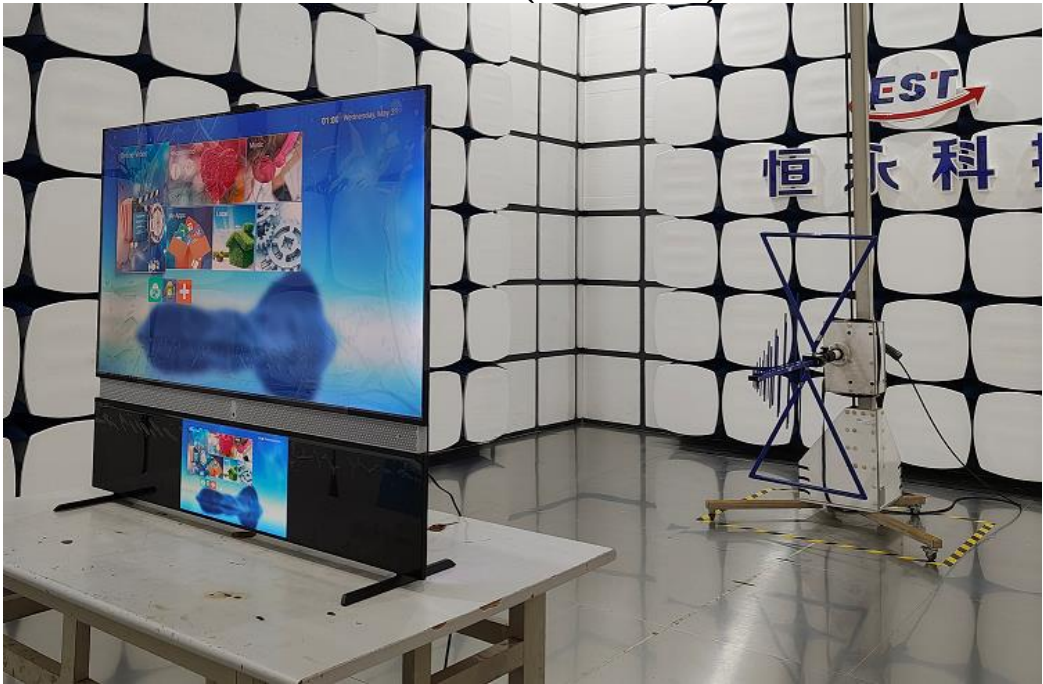
**Radiated Test (Below 1GHz)**

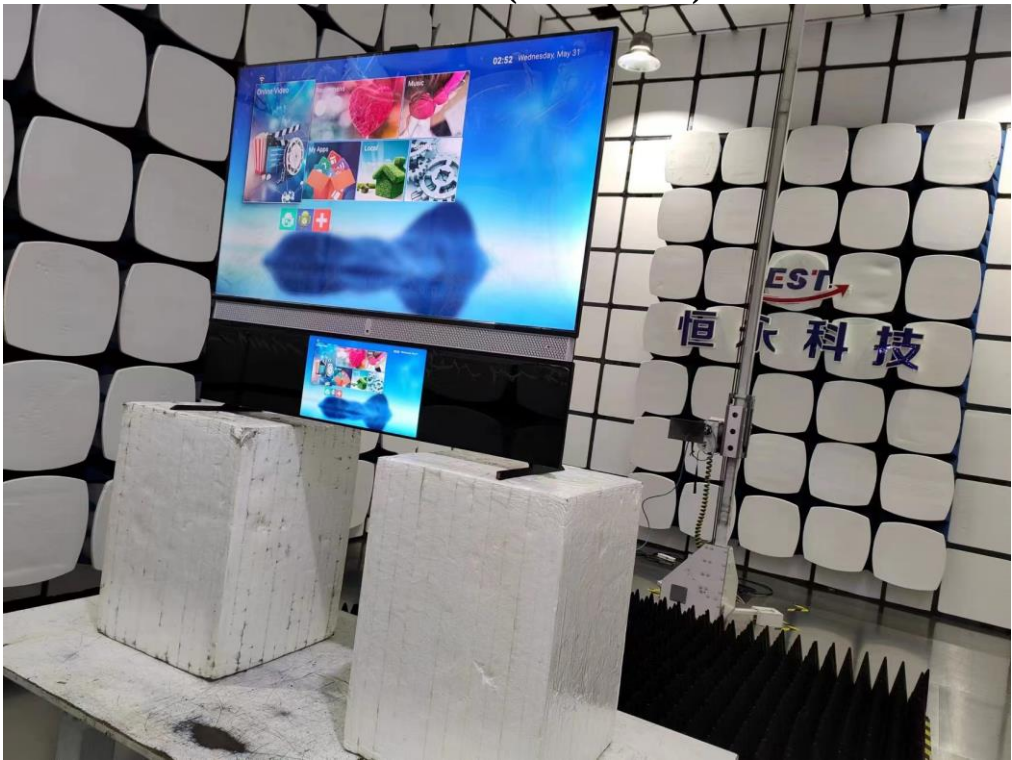
**Radiated Test (Above 1GHz)**
