## Tx. Spurious NVNT n40 2422MHz Ant2 Ref

## APPENDIX 2-PHOTOS OF TEST SETUP

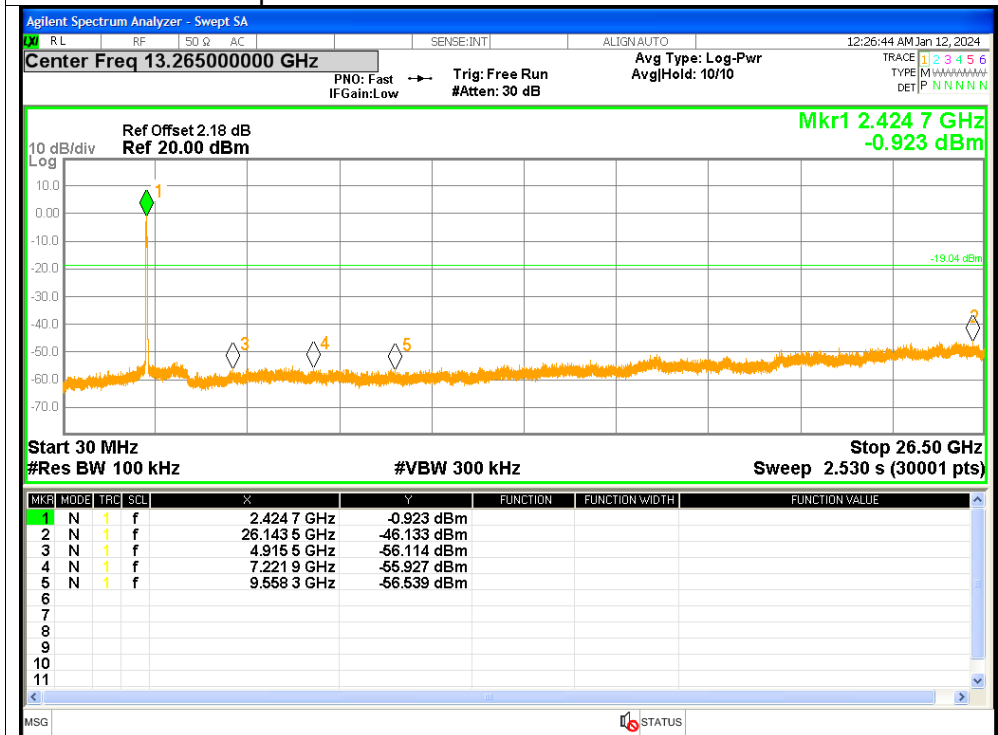
## Tx. Spurious NVNT n40 2422MHz Ant2 Emission

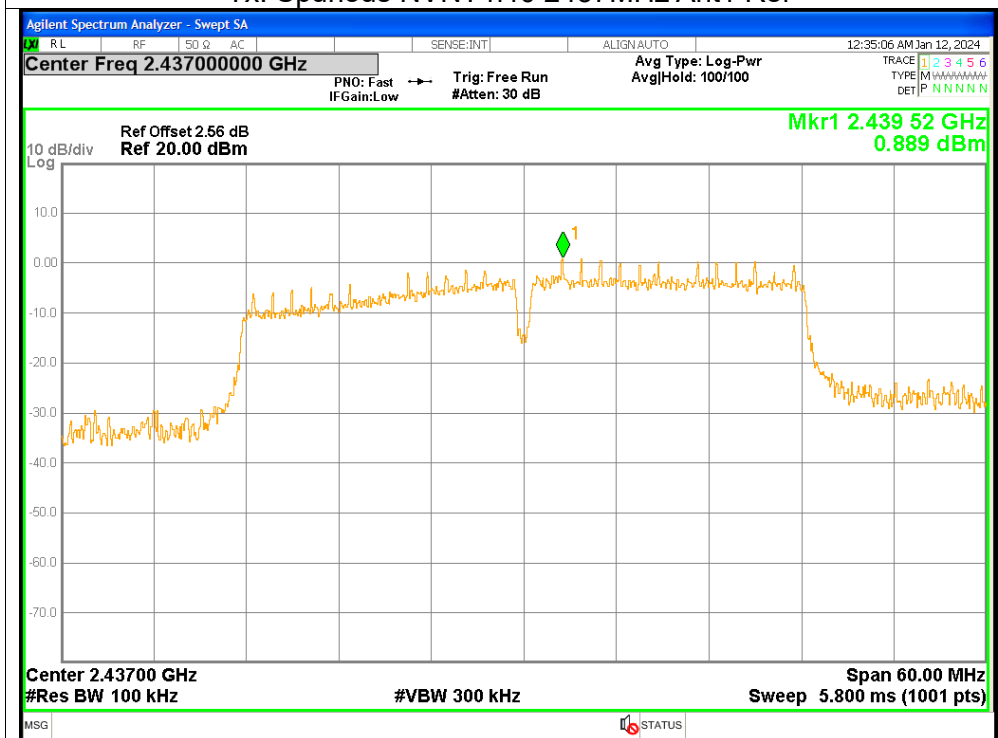
## Tx. Spurious NVNT n40 2437MHz Ant1 Ref

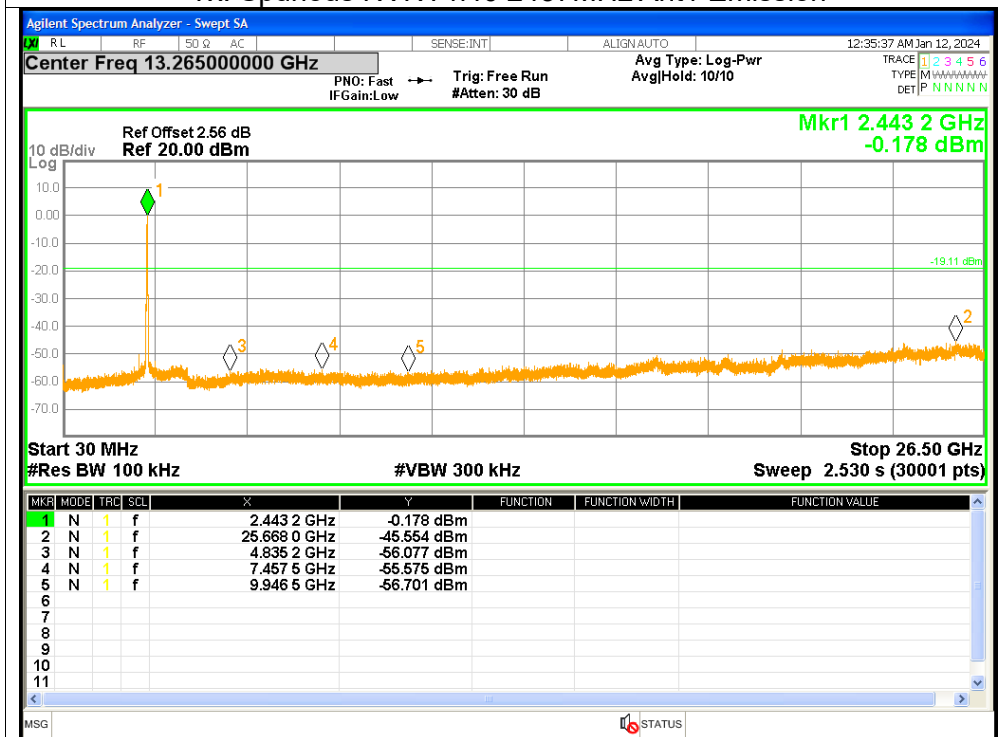
## Tx. Spurious NVNT n40 2437MHz Ant1 Emission
