# Radiated Emission Measurement

Condition : FCC\_part 15E RE\_Above 1GHz\_PK

EUT : W6M22311-23076

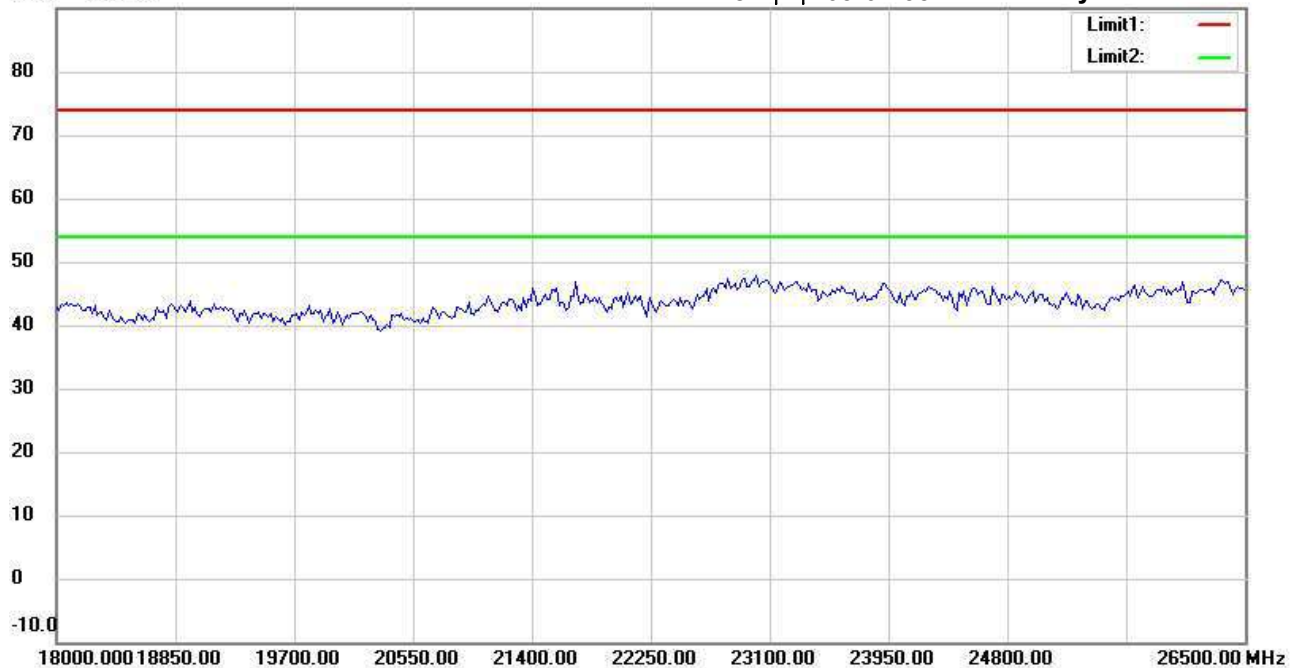
Test Mode : TX 802.11a CH165

Polarization: Horizontal

Distance: 3m

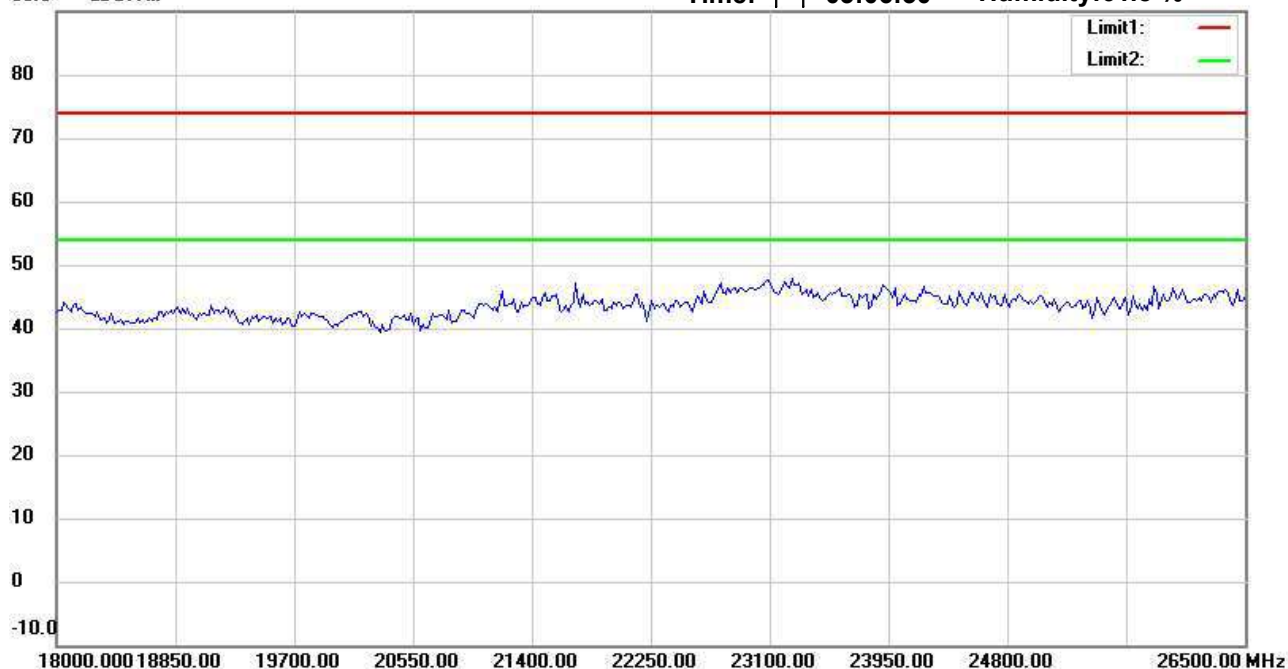
Condition : FCC\_part 15E RE\_Above 1GHz\_PK

Test Mode : TX 802.11a CH165

Polarization: **Vertical**

Distance: 3m

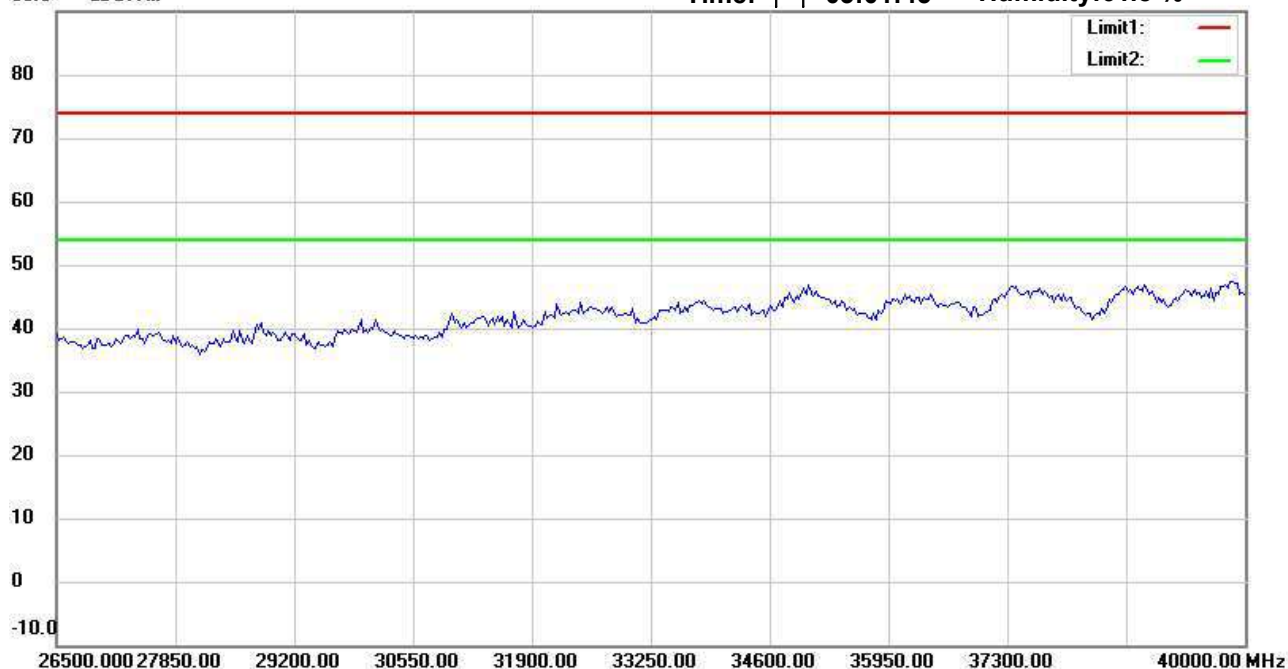
Condition : FCC\_part 15E RE\_Above 1GHz\_PK

Test Mode : TX 802.11a CH165

Polarization: **Horizontal**

Distance: 3m

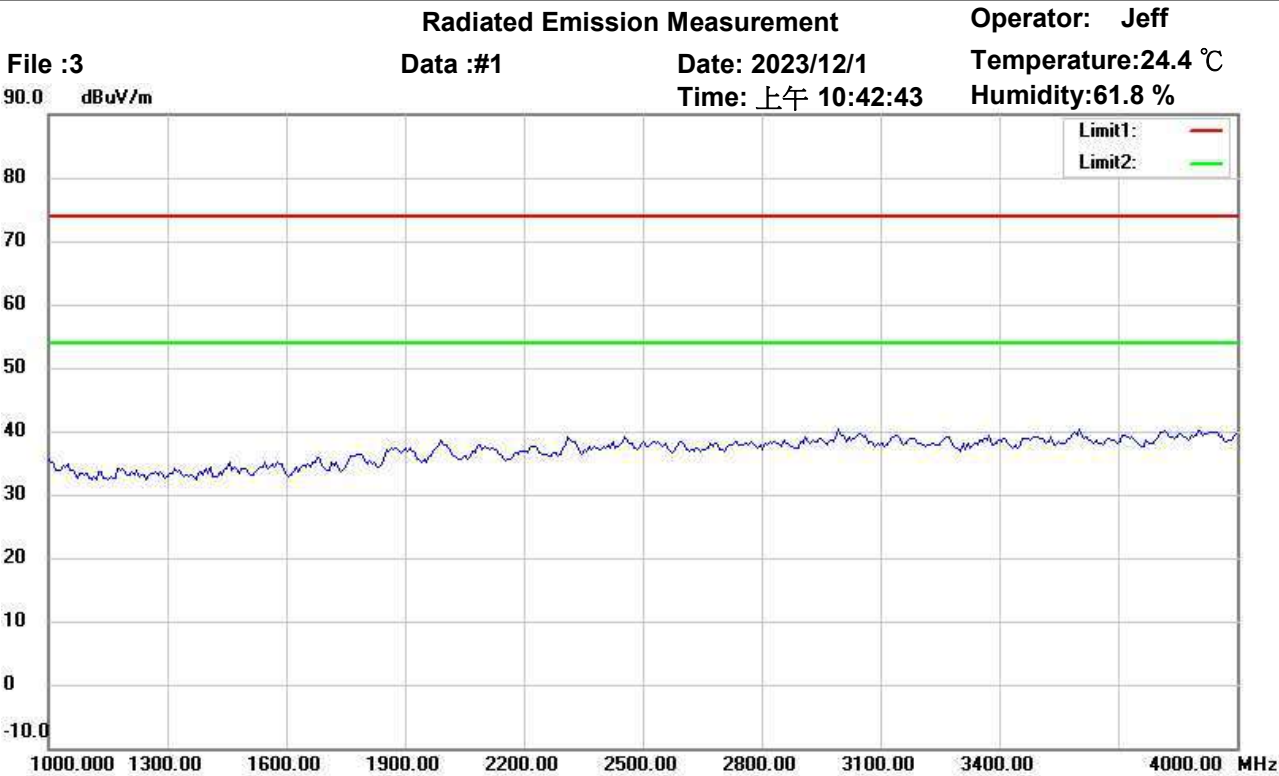
Condition : FCC\_part 15E RE\_Above 1GHz\_PK

Test Mode : TX 802.11n20 CH36

Polarization: Horizontal

Distance: 3m

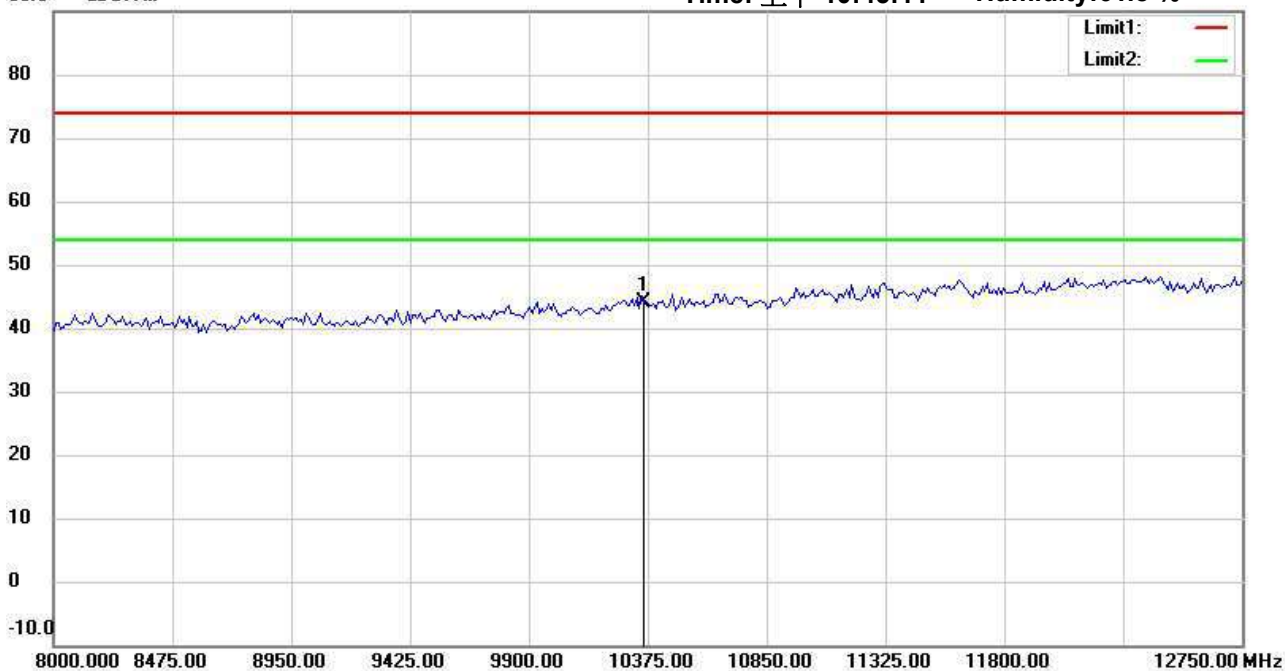
Condition : FCC\_part 15E RE\_Above 1GHz\_PK

Test Mode : TX 802.11n20 CH36

Polarization: **Horizontal**

| Mk. | Frequency (MHz) | Reading (dBuV) | Detector | Corr. factor (dB/m) | Result (dBuV/m) | Limit (dBuV/m) | Ant.Pos (cm) | Tab.Pos (deg.) | Margin (dB) | Comment |
|---|---|---|---|---|---|---|---|---|---|---|
| * | 10360.000 | 35.74 | peak | 8.27 | 44.01 | 74.00 | 150 | 45 | -29.99 | |

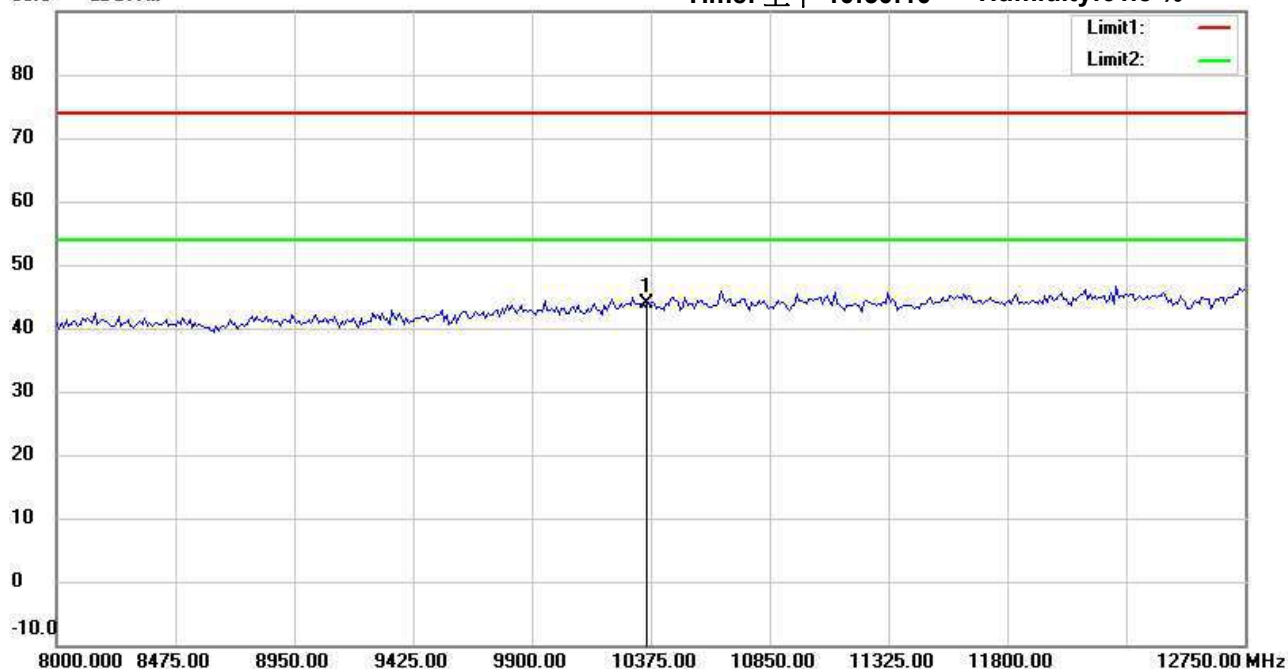
Condition : FCC\_part 15E RE\_Above 1GHz\_PK

Test Mode : TX 802.11n20 CH36

Polarization: Vertical

| Mk. | Frequency (MHz) | Reading (dBuV) | Detector | Corr. factor (dB/m) | Result (dBuV/m) | Limit (dBuV/m) | Ant.Pos (cm) | Tab.Pos (deg.) | Margin (dB) | Comment |
|---|---|---|---|---|---|---|---|---|---|---|
| * | 10360.000 | 35.53 | peak | 8.27 | 43.80 | 74.00 | 150 | 241 | -30.20 | |
