# TEST REPORT

Report No.: SHE23100070-02DE

## 4.2 Mains Emissions

### 4.2.1 Conducted Emission on AC Mains

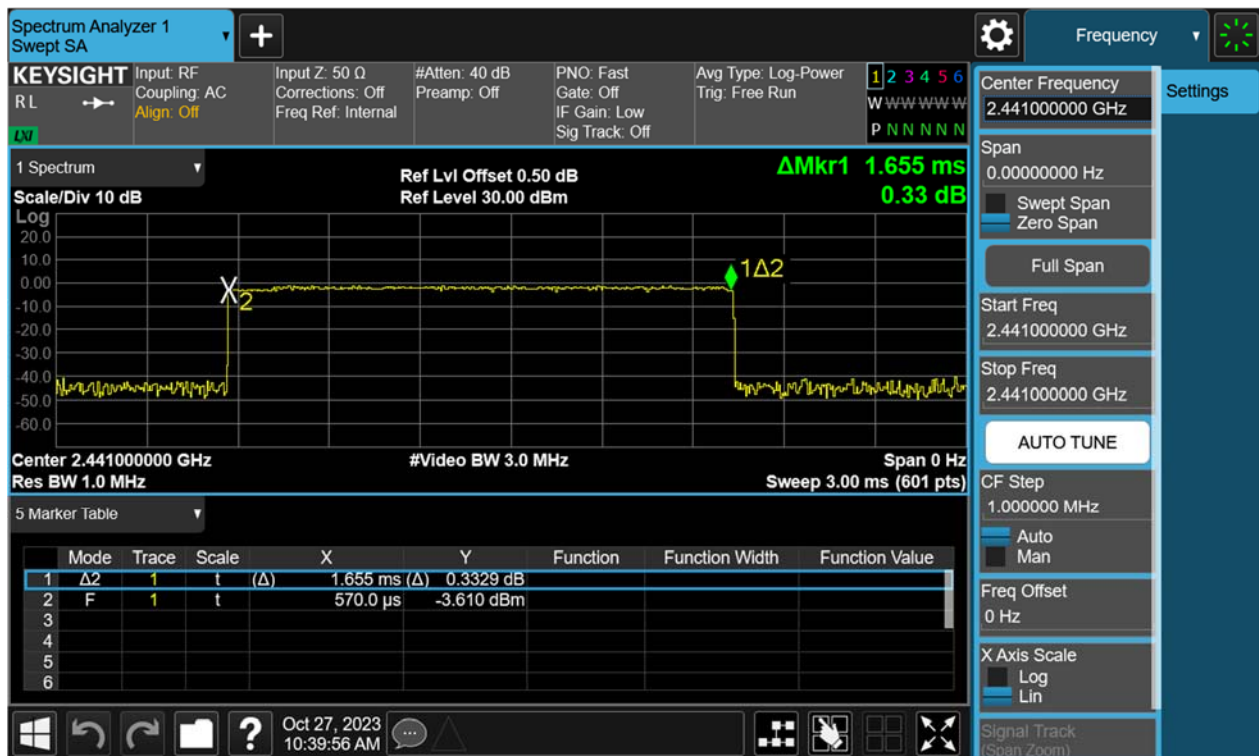
Figure 41: Time of Occupancy, 2441MHz,  $\pi/4$ -DQPSK DH3

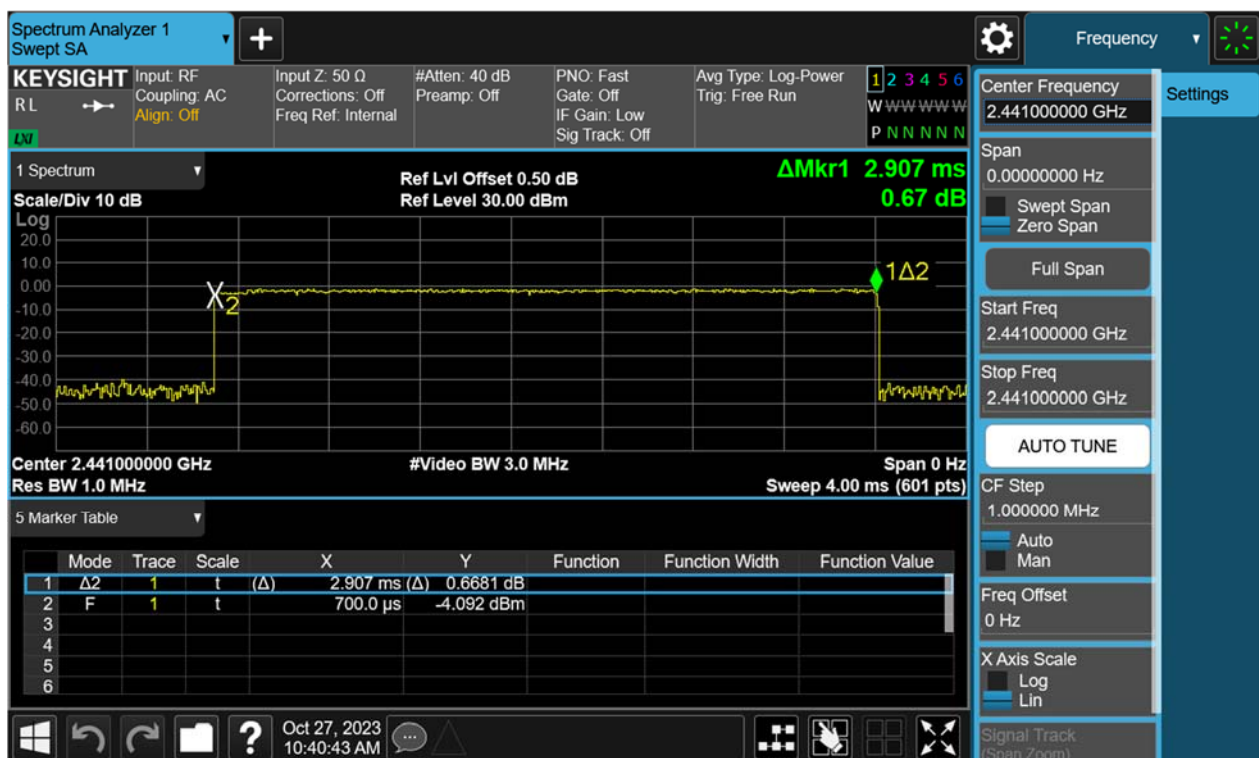
Figure 42: Time of Occupancy, 2441MHz,  $\pi/4$ -DQPSK DH5

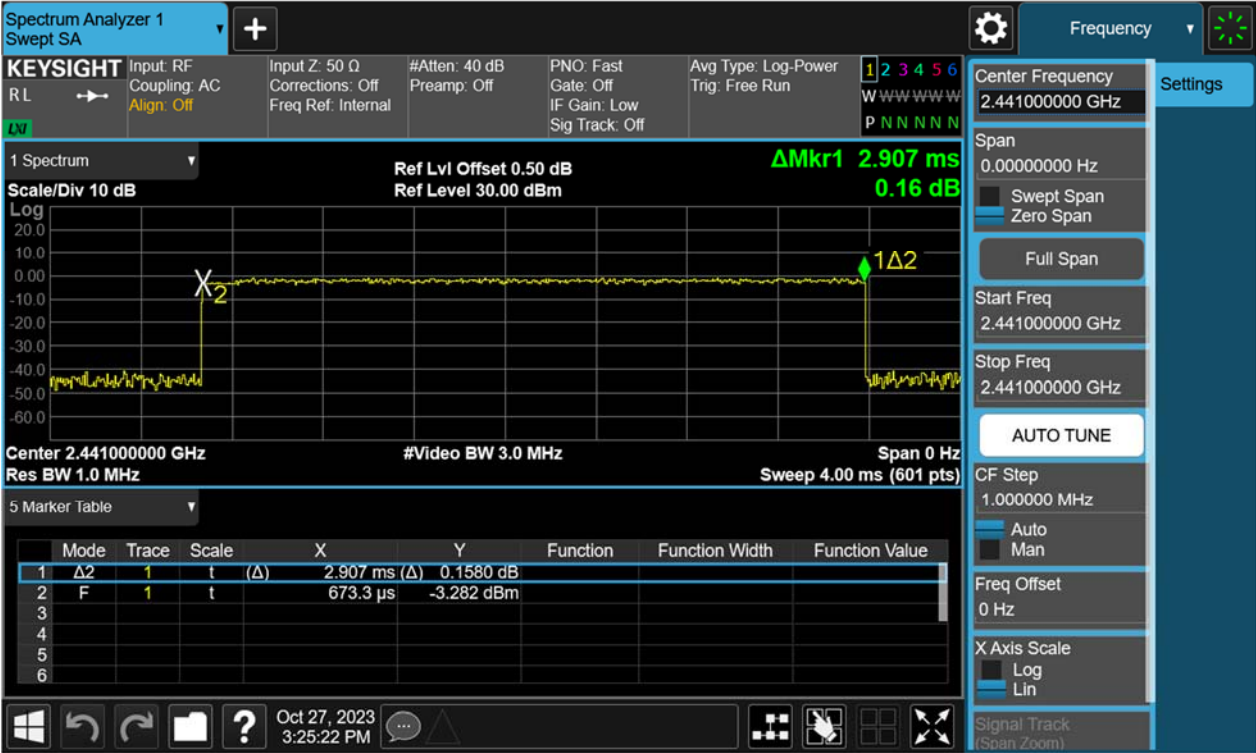
Figure 45: Time of Occupancy, 2441MHz, 8-DPSK DH5

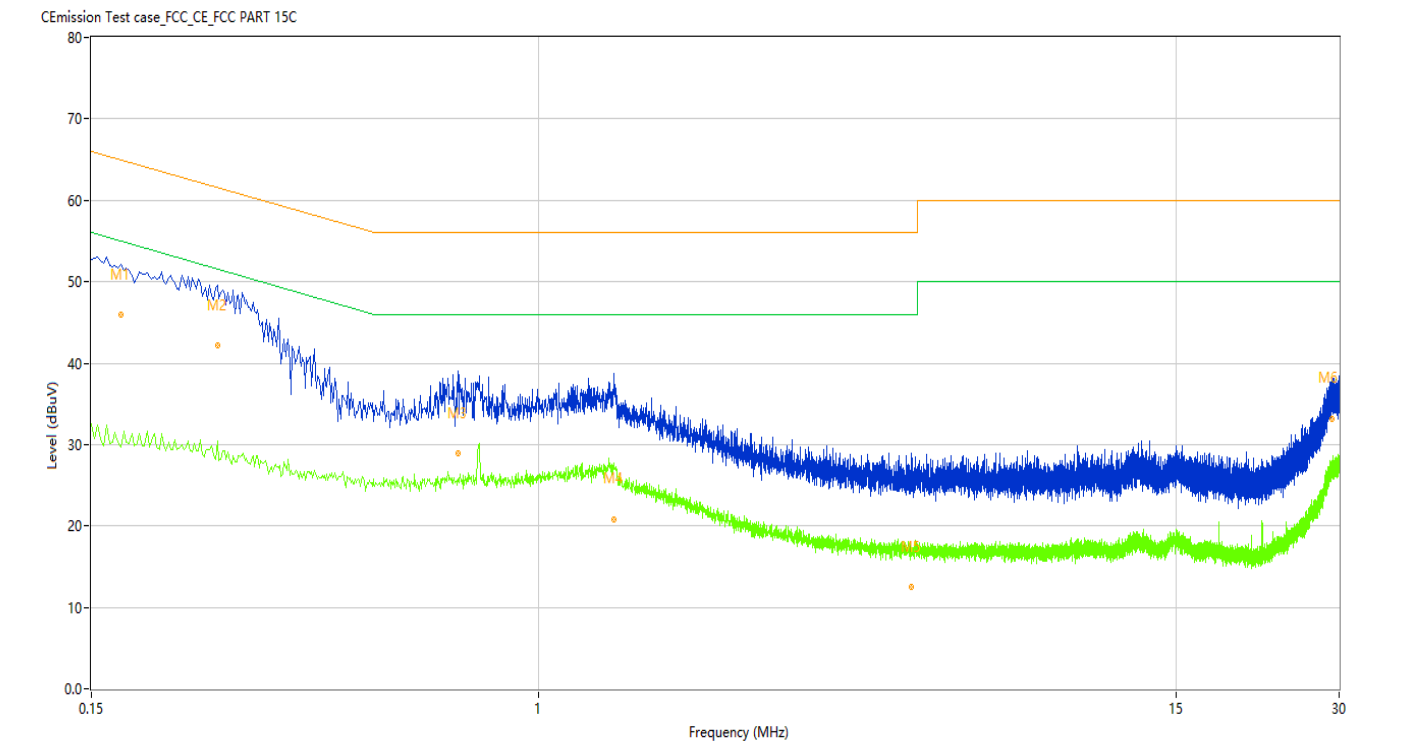
Figure 47: Conducted Emission on AC Mains, N Phase
