## Appendix B: photographs of test setup

## Appendix C: photographs of EUT

Reference to the test report no. BLA-EMC-202403-A10301

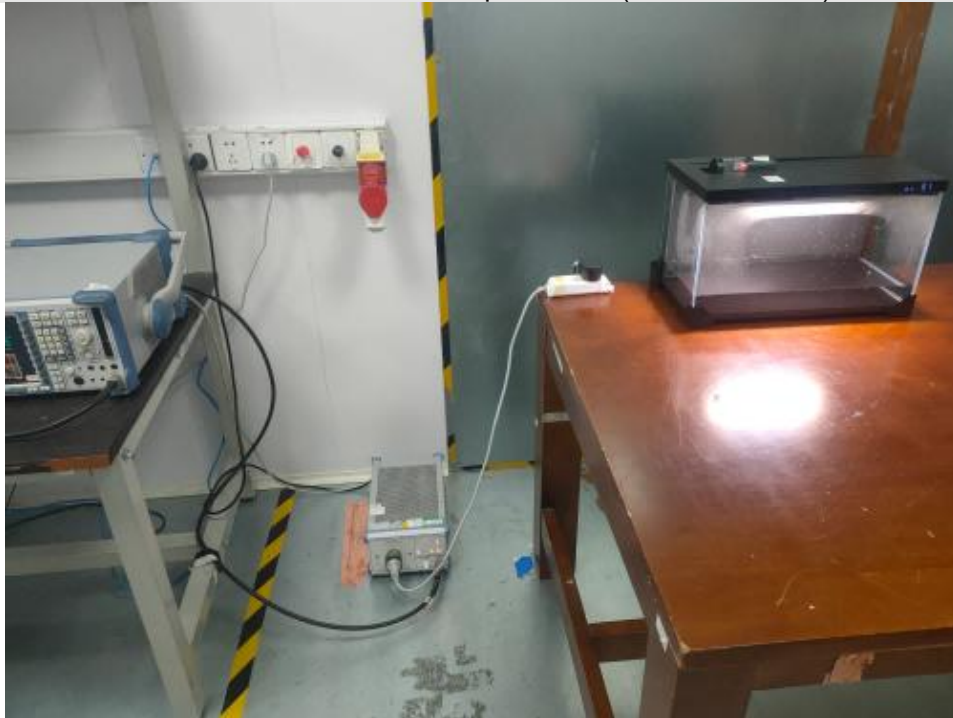
Conducted emissions at AC power line (150kHz-30MHz)

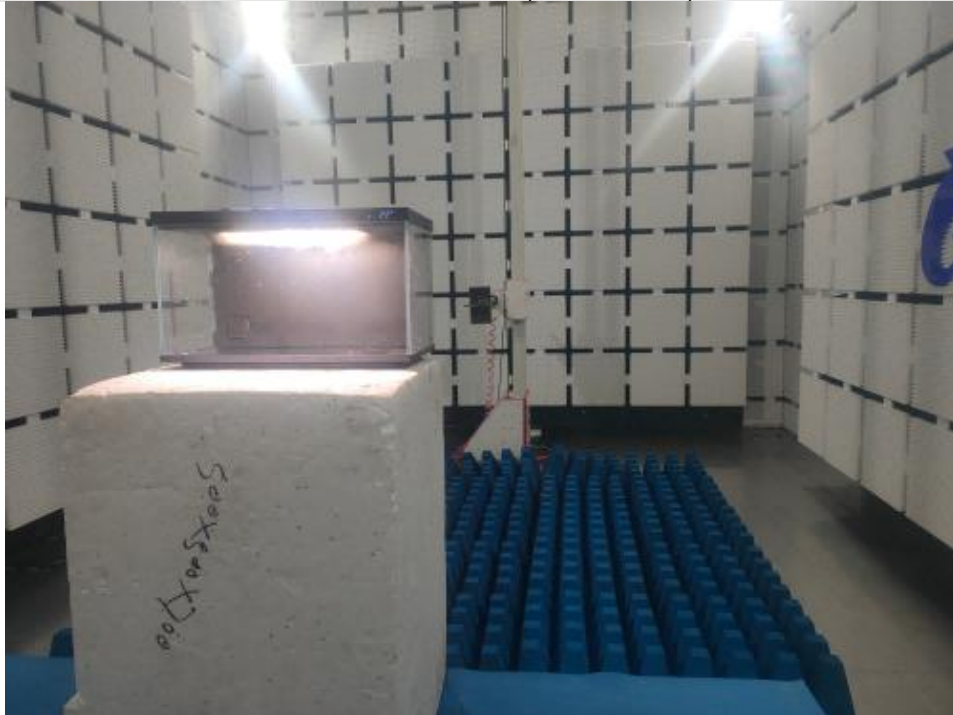
Radiated Emissions (above 1GHz)
