Tx. Spurious NVNT g 2437MHz Ant1 Ref

## APPENDIX A: PHOTOGRAPHS OF TEST SETUP

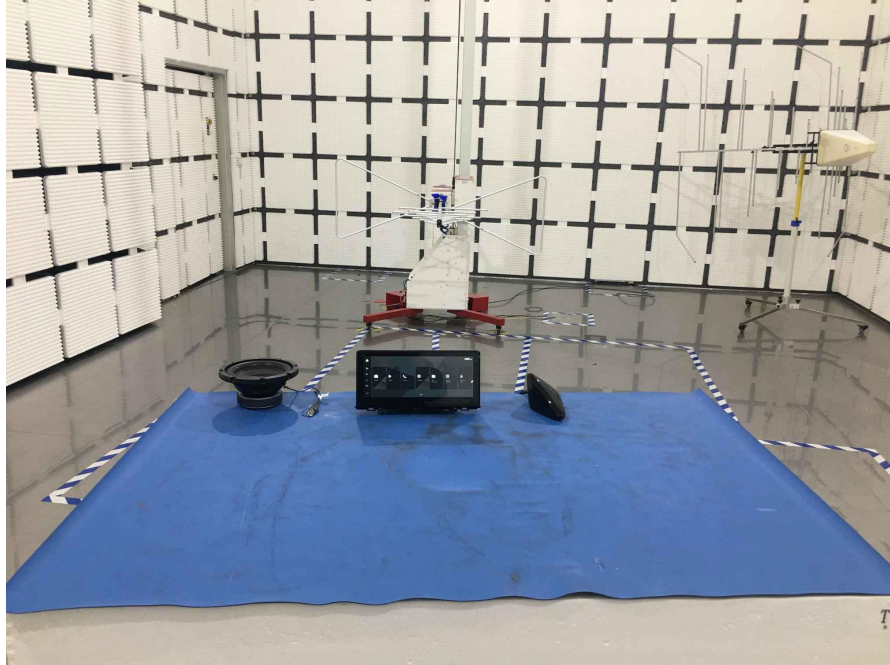
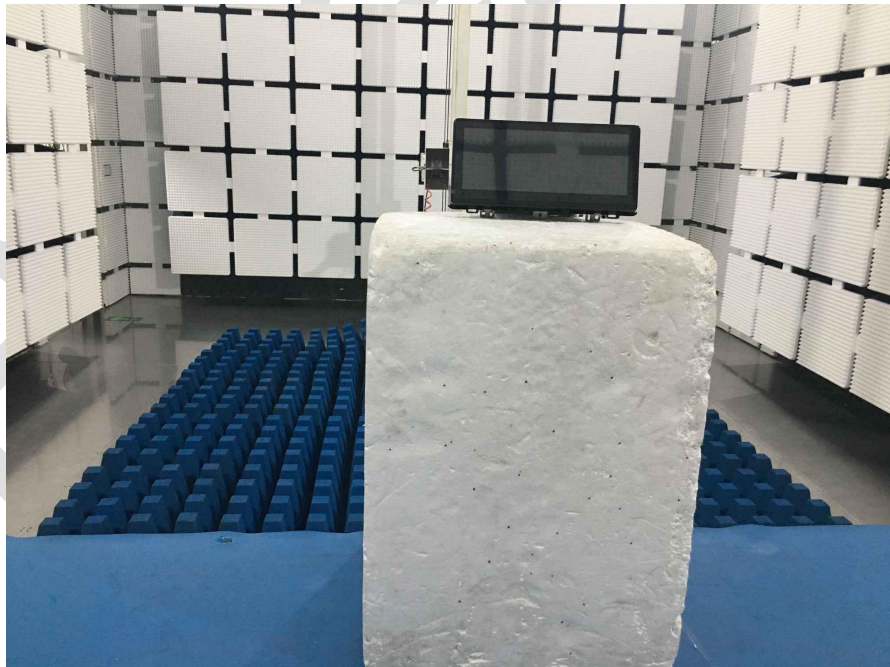
### Radiated Spurious Emissions
