## Appendix B: photographs of test setup

Reference to the test report no. BLA-EMC-202405-A5901

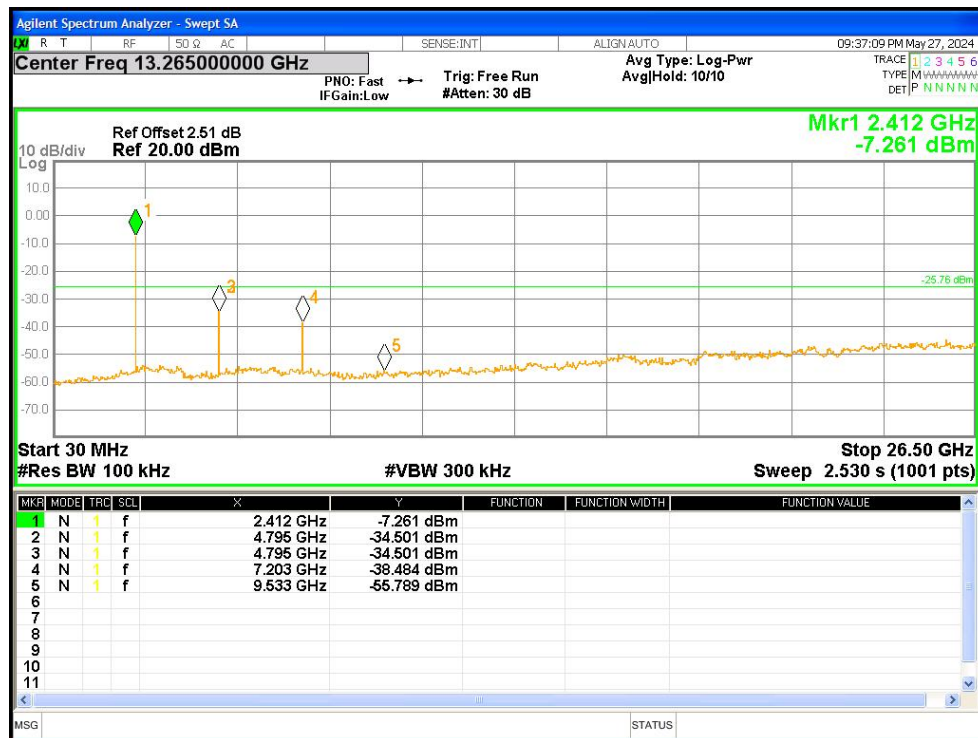
Tx. Spurious NVHT BLE 1M 2442MHz Ant1 Ref

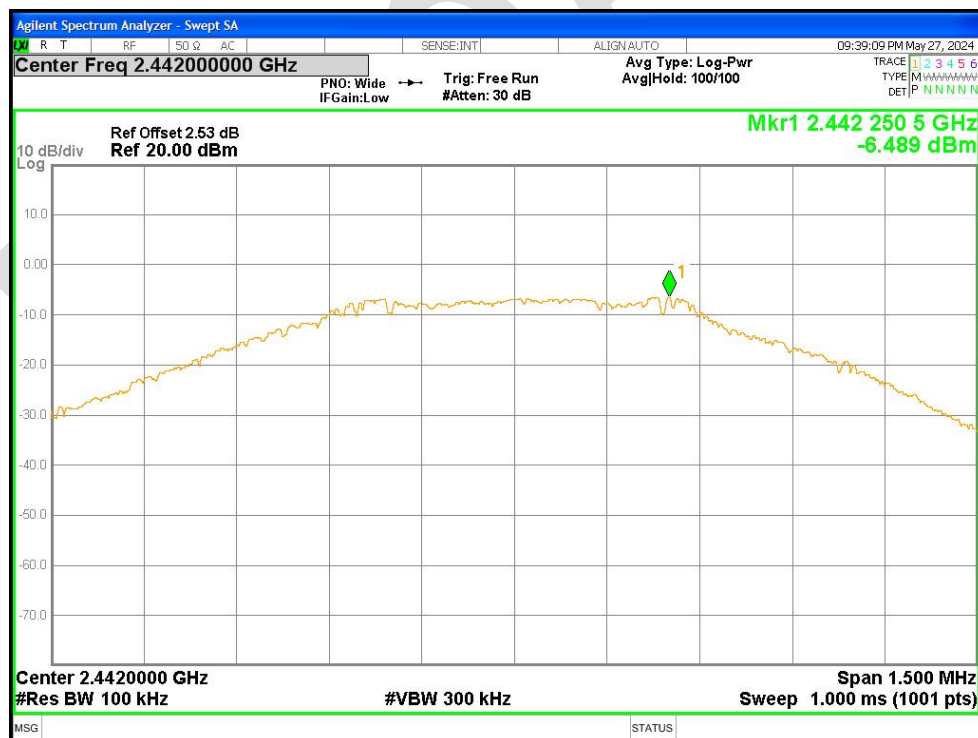
Tx. Spurious NVHT BLE 1M 2442MHz Ant1 Emission

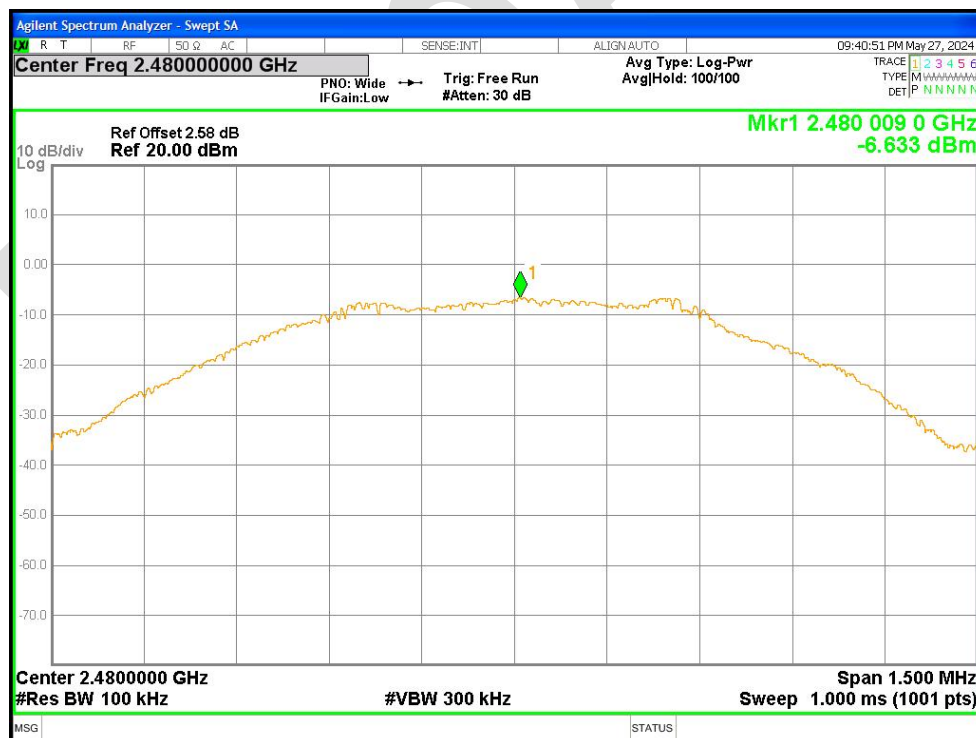
Tx. Spurious NVHT BLE 1M 2480MHz Ant1 Emission

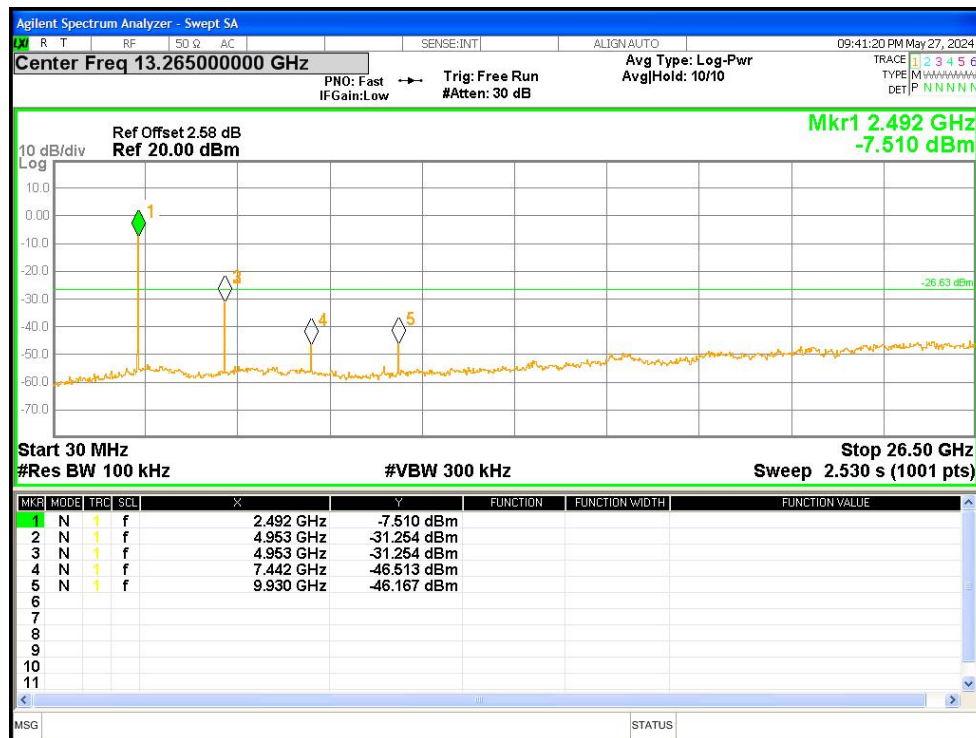
Tx. Spurious NVHT BLE 2M 2402MHz Ant1 Ref

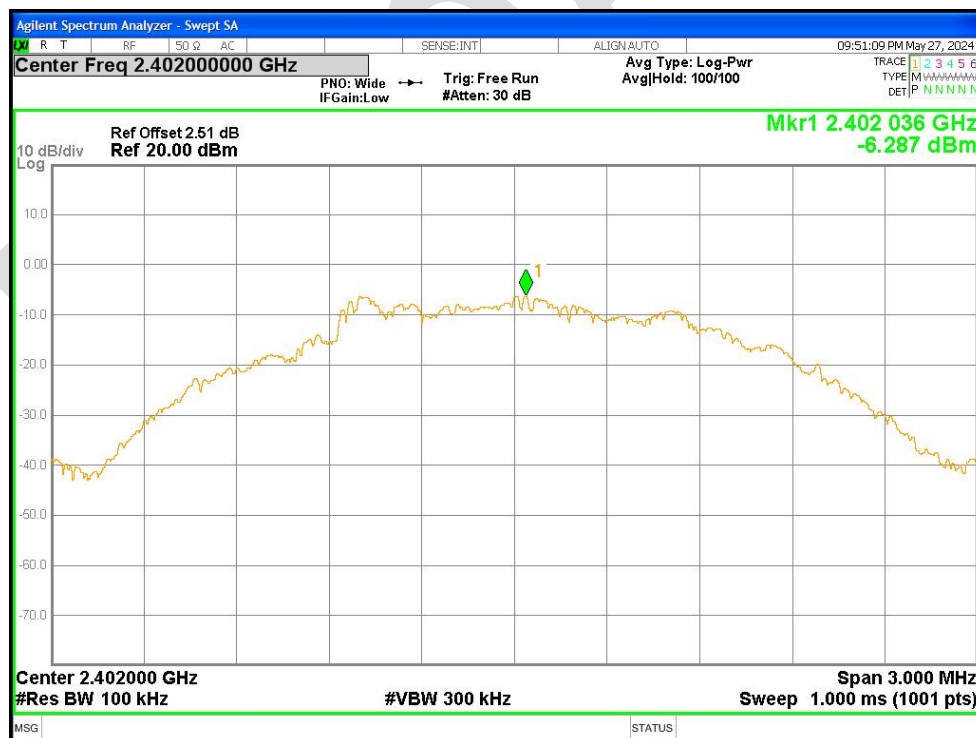
Tx. Spurious NVHT BLE 2M 2402MHz Ant1 Emission

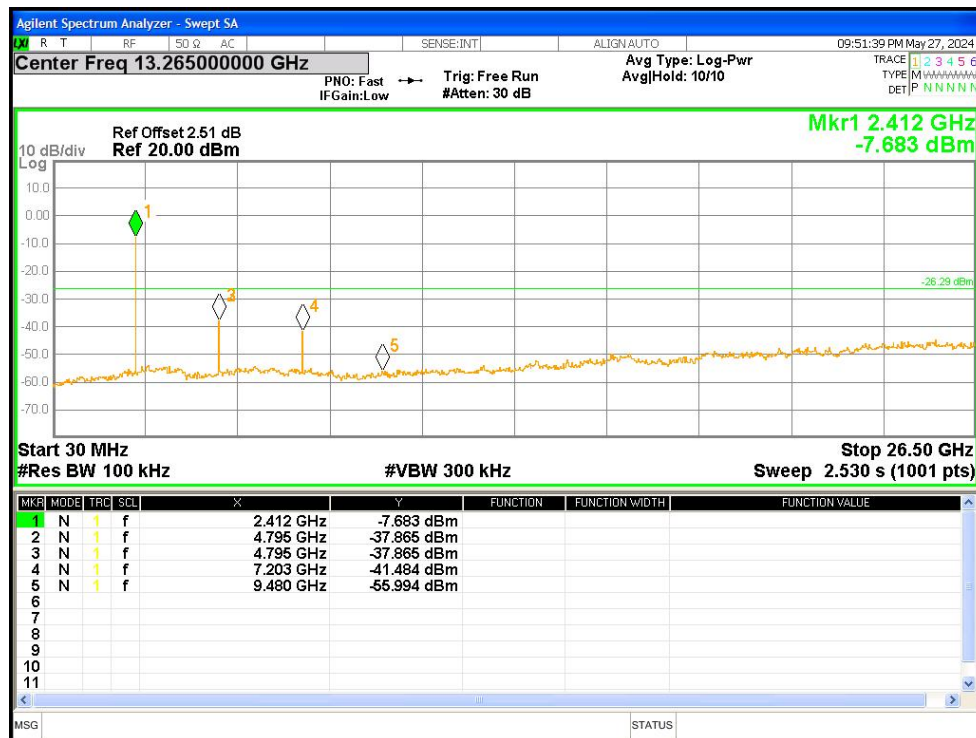
Tx. Spurious NVHT BLE 2M 2442MHz Ant1 Ref

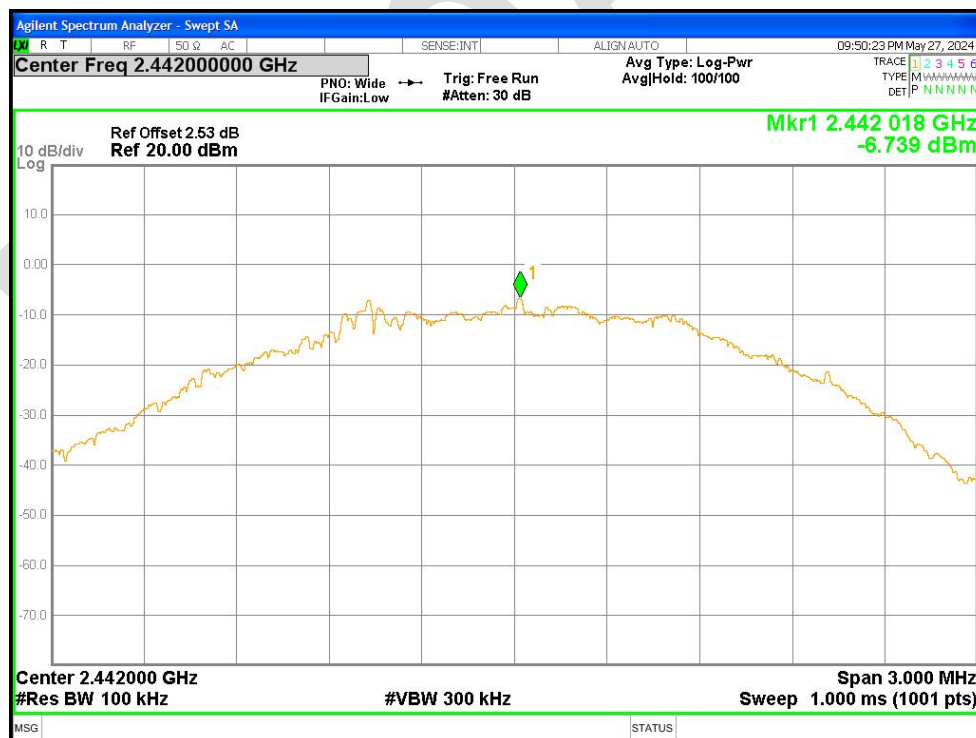
Tx. Spurious NVHT BLE 2M 2442MHz Ant1 Emission

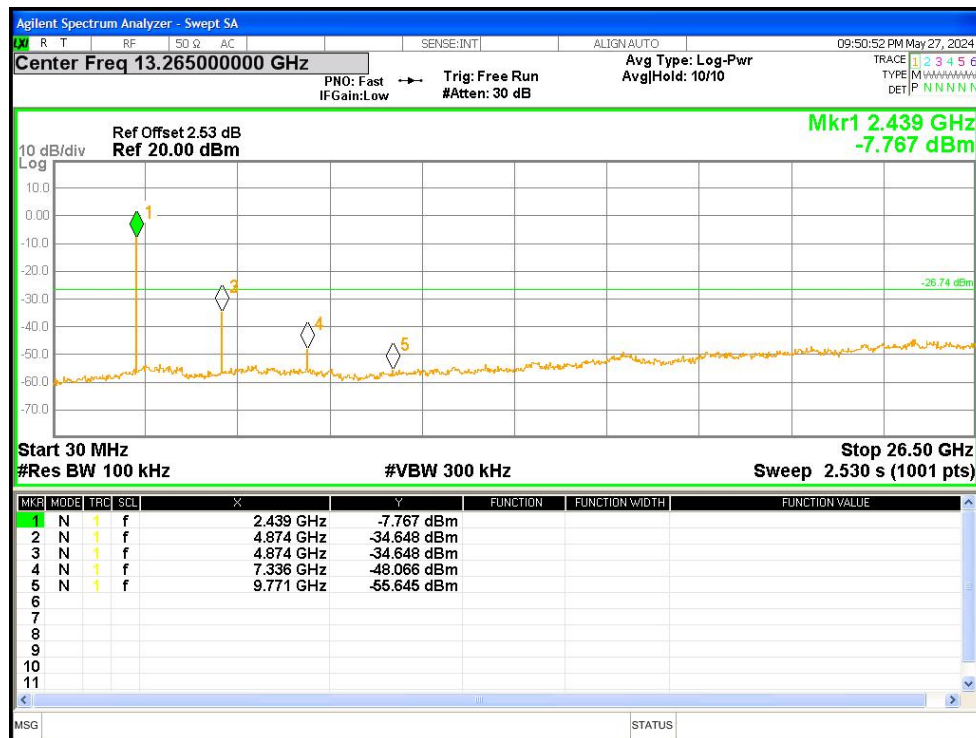
Tx. Spurious NVHT BLE 2M 2480MHz Ant1 Ref

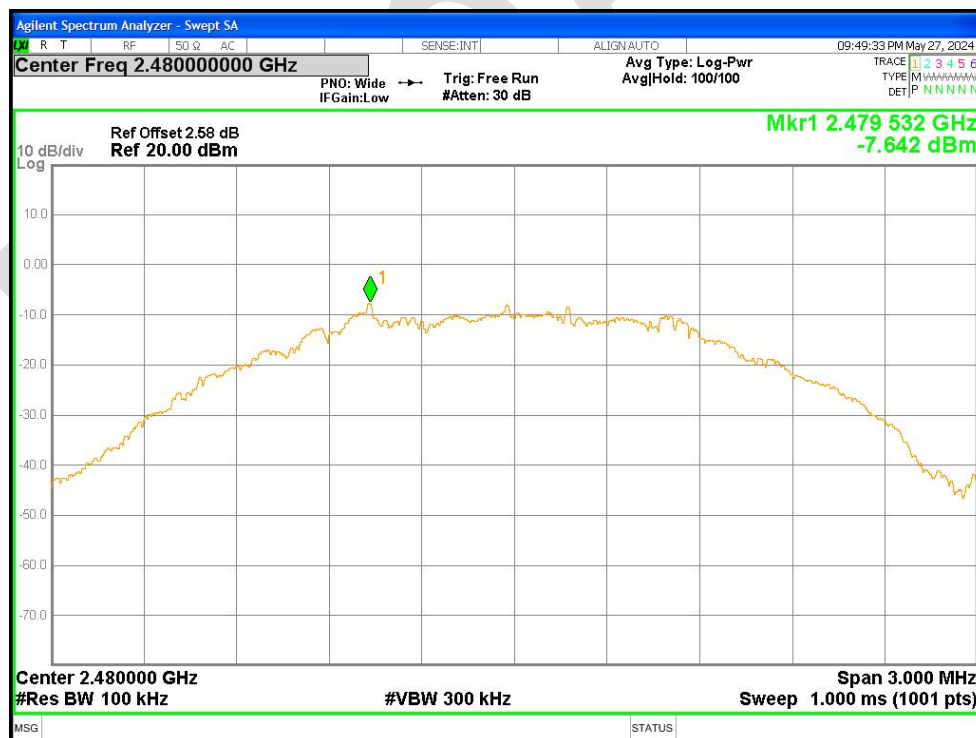
Tx. Spurious NVHT BLE 2M 2480MHz Ant1 Emission

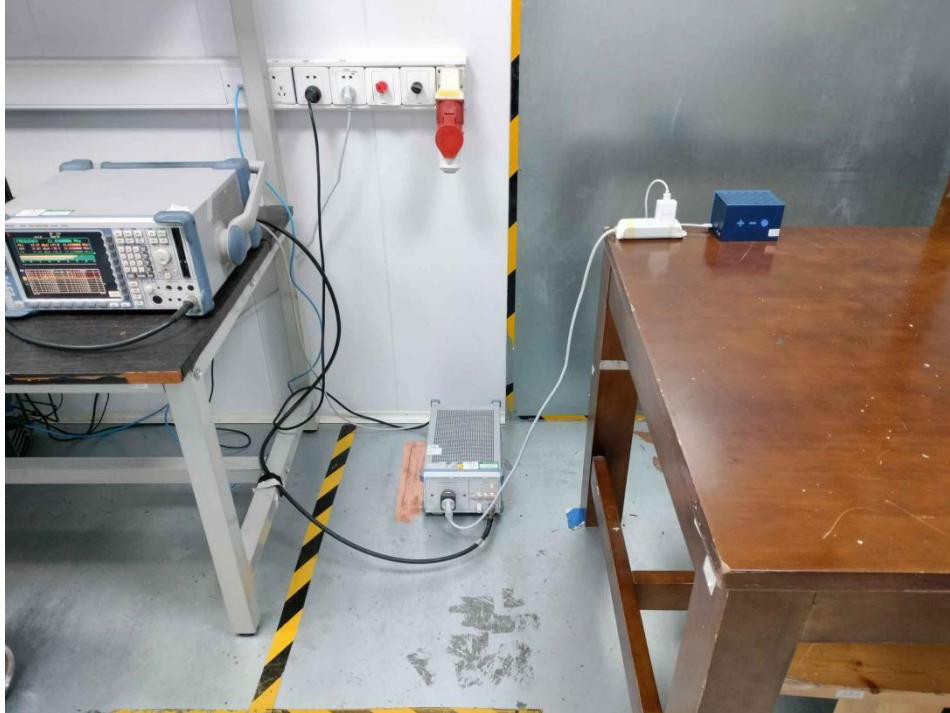
Conducted emissions at AC power line (150kHz-30MHz)
