## Tx. Spurious NVNT ax20 5785MHz Ant1 Emission

## 5 Test setup photo

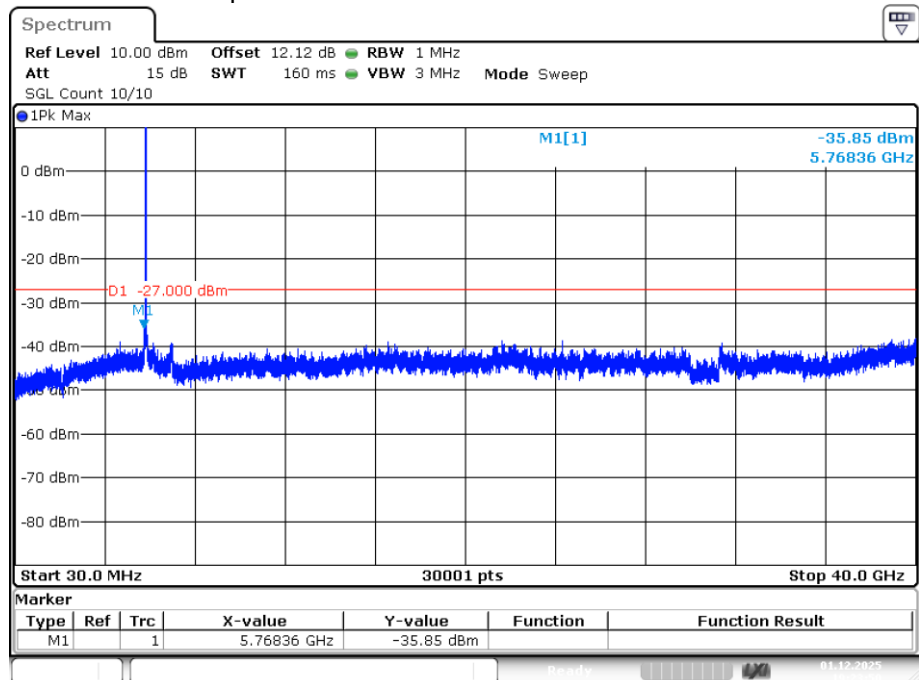
## Tx. Spurious NVNT ax20 5825MHz Ant1 Emission

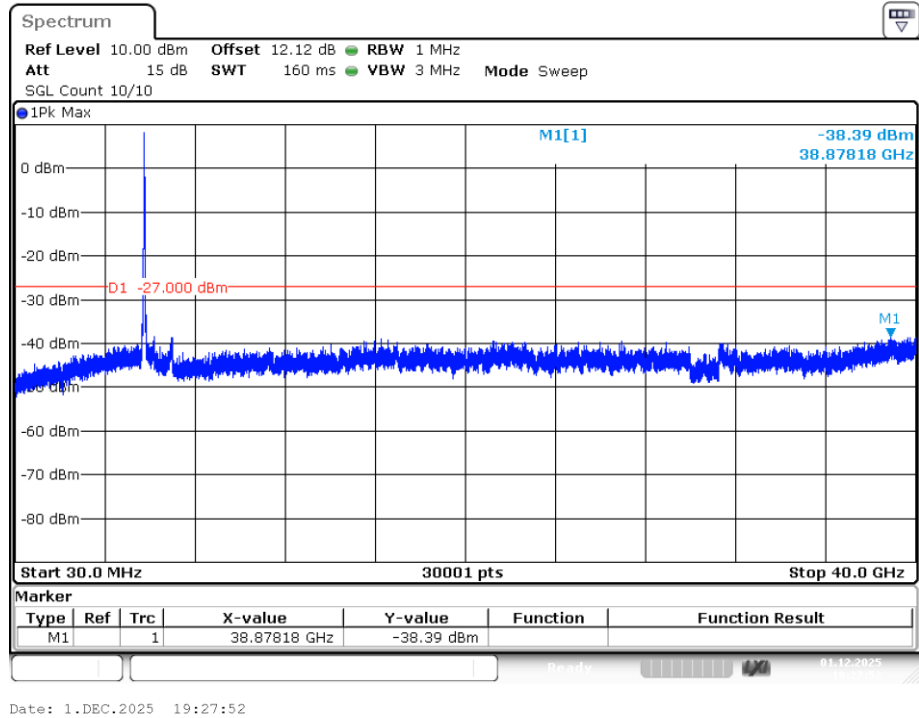
## Tx. Spurious NVNT ax40 5755MHz Ant1 Emission

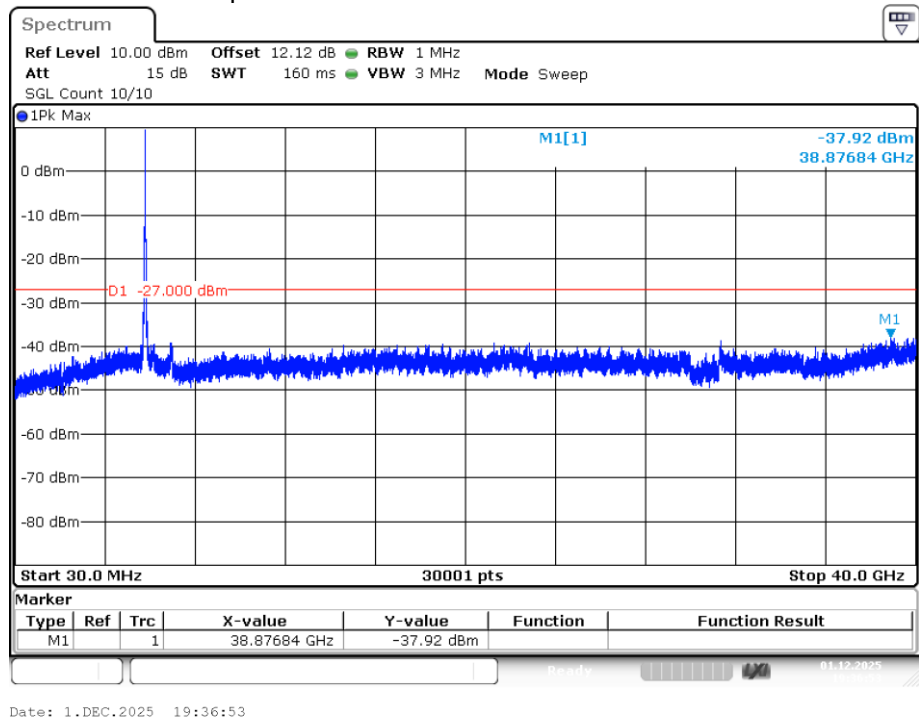
## Tx. Spurious NVNT ax40 5795MHz Ant1 Emission

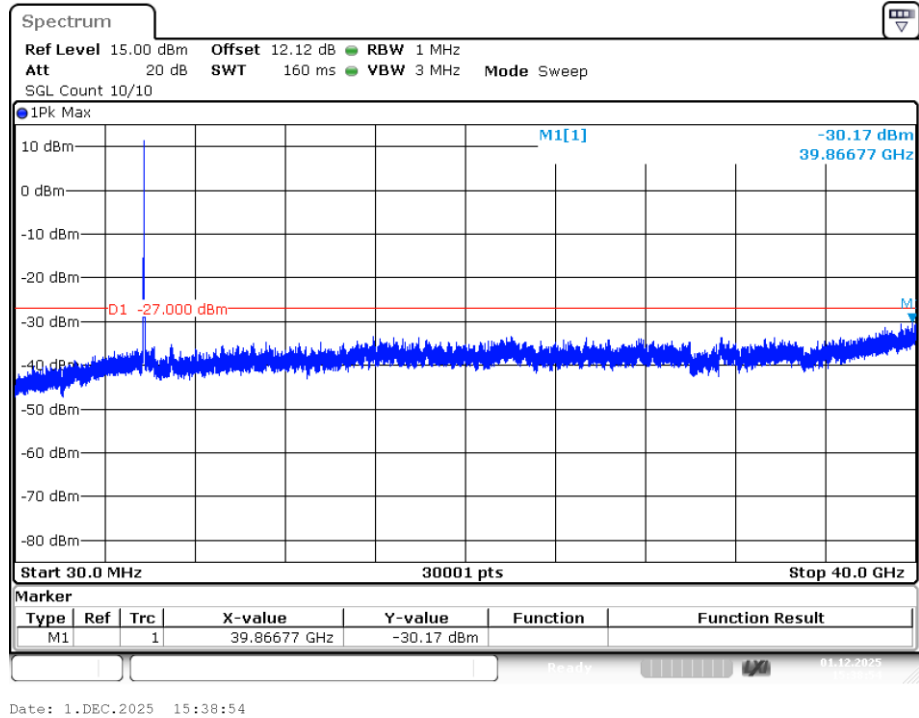
## Tx. Spurious NVNT n20 5745MHz Ant1 Emission

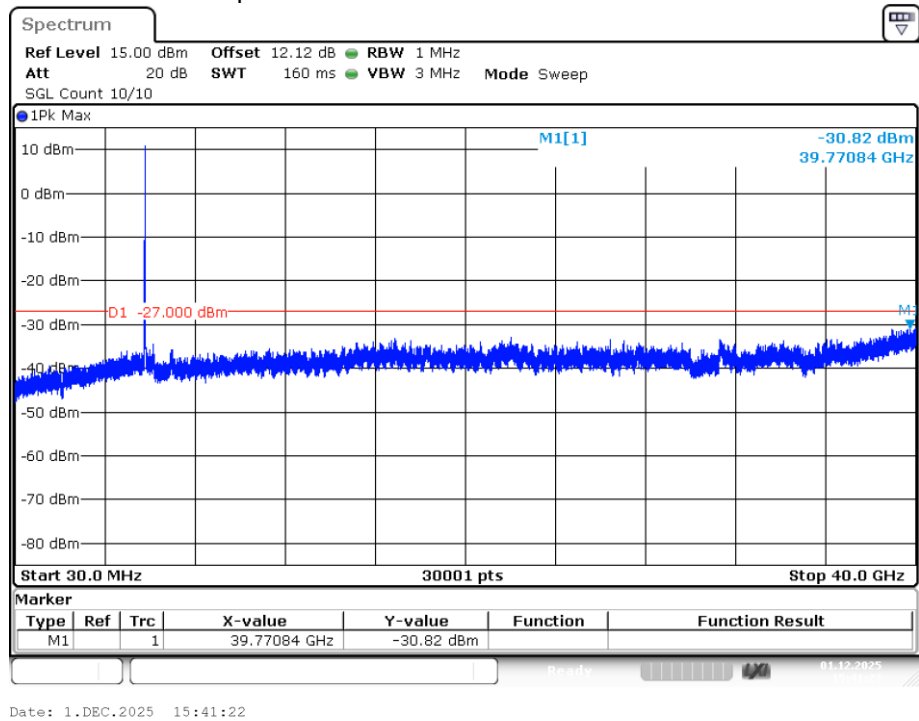
## Tx. Spurious NVNT n20 5785MHz Ant1 Emission

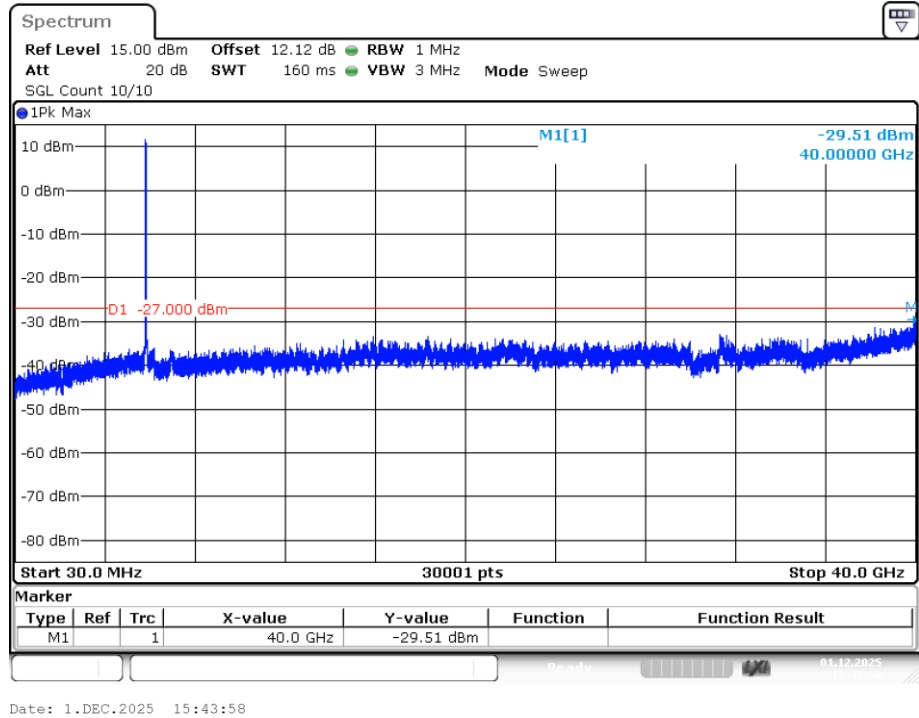
## Tx. Spurious NVNT n20 5825MHz Ant1 Emission

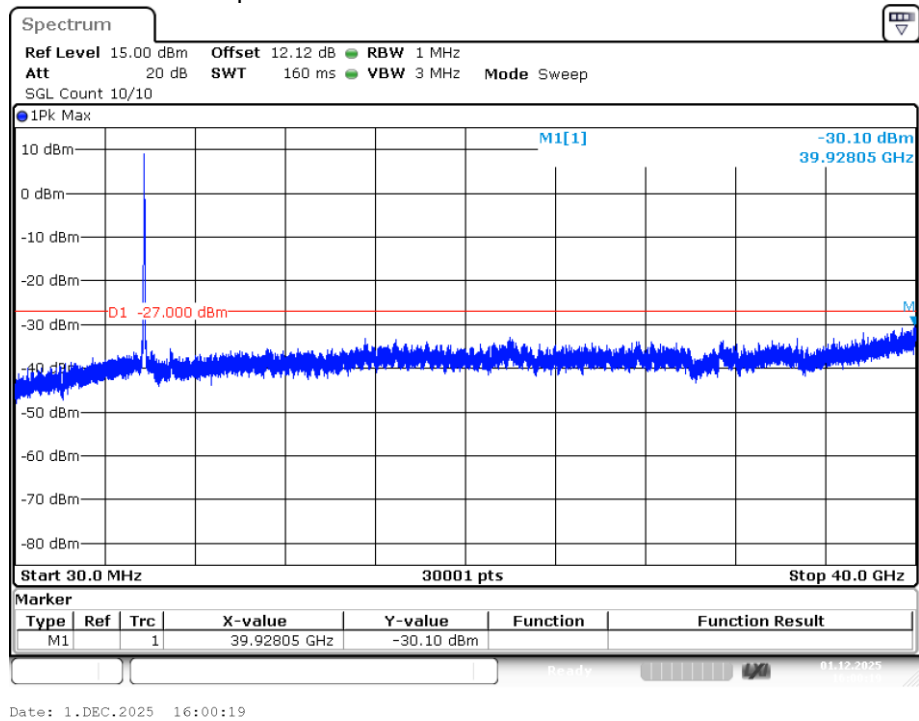
## Tx. Spurious NVNT n40 5755MHz Ant1 Emission

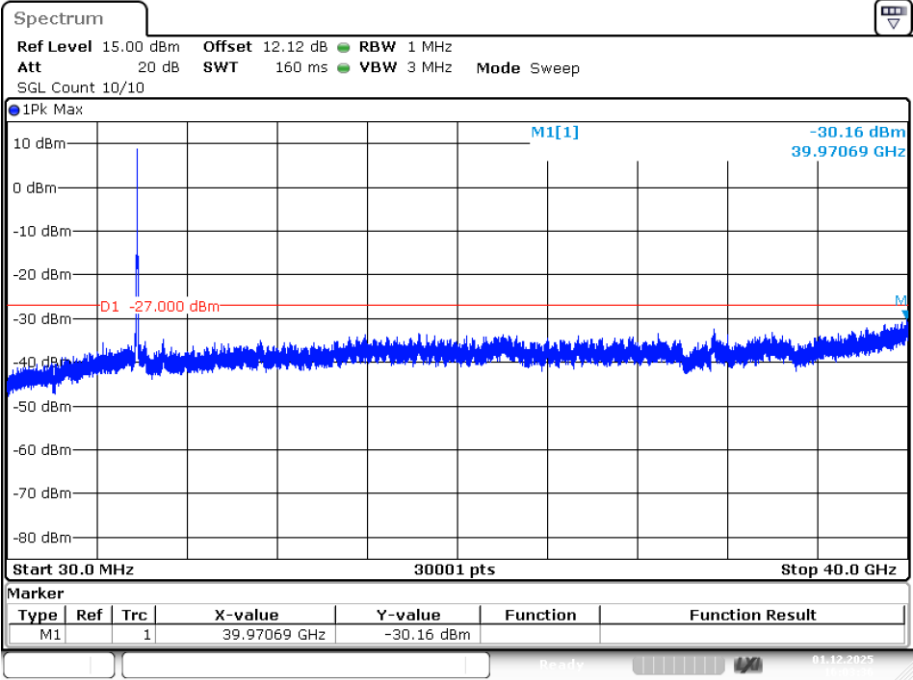
Tx. Spurious NVNT n40 5795MHz Ant1 Emission

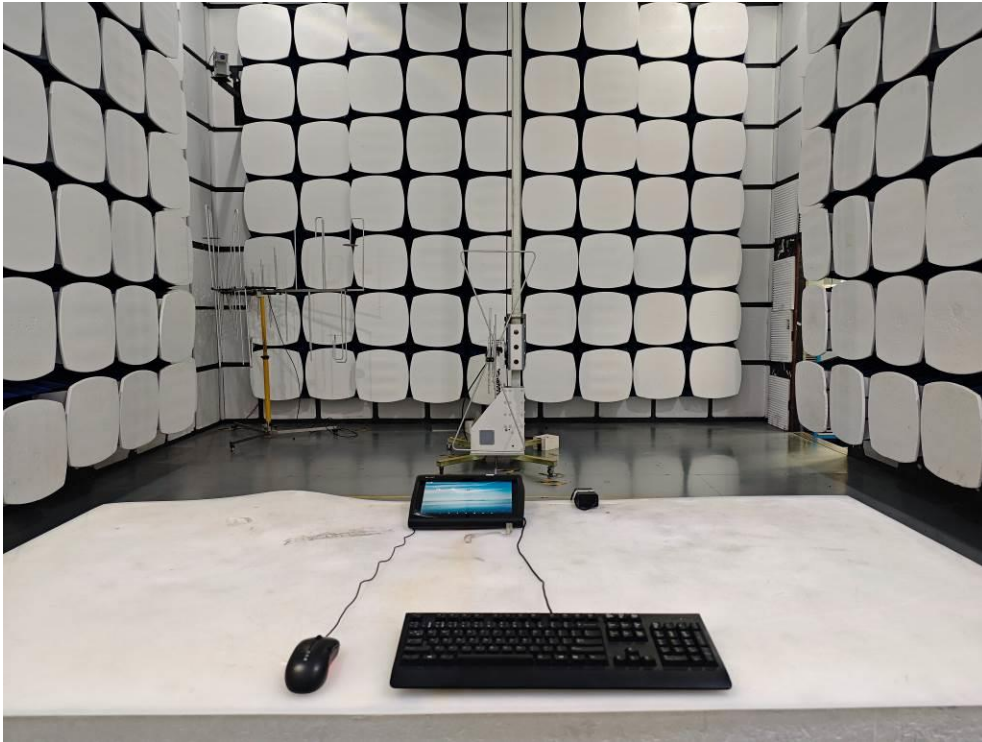
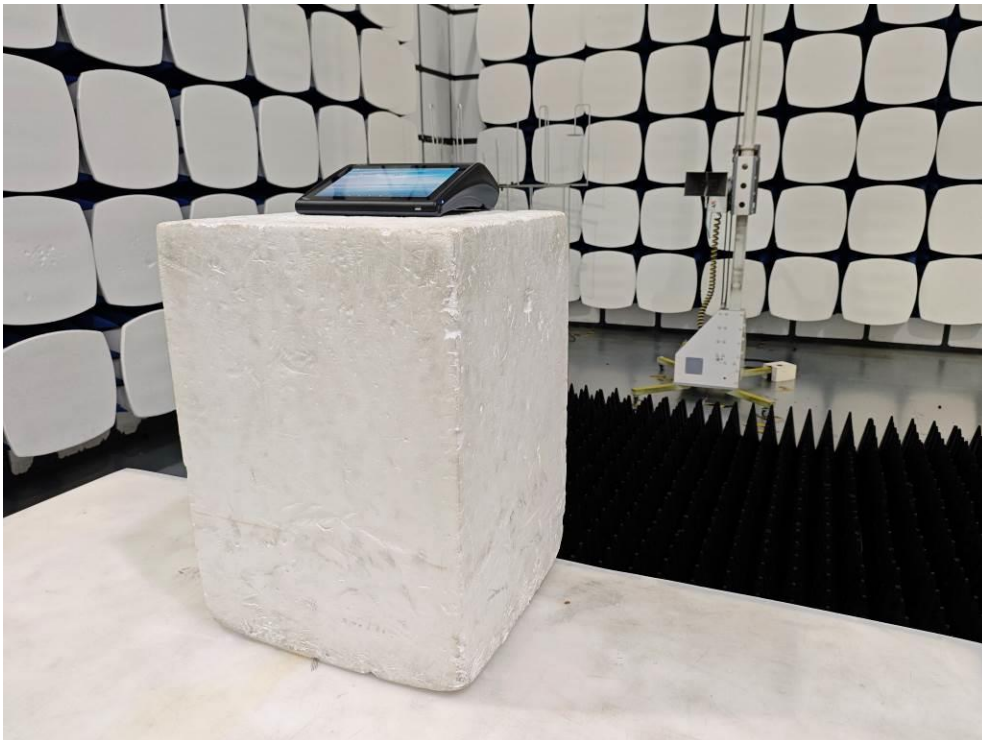
ADP-60D24:

### 5.1 Photo of Radiated Emission test

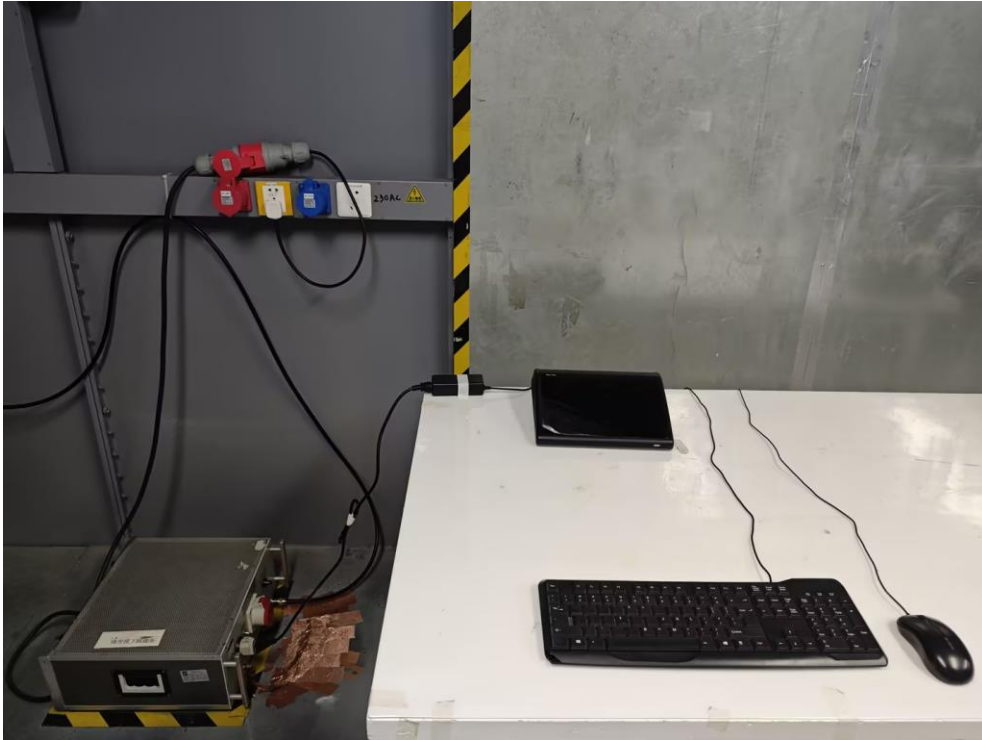
ADP-60D24:

## 5.2 Photo of Conducted Emission test
