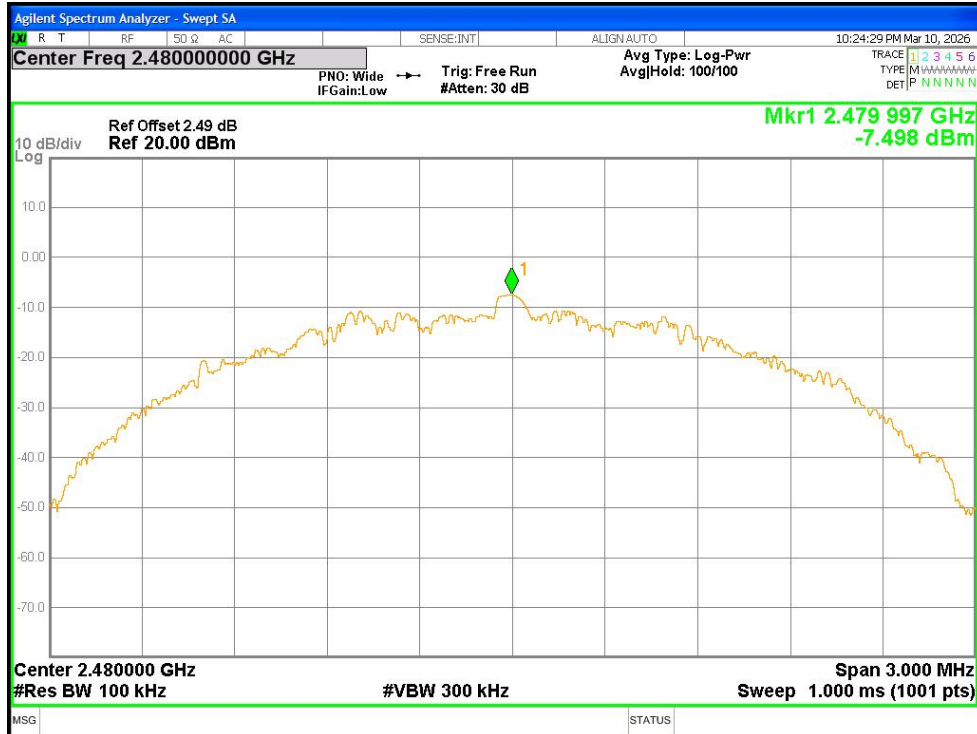
Tx. Spurious NVNT BLE 2M 2480MHz Ant1 Emission

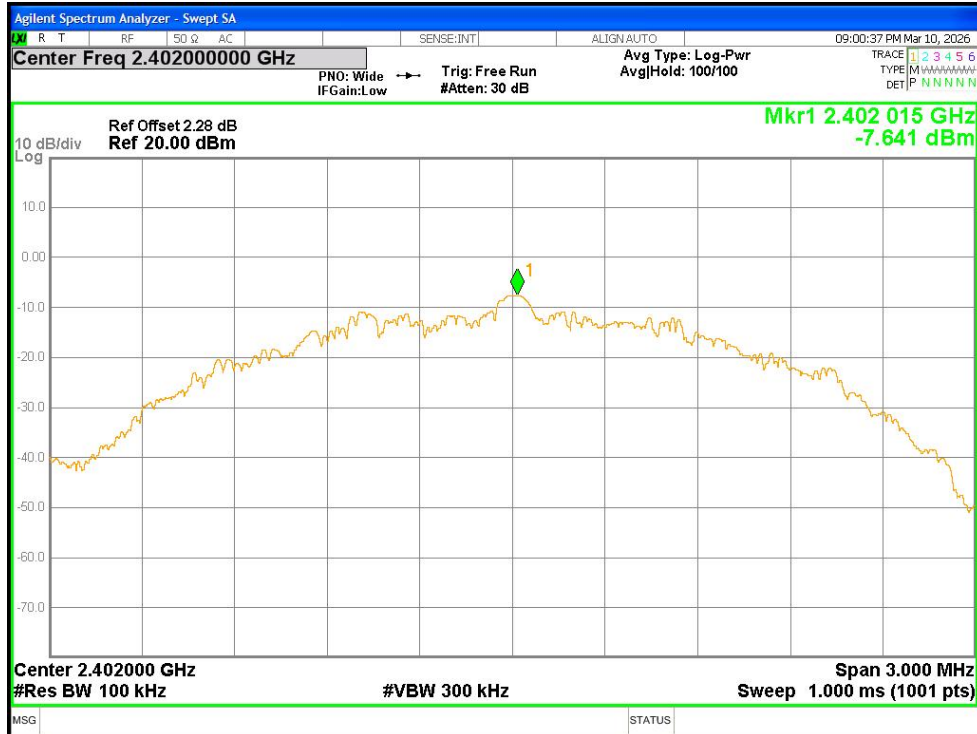
Tx. Spurious NVNT BLE 2M 2402MHz Ant1 Ref

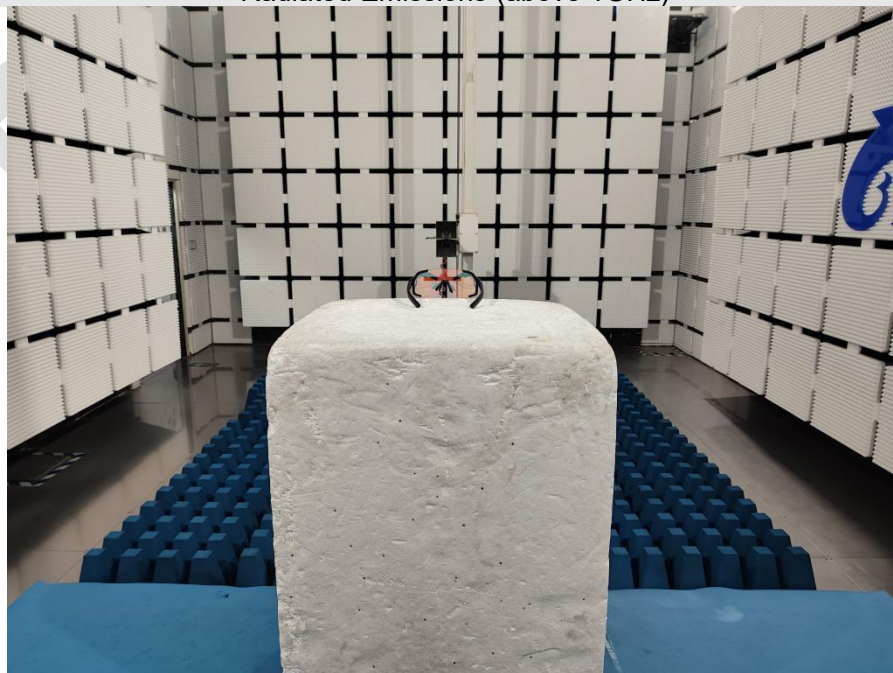
Radiated Emissions (above 1GHz)

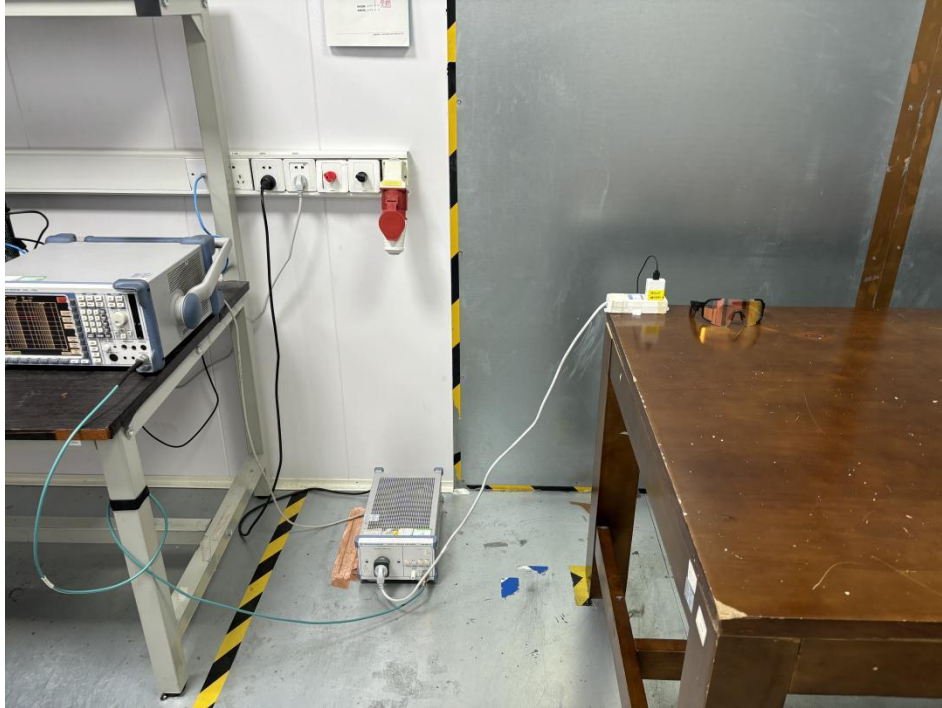
Conducted Emissions at Mains Terminals (150 kHz-30MHz)
