## Appendix B: photographs of test setup

## Appendix C: photographs of EUT

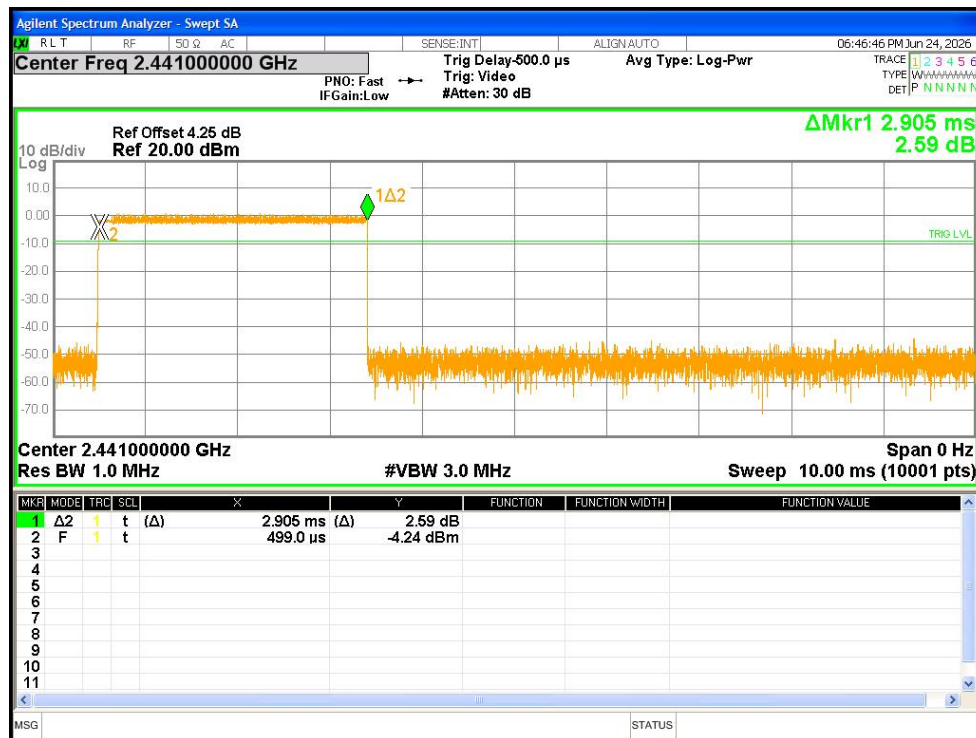
Dwell NVNT 3-DH5 2441MHz Ant1 Accumulated

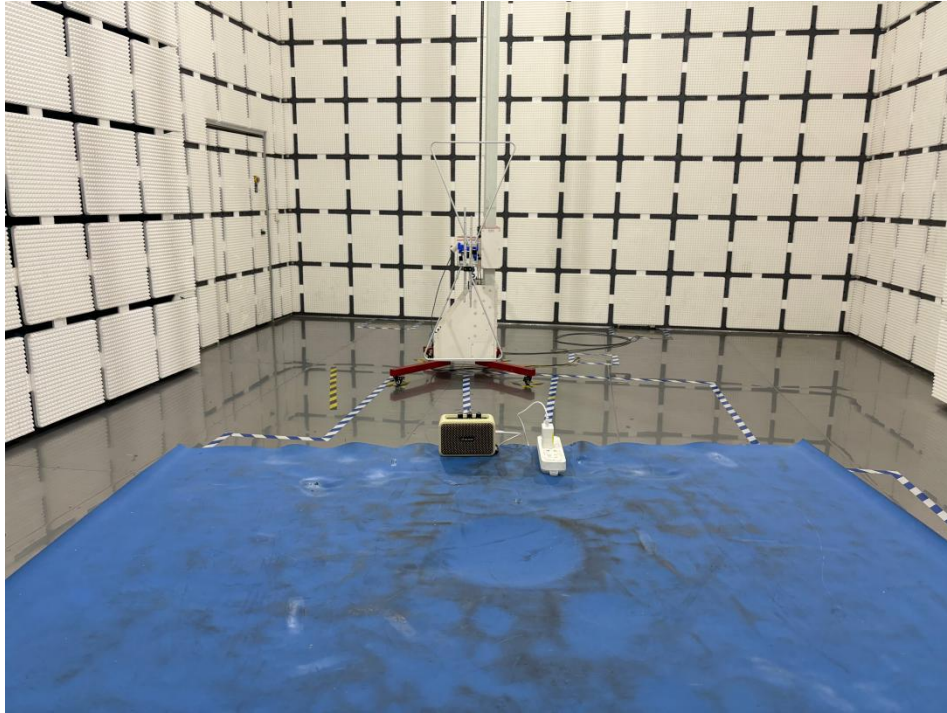
Radiated Emissions (30MHz-1GHz)

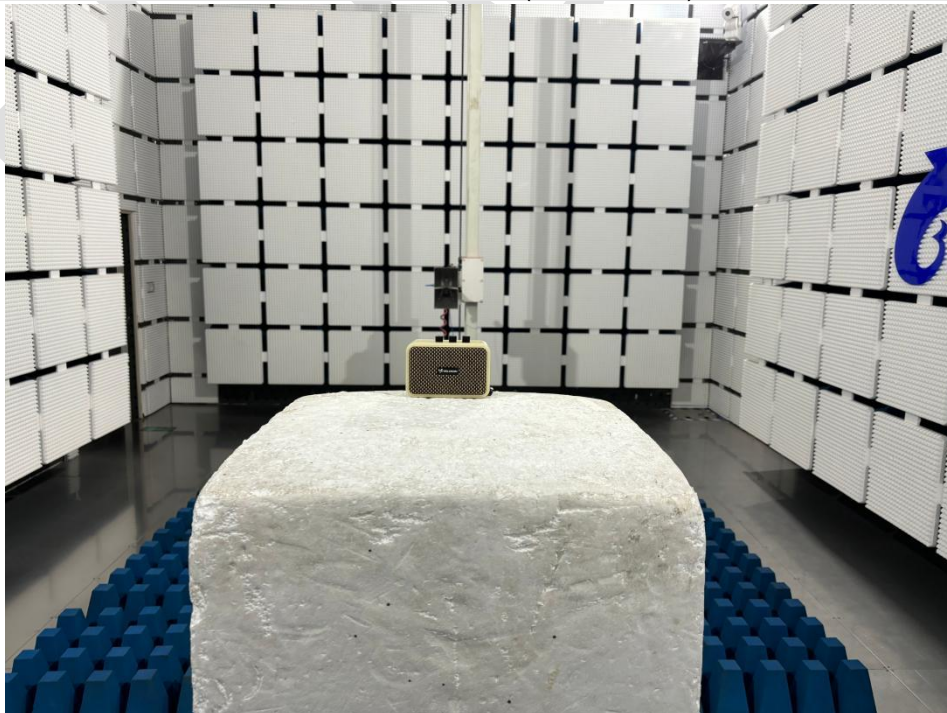
Radiated Emissions (above 1GHz)

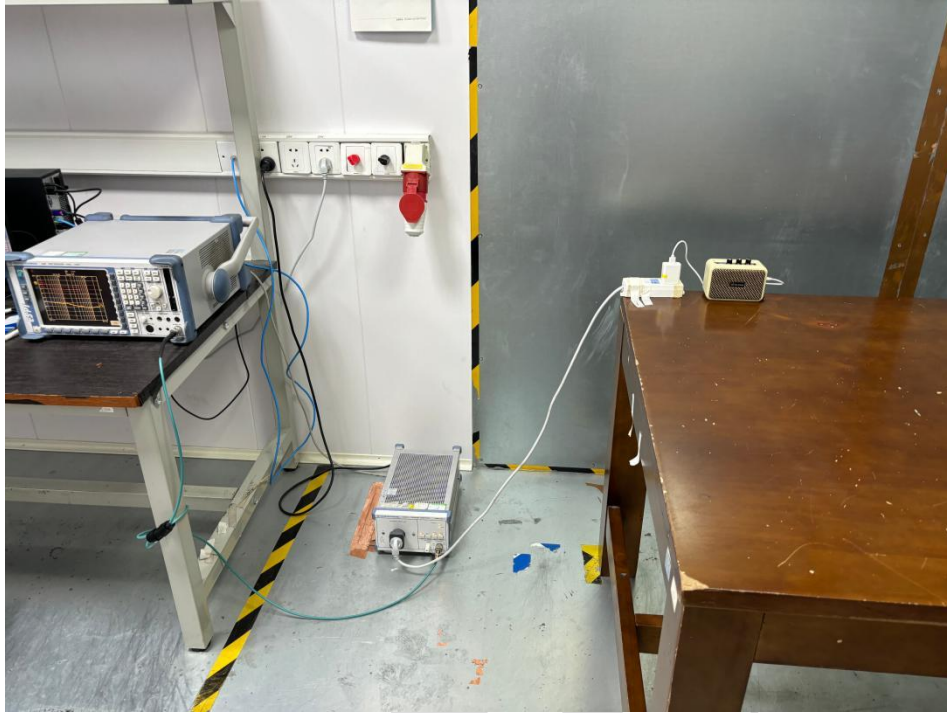
Conducted Emissions at Mains Terminals (150 kHz-30MHz)
