## Description of Changes

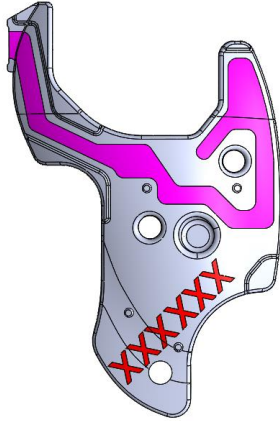
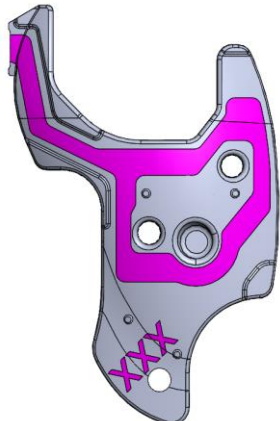
| Item | Antenna_Left | Antenna Gain |
| Before | | -7.3 dBi |
| After | | -7.5 dBi |

- There is change of the antenna pattern.  
Equivalent antenna.
  - Lower antenna gain.
  - Same antenna type.
- There is minor change in PCB layout.  
Minor change in PCB layout does not affect to radio performance.

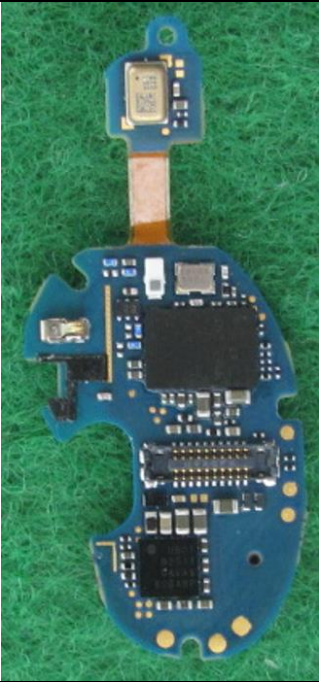
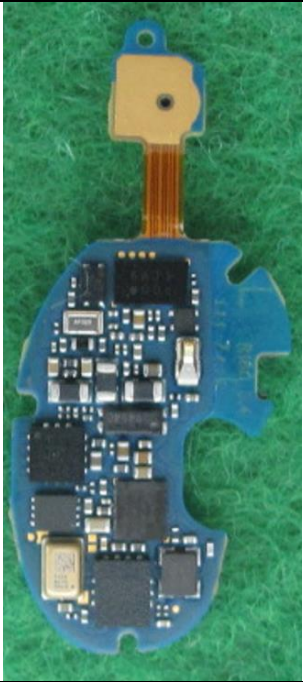
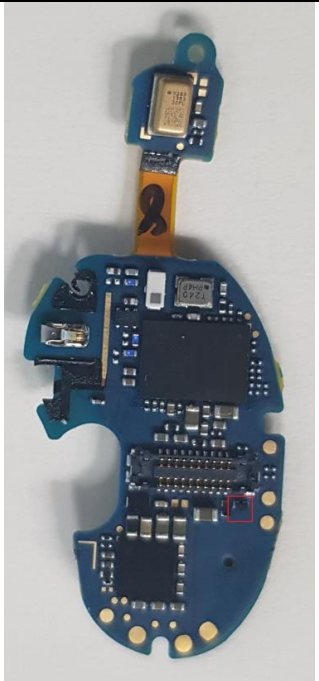
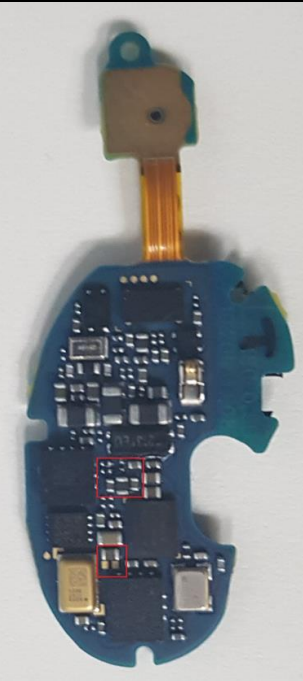
| Item | Main board_Front | | Main board_Rear | |
| Before | | | | |
| After | | | | |
