### **APPENDIX 3: Photographs of test setup**

#### **Radiated Spurious Emission**

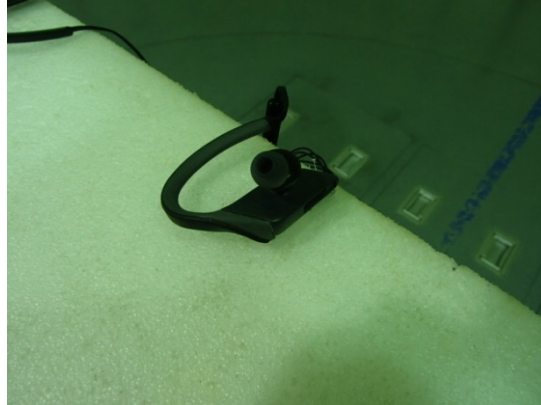
**X-axis**

### **Worst Case Position**

Above 1GHz (Horizontal: X-axis/ Vertical: Z-axis)

Below 1GHz (Horizontal: X-axis/ Vertical: X-axis)
